# The Performance of Vacuum Insulating Glazing Units Subjected to a Soft Body Impact

Isabell Schulz <sup>a</sup>, Cenk Kocer <sup>b</sup>, Franz Paschke <sup>a</sup> and Jens Schneider <sup>a</sup>

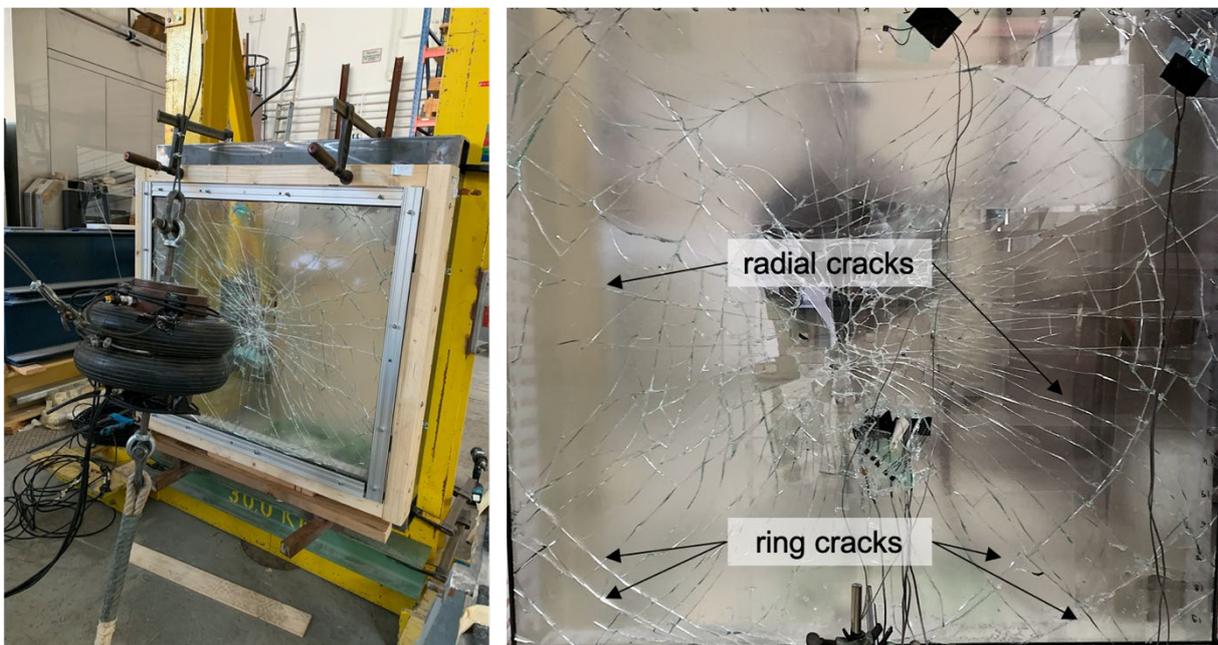
It is worthwhile to consider the impact test of the VIG (producer A) at the 100 mm drop height. Both the glass panes of this VIG unit failed catastrophically when impacted at 100 mm. Two fundamental fracture processes were observed on the glass panes (see figure 4). First, in both glass panes radial cracks originating in the impact contact region (centre-of-glass) formed. The impact energy was high

enough so that pieces of broken glass were ejected from the centre-of-glass area despite the thin plastic foil covering the glass surface. Over the glass pane facing the impactor, additional concentric circular cracks (ring cracks), axially centered to the centre-of-glass, were formed. These fracture patterns are consistent with the centre impact and progressive bending of the sample. At the impact point, bending creates compressive stress on the glass under the impactor (Surfaces 1 and 3), and tensile stresses over the glass surface on the opposite surfaces (Surfaces 2 and 4). As the bending continues, the stresses in the glass at the edge of the frame increase such that there are tensile stresses produced on Surfaces 1 and 3, closer to the edge of the sample. It is from these edge tensile stresses that the ring cracks, as shown in figure 4, originate. This was reported by Chiu (2015) for VIGs under a ball drop impact test and matches stress plots of monolithic panes simulated in SJ Mepla. Figure 5 is a plot of the  $\sigma_1$  stress on Surface 4. From the stress result one can see that glass failure progressed in two steps. About 17ms after initial impact the first pane broke leading to a sudden increase in the stress and 15ms later the second pane broke, being the one on which the strain gauge was applied.

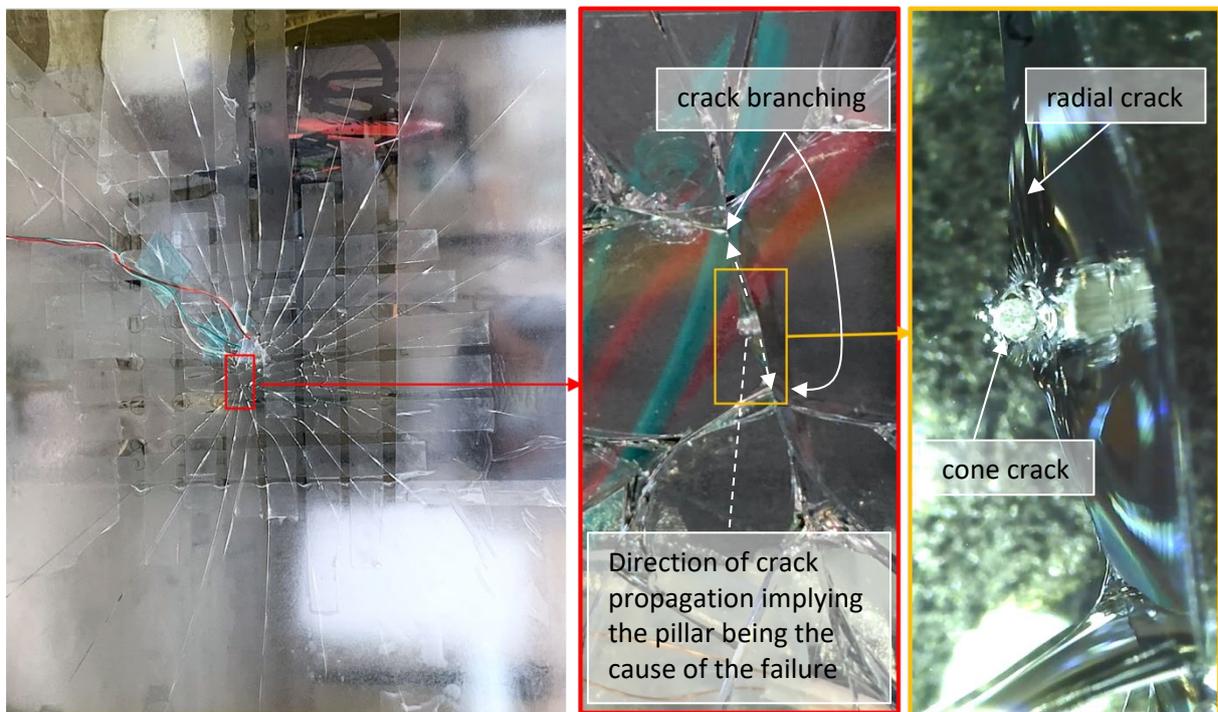
Fig. 9: Location of failure origin for 3 different magnifications

The pillars surrounding the fracture origin within the contact location of the impactor were also inspected using a microscope camera with a x200 magnification. Asymmetric cone cracks at these pillars were found which imply that strong shear forces acted on the pillars during the impact event. When the VIG is placed into bending during the impact event, the glass surfaces facing the vacuum gap will move relative to one another (Surfaces 2 and 3). This means that the pillars on the glass surface will feel a shear force, which is equal and opposite on either side of the pillar contact (Kocer 2005). The shear forces on the pillar will produce high tensile surface stresses on the trailing edge, and high compressive surface stresses on the leading edge, of the pillar, in the direction of the shear load. Similar cone crack patterns were observed in all the other tested VIG products. The size of the cone cracks, and the number of affected pillars, were especially high in regions near the impact contact zone. The

overall damage at pillars in the VIG tested at a drop height of 100 mm was much higher than that observed in the VIGs tested at a drop height of 20 and 50 mm. What is noteworthy is that damage at the pillars was also found at the initial drop height of 20 mm. It is reasonable that the initial damage observed would have continued to grow when the units were tested at 50 mm. This does raise the question of whether or not the procedure of soft body impact is applicable to VIGs. It would be much more appropriate if the impact test procedure required the local damage at pillars to be identified and recorded. Which in turn raises the question: Is it reasonable to suggest that if fracture of the glass at a pillar is observed then the VIG unit is deemed to have failed the impact test?
