Restoring Hi-Tech Architecture

Peter Lenk ^a, Peter van de Rotten ^b, Ed Forwood ^c

In this paper we will discuss a challenging, iconic, heritage, refurbishment project – Channel 4’s headquarters building located in London, England. The building was originally designed by Richard Rogers and Partners in collaboration with Arup, RFR and was executed in 1994 by Eiffel under a sub-contract package with Permasteelisa. We will methodically outline the procedures that were followed to assess and restore this ageing, iconic cable net façade where, in an almost unprecedented way, the face glass is used structurally to support the dead load of the panels below to create a chain of suspended glass panes. After approximately 25 years of service Arup was called back to provide advice to the client following a glass breakage incident. This triggered a detailed condition survey which concluded that a project refurbishment was overdue. Arup then provided further studies to inform strategic options as to how to best refurbish the façade. This advice led to the appointment of Octatube to provide Pre-Construction Services Agreement (PCSA) support to assist the façade appraisal and to carry out desi

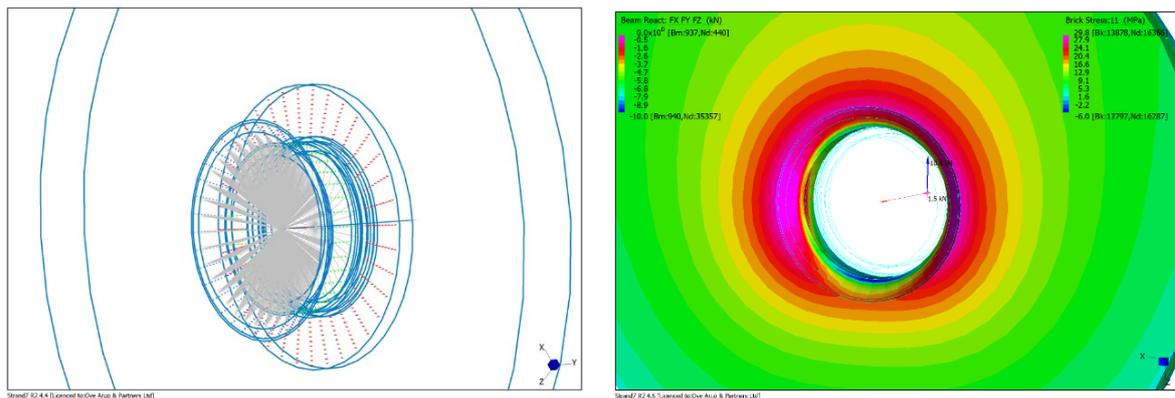
Fig. 4 Left: Analysis model of the undercut glass connection, Right: Analysis results under in-plane force of 10 kN, glass stress is 30 MPa.

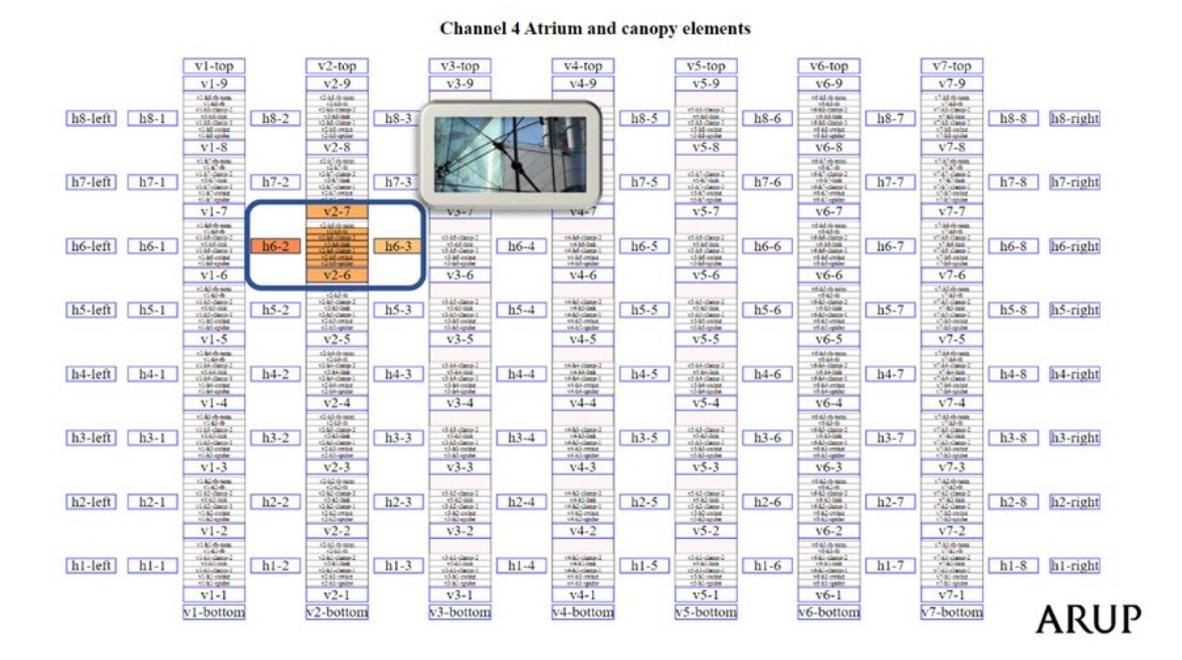
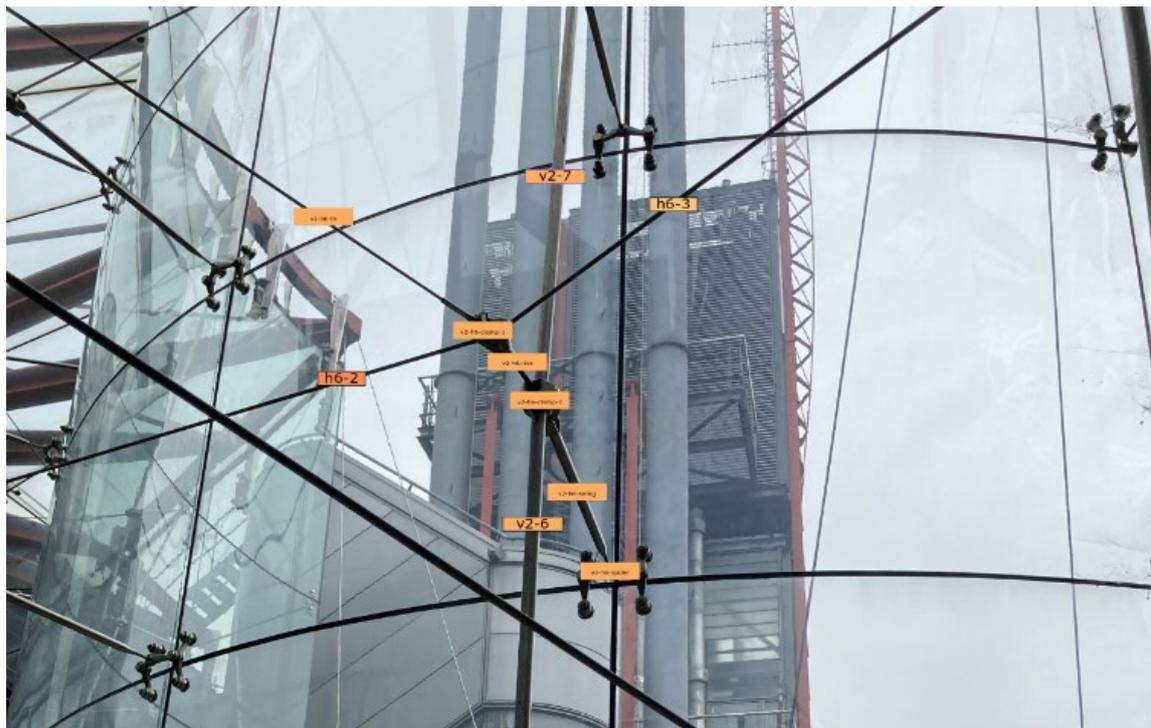
Fig. 5: Dashboard of cable net elements showing naming convention with crossover V2-H6 highlighted, Close-up of horizontal and vertical cable cross overs at crossover V2-H6.

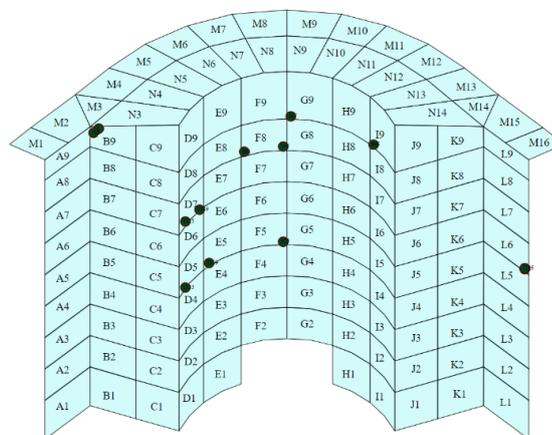
Fig. 8: Image shows the shell images with location tagging on Arup Street.

From the original Permasteelisa abseil survey, 10 panels were identified with shelling. After this initial investigation an additional 8 glass panels with and 10 steel fixings in total were identified as compromised.

All shelling occurred around the countersunk hole detail at the point connections including the uppermost fixing.

To avoid peak stresses in the glass the countersunk design was abandoned and mortar injection between rotula and glass to activate both plies was adopted. This solution has been extensively studied and tested as described later in this paper.

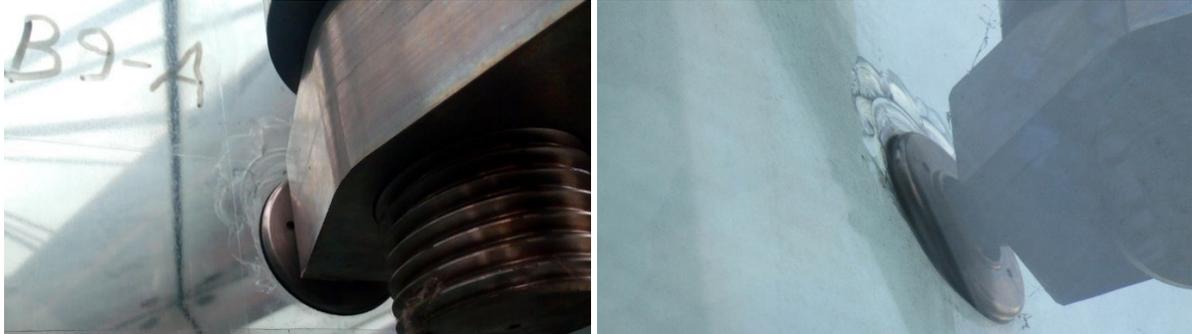
Fig. 9: Example of glass shell located in panel B9.

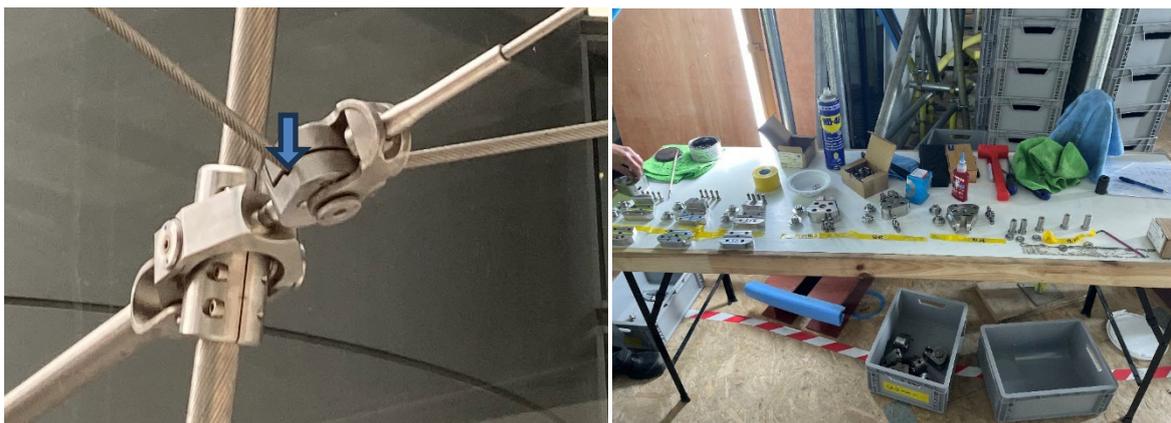
An additional challenge noticed during the detail cable net inspection were alignment of clamps, forks, pins and bolts which needed particular attention during the disassembly as the exact condition was not fully known prior de-tensioning. Only a small fraction of cable net components were replaced with new like for like fixings due to their wear and tear and concerns relating to their current precision. Where concerns were attributed to the wear and tear of cable net clamp settings precautionary and ingenious safety over-clamps were installed to ensure that the cable net could not experience a sudden release of energy by a connection losing its interlocked state.

Fig. 10: cable clamp misalignment and in-situ inspection.

Prior to the façade disassembly safety over-clamps were also installed in some locations to provide a secondary connection detail where the surveyed fit of the nodes appeared at risk of loosening to such an extent that there was potentially risk of attachment of key connections.

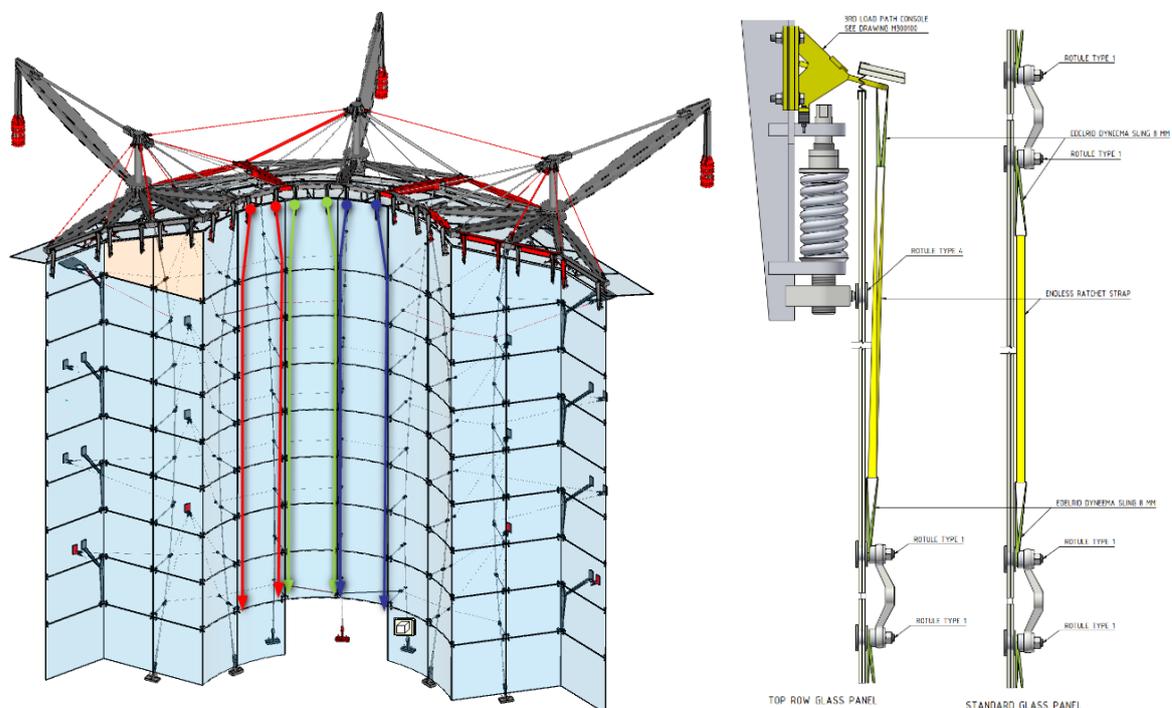
Fig. 13: Indication of position 3rd load path. For 3 columns of glass shown.

This additional load path was also used for the installation of the new façade as a part of the temporary works to provide a safety measure during the construction.

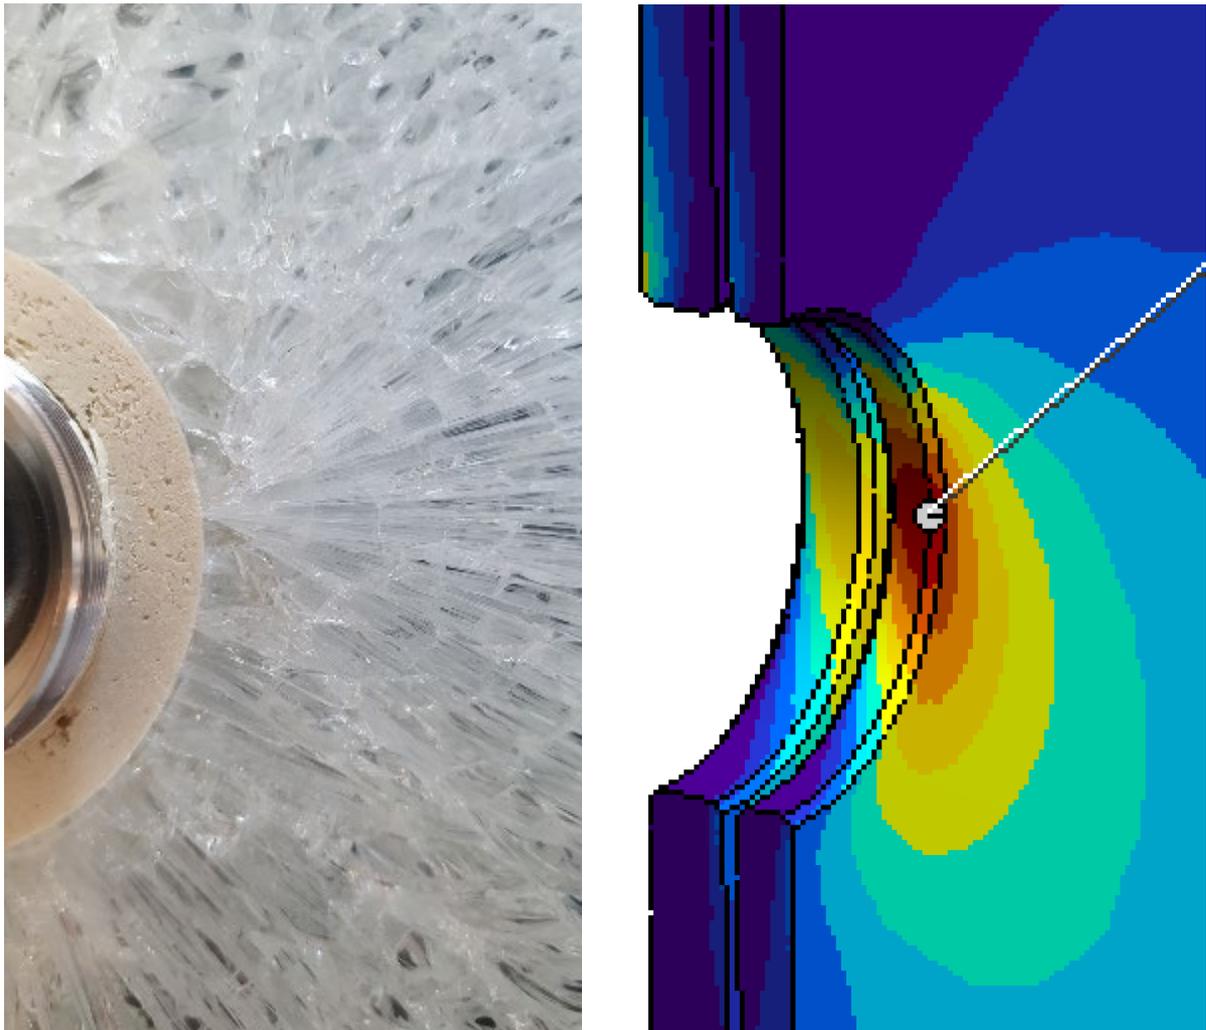
The custom designed point fixing, with the rotula captured with mortar in the glass, was tested. The rotula is subject to high in (glass) plane loads due to the suspension of the façade panels as a chain. According to the results of the tests it can be stated that the special designed rotula with mortar injection is strong enough for this project. The 6 mm glass sheet (inner sheet) broke first followed almost immediately by the 8mm sheet.

The glass initial breakage can be attributed to the point of the highest stress in the calculations as seen in the screenshot of the FEM model showing the location of the highest stress. There were no changes in the appearance of the Hilti resin and no damage observed.

Fig. 18: Sample after test, glass broken, Hilti undamaged.

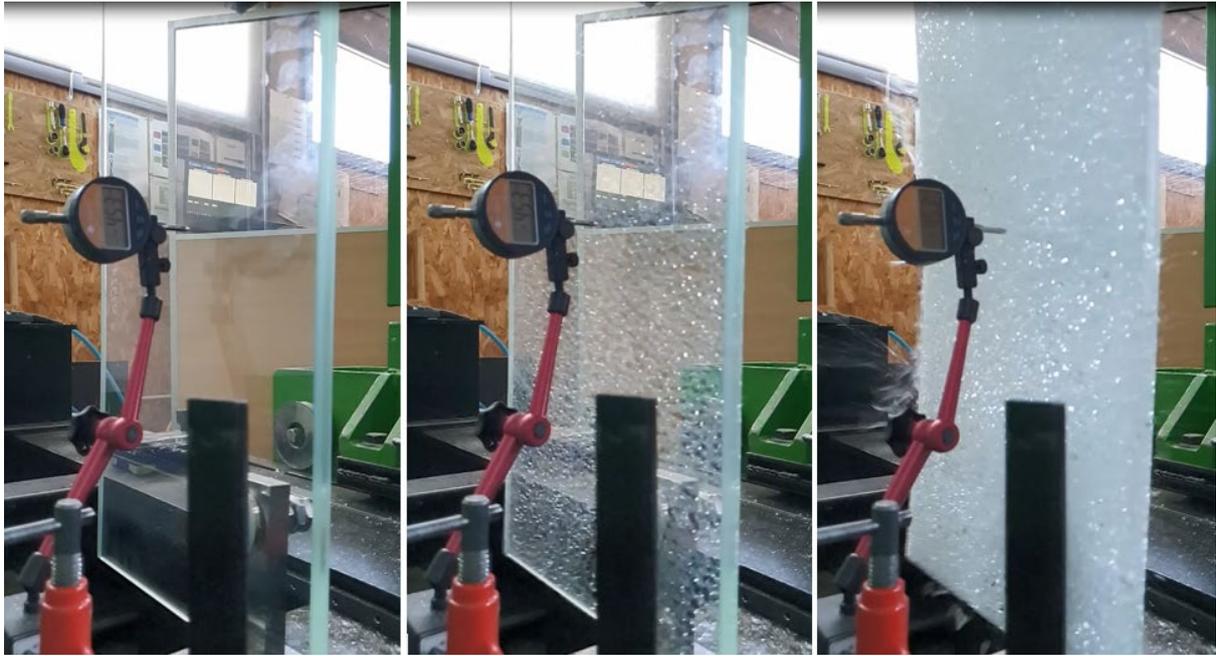
Fig. 19: Sequence of breaking. 6mm sheet first.

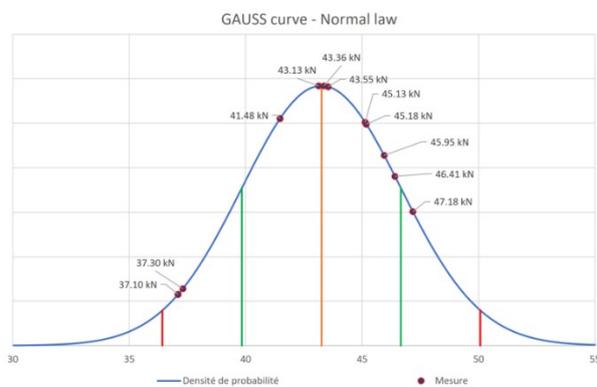
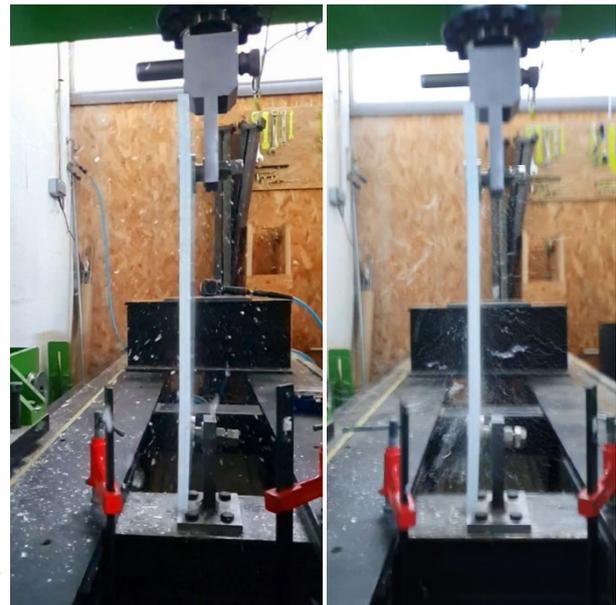
Fig. 20: Glass sample just after breaking with a loud bang.

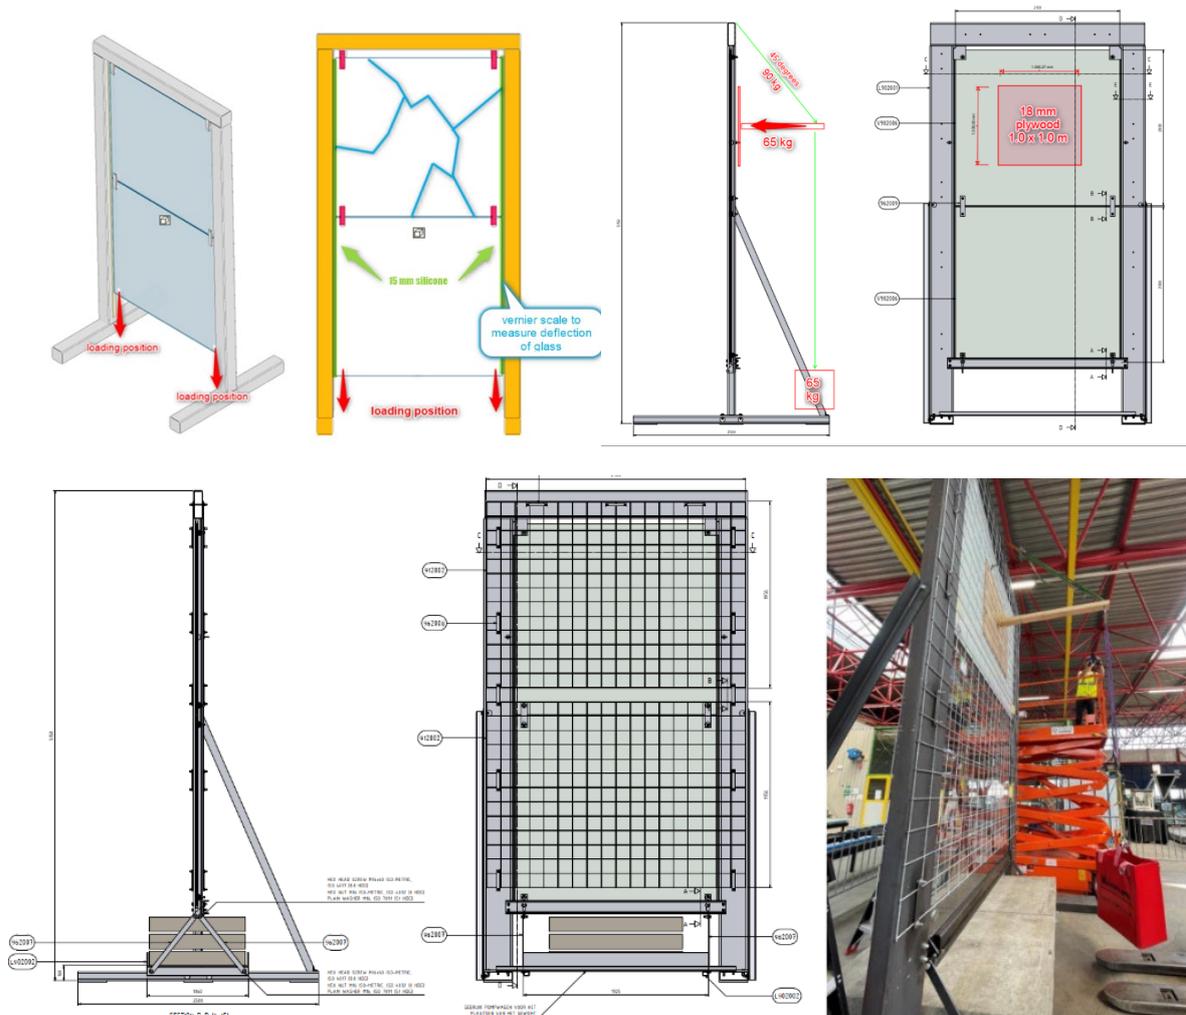
All the panes were broken, and a horizontal load was applied on the broken glass. The broken glass remained in place and didn't fall out.

The panel slightly deformed during the breaking of the plies. The panel further deformed when the horizontal load was applied. The glass didn't break off around the point fixing. Even though in the test there was allowed for more deformation than is to be expected in practice, the silicone was able to carry the load. The second load path through the silicone was activated and functioned fully.

The glass and silicone system successfully passed the full-scale post breakage behavior test.

Fig. 22: Full scale test mock up: two glass panels are suspended in a steel frames, the first load path are the mechanical connections, the second load path the structural sealant.

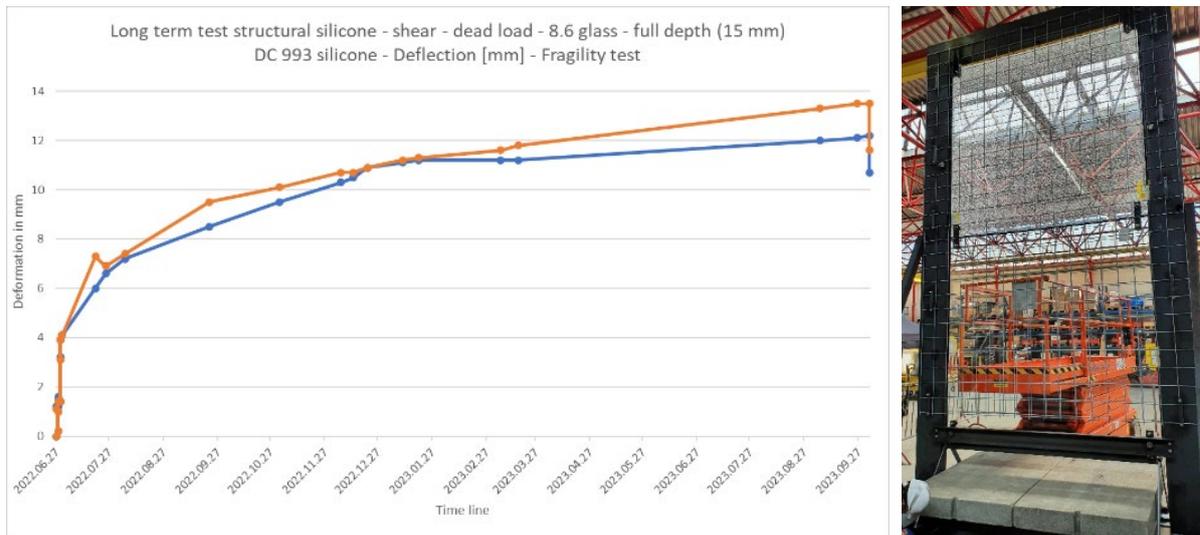
The glass deflected 0.7 mm immediately after the test started. According to FE Analysis, the expected deflection was 0.6 mm. A long term deformation of up to 2 mm was noted after 15 months. For both tests a similar deflection profile over time was observed.

Fig. 23: Long term test, 9.5 kN load on duos. (total load 19.0 kN)
(two glass points measured on the left and right side of the glass panel, orange and blue).

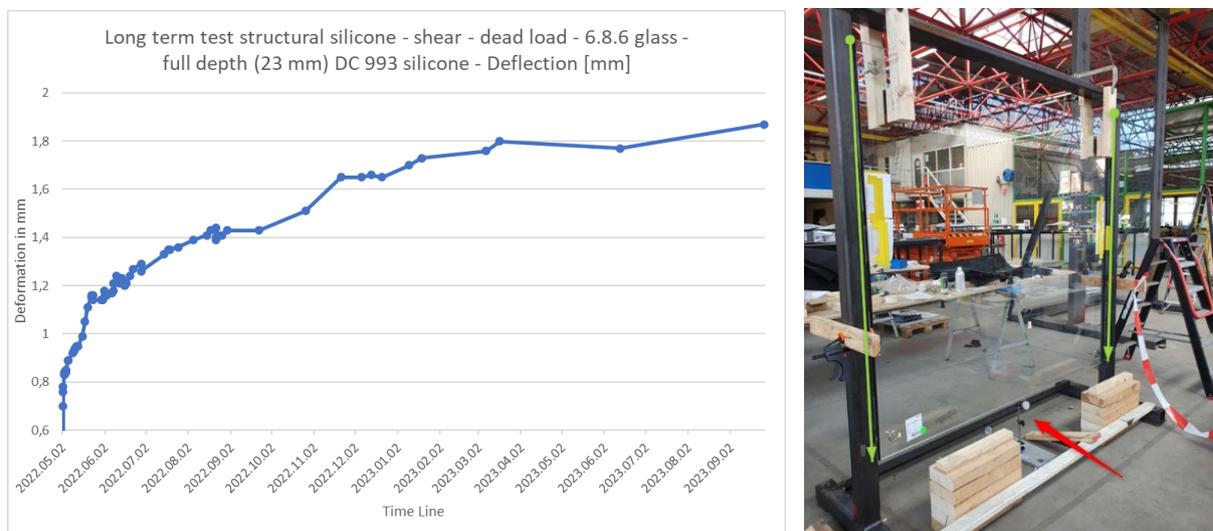
Fig. 24: Long term test single pain, no additional load, stress in silicone 0.026 N/mm².
