# Post Breakage Strength Testing for Overhead Laminated Glass

I. Stelzer<sup>a</sup> & M. Singh Rooprai<sup>b</sup>

<sup>a</sup> Kuraray Europe GmbH, Germany, [ingo.stelzer@kuraray.com](mailto:ingo.stelzer@kuraray.com)

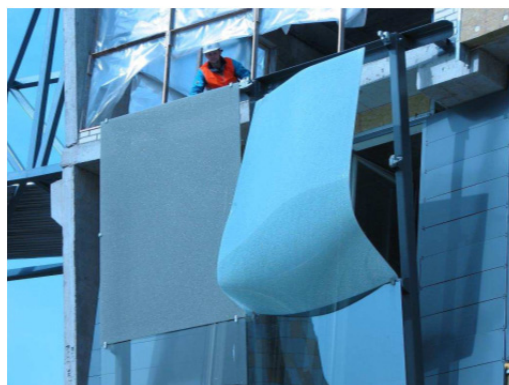
Fig.1 The “Wet Blanket” Effect

Laminated glass has a significant improvement in the post breakage strength over a monolithic layer of glass, the glass fragments adhere to the interlayers so that a certain remaining structural capacity is obtained as the glass fragments ‘arch’ or lock in place. This capacity depends on the fragmentation of the glass and increases with increasing fragment size. Therefore, laminated glass elements would typically achieve a particularly high remaining structural capacity when made from annealed or heat strengthened glass that breaks into large fragments. The post breakage behavior furthermore depends on the interlayer material. The most common interlayer is PVB whose mechanical properties are heavily depended on temperature and load duration. At room temperature, PVB is soft with an elongation at break of more than 250%. For higher temperatures and load durations the shear transfer is greatly affected. Low stiffness of the PVB interlayer results in “Wet Blanket Effect” (Fig. 1) as soon as the glass breaks even for vertical applications because of the self-weight of the panel especially with large panel sizes and minimal supports. SentryGlas® Ionoplast Interlayer, from Kuraray (originally invented by DuPont), was developed with the aim of achieving higher stiffness, temperature resistance, resistance to tearing in point fixed rotule applications. This helps in achieving a superior post breakage strength and design redundancy.

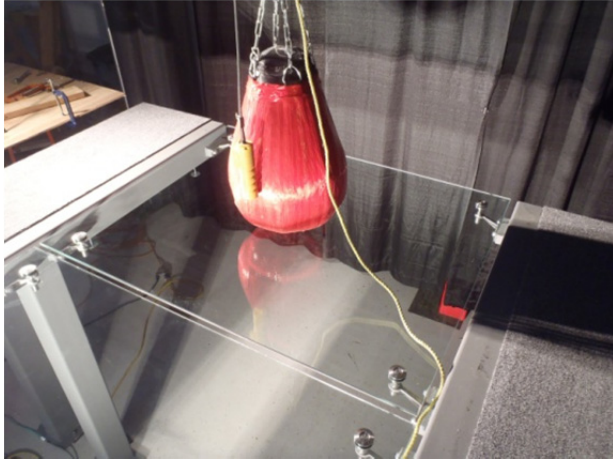
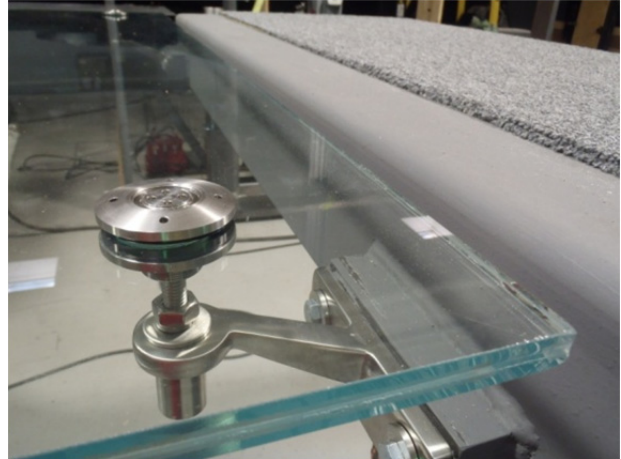
Fig. 2 (a & b) Impact Test on a Frameless (point supported) canopy application, view from above showing the impactor before the impact (a) and a close-up picture of the rotule type fixation system

Impact tests were done at Intertek ATI Inc. York, Pennsylvania by dropping a soft bag weighing 100 Kg (typical weight of maintenance working carrying his tools and personal equipment) from a height of 1200 mm at a test temperature of 50°C. The test method simulates potential loading from installation and /or maintenance workers in distress. The panels were conditioned at 50°C for 1 hour before the test. The test set up was enclosed with insulated panels and the temperature controlled by an air conditioning device to ensure there is no variation in test results due to temperature. The insulated panels on top of the glass were removed just before the impact (Fig. 2).

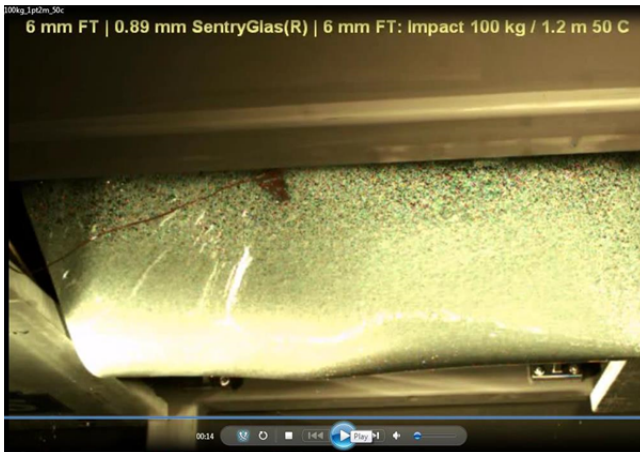
Fig. 3 Ionomer laminate provided "Fall Through" resistance, view from below during the impact

Fig. 3 shows how the laminate made from SentryGlas® Ionoplast Interlayer provided a barrier against the impactor. The impactor was removed after 15minutes without any tearing of interlayer observed at the rotules. Whereas laminates made from EVA, Standard PVB and Stiff PVB in Fig. 2, 3, 4, 5, 6 respectively, collapsed as soon as the impactor strikes, and failed to act as a barrier.

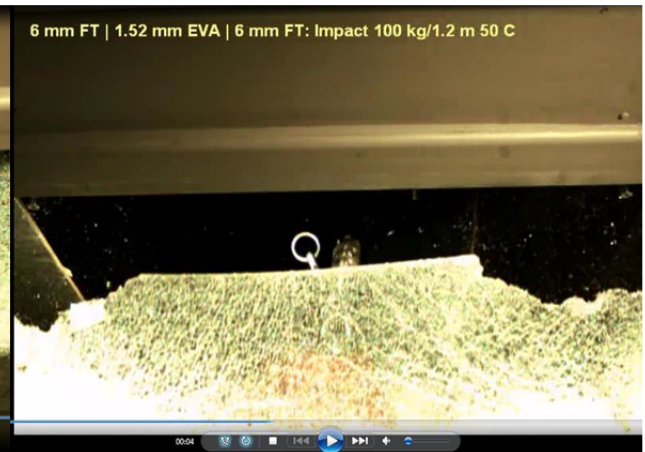
Fig. 4 EVA laminate provided no "Fall Through" resistance, view from below just after the impact, see failure of the laminate

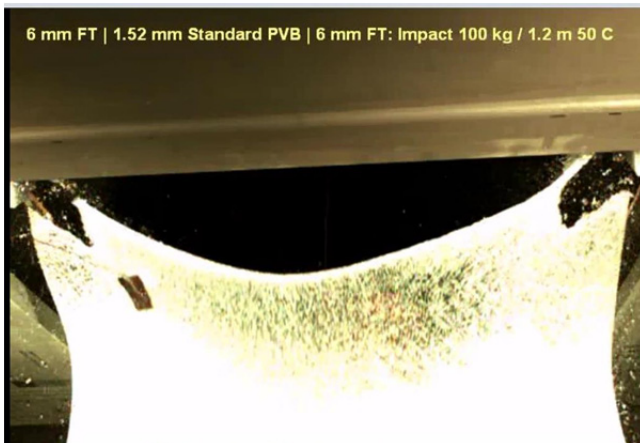
Fig. 5 Standard PVB laminate provided no "Fall Through" resistance, view from below just after the impact, see failure of the laminate

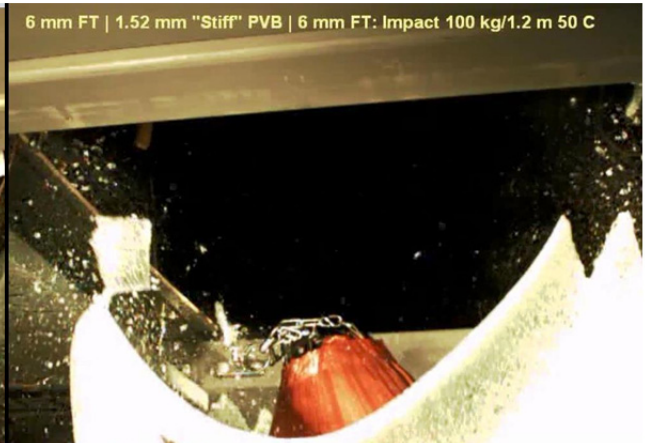
Fig. 6 Stiff PVB laminate provided no "Fall Through" resistance view from below just after the impact, see failure of the laminate

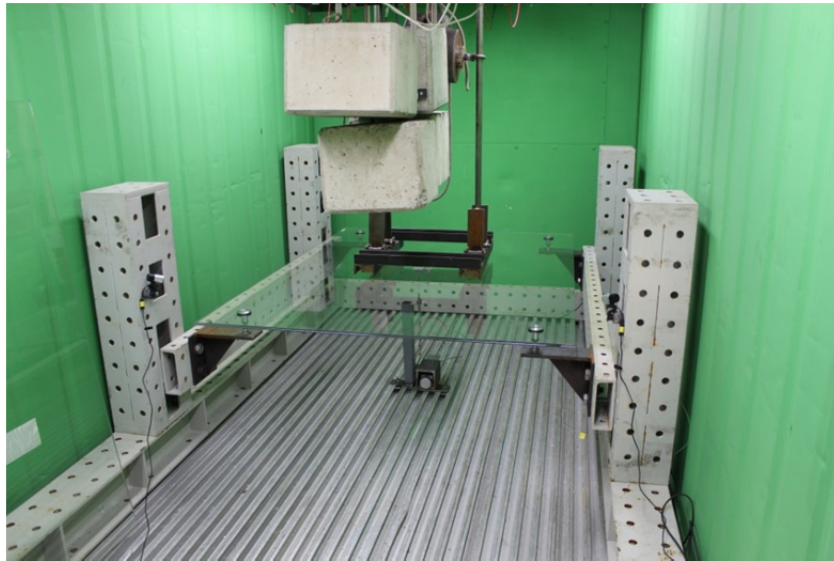
Fig. 7 Post Breakage Test layout in climate chamber

Post breakage strength tests on point supported glass panels (1500 mm x 2000 mm) for a typical canopy application were conducted at University of Armed Forces in Munich, Germany. 9 glass panels with each of 4 different interlayers – Ionomer (1.52 & 0.89mm), Stiff PVB (1.52mm) , and PVB (1.52 mm) were prepared for testing at 3 different temperature scenarios.

The objective was to know which interlayer type laminate construction can pass the requirements set by pr DIN 18008-6 at 3 different temperatures (-20°C, +21°C and +50°C). 3 panels were tested for each temperature scenario. An attempt was made to know the ultimate capacity of the laminates. However, the test apparatus had a limitation of applying a maximum load of 400 Kg. The laminates were conditioned for at least 3 hours for each temperature scenario. The test chamber had a temperature control mechanism (AC-System) for a temperature range of -25° C to +50°C. The laminate construction with all different types of interlayers was strong enough to withstand the impact against any breakage. Therefore the upper layer of laminates in each case had to be broken manually with a centre punch. It was followed by placing a 100 Kg concrete block on the glass panel for 30 minutes. The test was aimed to know the ultimate post breakage performance limit so load was ramped up to 400 Kg in increments of 100 Kg, with a 15 minute time interval between each load increment.

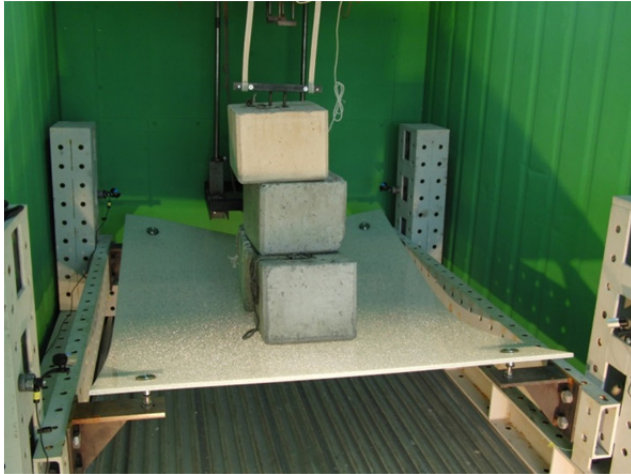
Fig. 8 400Kg load on Ionomer laminate at +21°C

Laminates with Ionomer and Stiff PVB interlayers sustained this load of 400 Kg without collapse at -20 °C and +21°C temperatures (Fig. 11) Whereas in Fig. 9, Standard PVB laminate could not sustain the 100 Kg imposed load at +21°C as it collapsed in few seconds when load was placed due to tearing of the interlayer at the rotules.

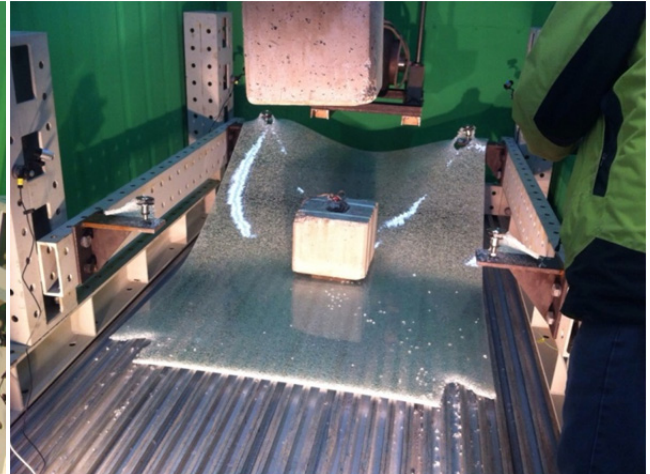
Fig. 9 Collapsed PVB laminate with 100Kg at +21°C

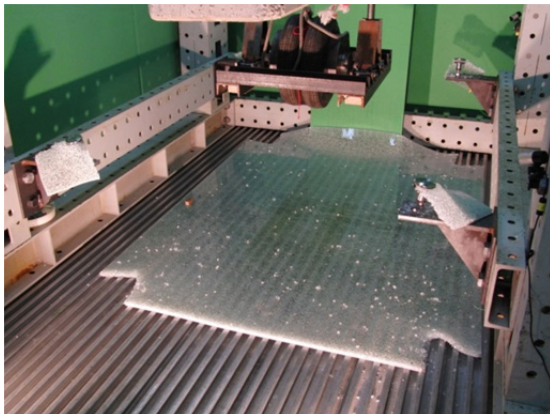
Fig. 10 Broken Standard PVB laminate collapsed at +50°C

At elevated temperature of 50°C, broken laminate construction with PVB & Stiff PVB interlayers could not sustain their own self weight as they collapsed (Fig. 10 & Fig. 12) soon after breakage of both layers.

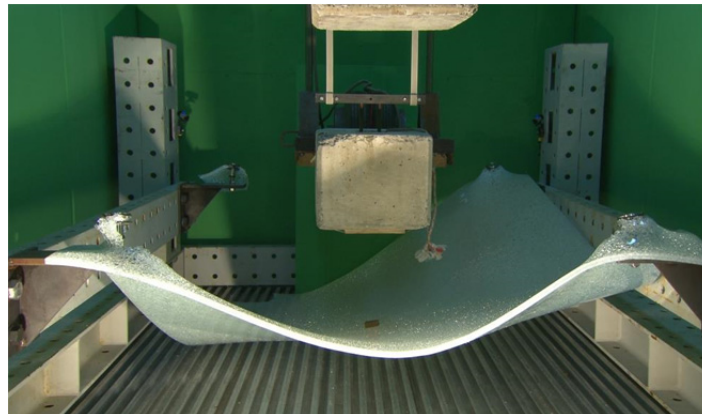
Fig. 11 Broken Stiff PVB laminate collapsed at +50°C

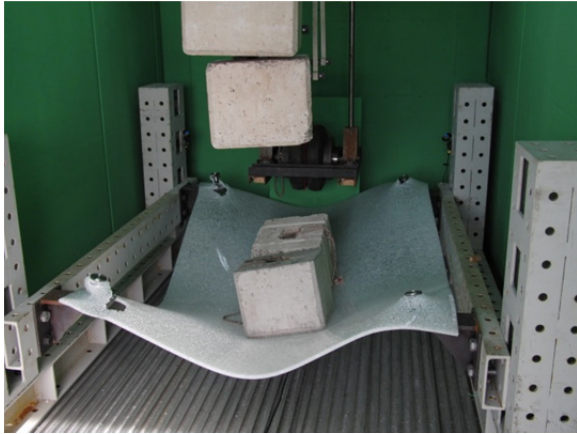
Fig. 12 0.89mm Ionomer laminate collapsed at 200Kg at +50°C

Whereas, the laminate construction made with 0.89 mm Ionomer interlayer sustained a weight of 100 Kg for more than 30 minutes and collapsed when load was ramped up to 200 Kg. (Fig. 12). Similarly, 1.52 mm Ionomer laminate could sustain a load of 200 Kg for more than 30 minutes after breakage and collapsed when load was ramped up to 300 Kg ( Fig. 13).

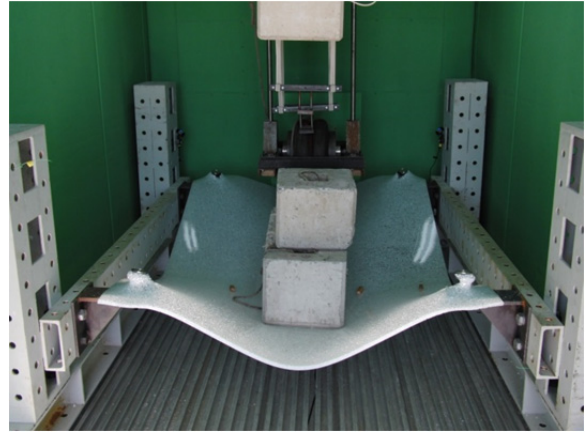
Fig. 13 1.52mm Ionomer laminate collapsed at 300Kg at +50°C

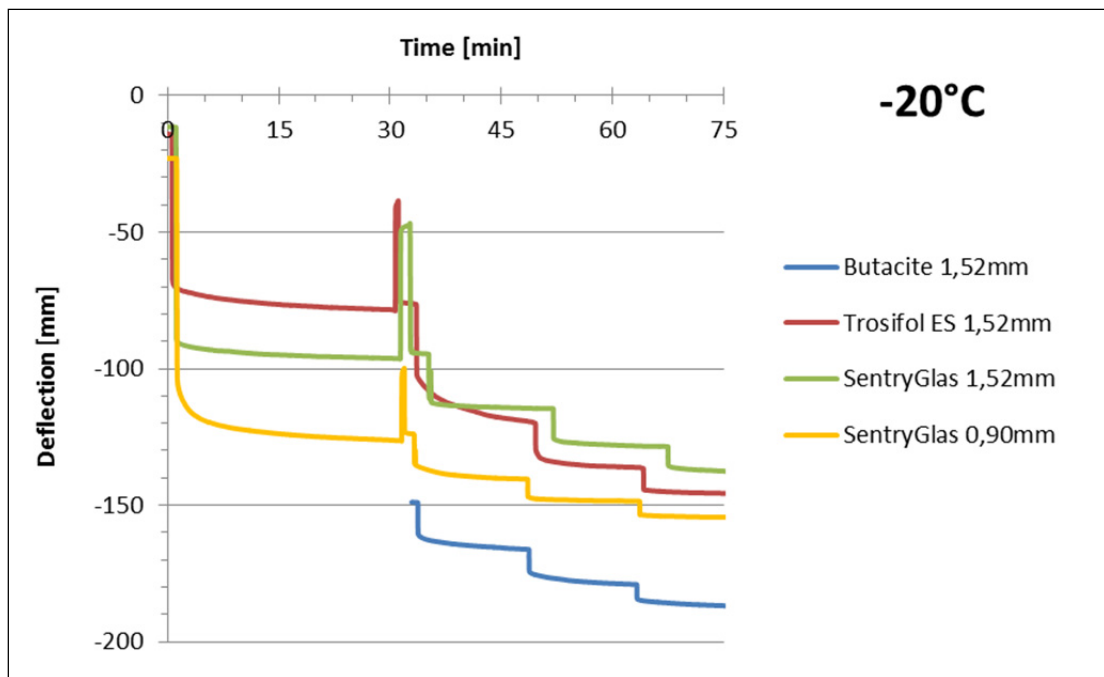
Fig. 14 Deflection Vs Time Measurements @  $-20^{\circ}\text{C}$   
 Butacite® = Standard PVB, Trosifol® ES = Stiff PVB, SentryGlas® = Ionomer

Deflection measurements were made during the test for all three temperature scenarios to make an estimate of the post glass breakage strength of the laminate constructions. At  $-20^{\circ}\text{C}$  the 1.52 mm Ionomer laminate demonstrated the lowest deflection after 30 min (Fig. 17), whilst at  $+21^{\circ}\text{C}$  both Ionomer laminates (1.52 and 0.89 mm) outperformed the PVB laminates (Fig. 18).

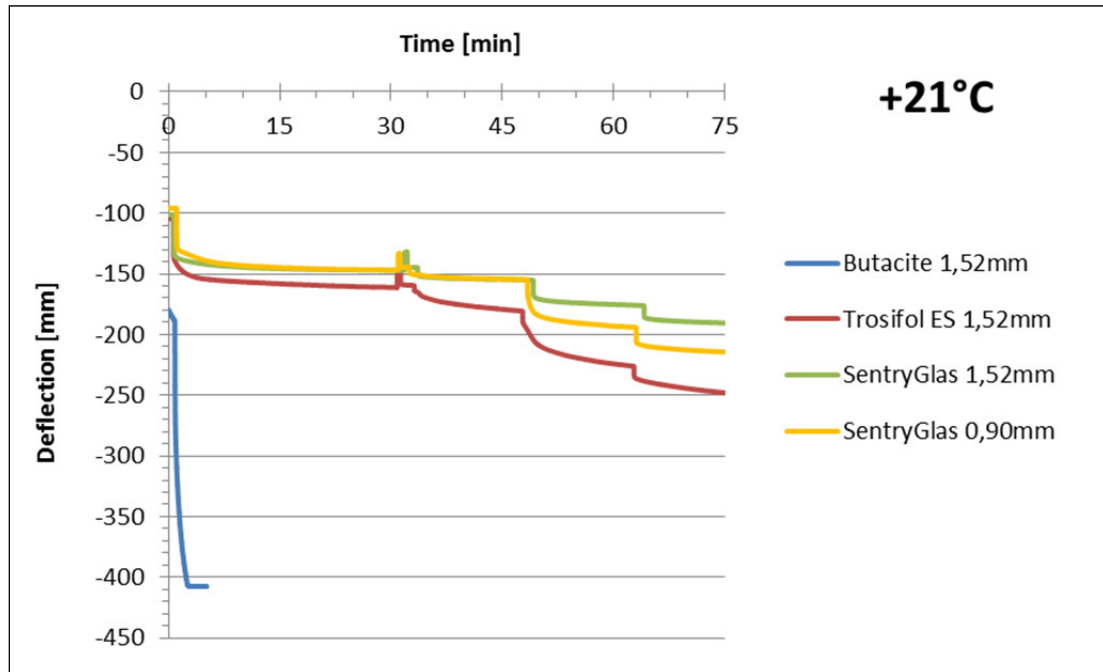
Fig. 15 Deflection Vs Time Measurements @ +20°C  
Butacite® = Standard PVB, Trosifol® ES = Stiff PVB, SentryGlas® = Ionomer
