# A new Façade Concept for an Existing Office Building

Iris Maniatis, Barbara Siebert

*Ingenieurbüro Dr. Siebert – Consulting Engineers, Munich, Germany,  
ima@ing-siebert.de, www.ing-siebert.de*

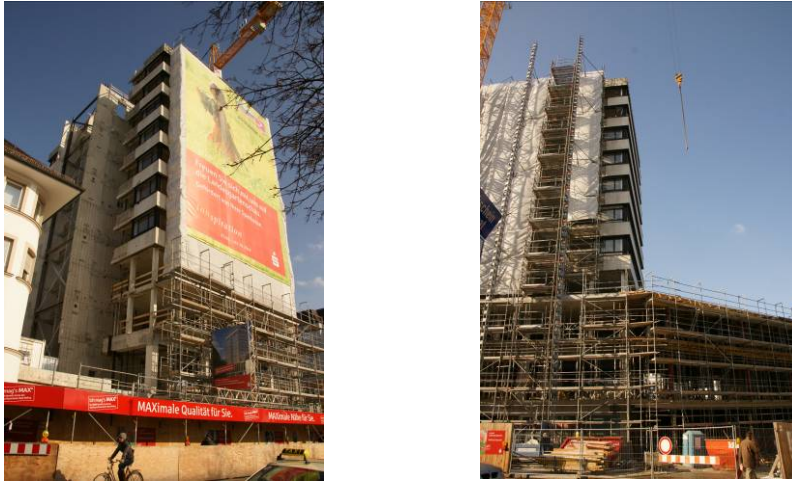
Figure 1a, b: Dismantling of the Concrete Façade Elements.

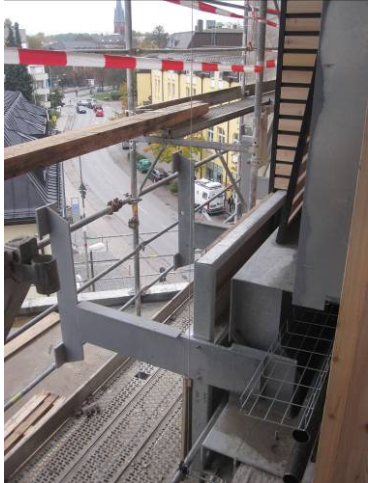
The outer façade is suspended from steel fins which are fixed to the concrete slabs by anchors (Figure 3). The steel fin itself consists of welded flat steel plates (Figure 4).

Figure 4: Installed Steel Fin.

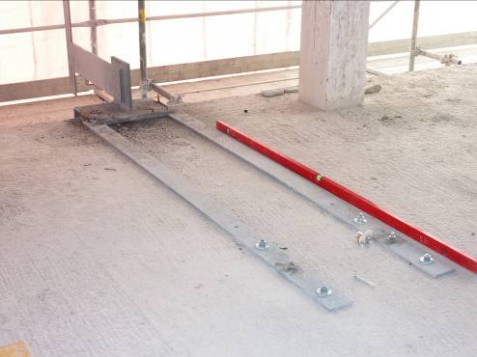
When designing the supporting elements the main problem was the connection to the concrete structure. Due to the poor concrete quality dating from the 1960s and insufficient reinforcement at the slab edges it was necessary to fix the anchors at defined locations which were able to resist these additional loads (Figure 5). The gap between anchor and drill hole was filled with a suitable mortar to avoid any slip.

Figure 5: Steel Fins are fixed to the Concrete Floor by Anchors.

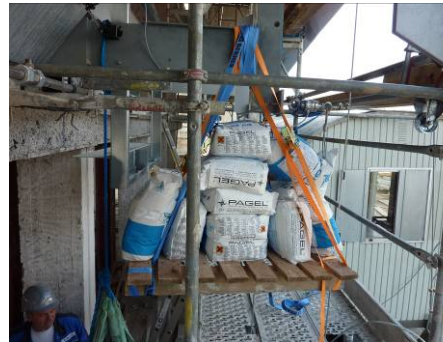
Figure 10: Load application.

The loads were simulated by cement bags (Figure 10) and fixed to the location of load application by steel cables and deflection pulleys. The exact load value was determined by force transducers.

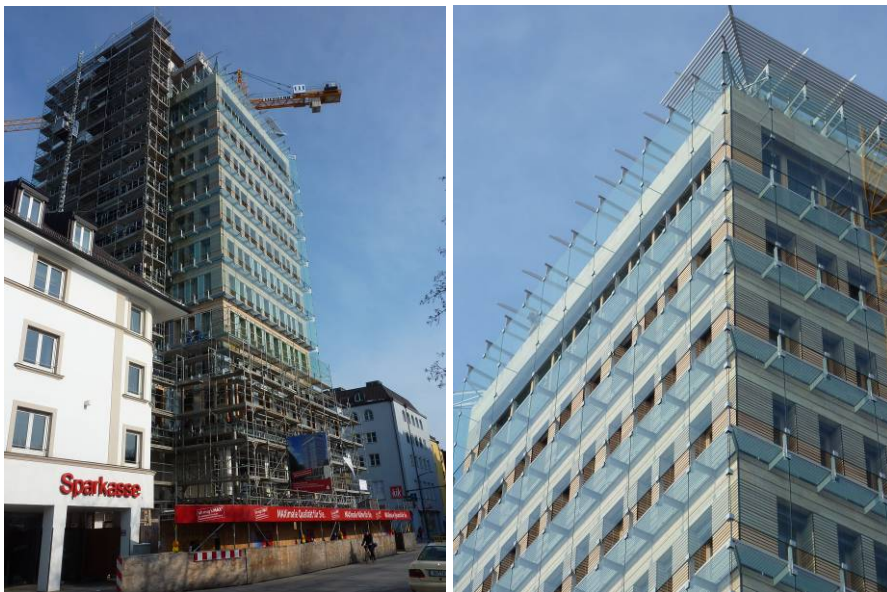
Figure 15a, b: New double skin facade

Although redesigning the building was very complex, by improving the energy efficiency and present the public a modern appearance the renovation of the building was very successfully (Figure 15a, b).
