Square One Shopping Centre – Long Span Glass Fin Wall

Andrew Crosby, John Kooymans
Read Jones Christoffersen Ltd, Canada

Keywords: Glass fin, Connection, Testing

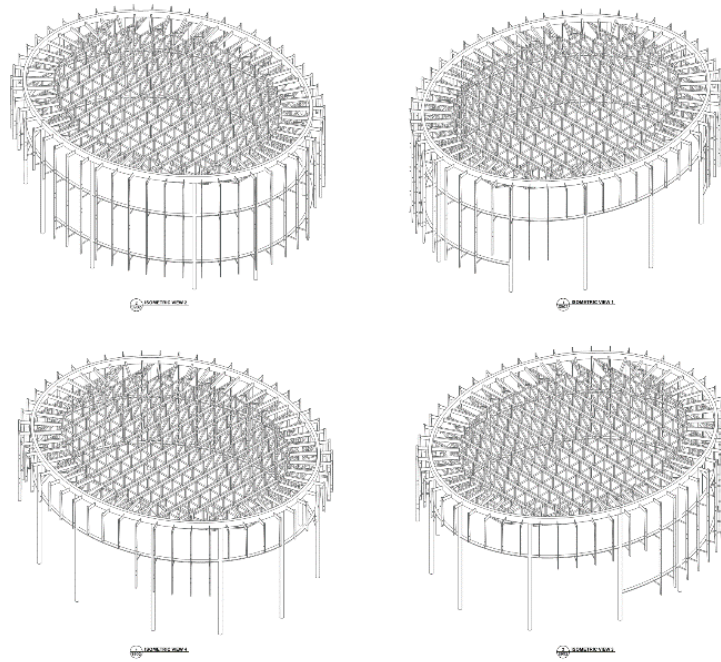
Figure 1 below shows the steel structure and glass fin locations in the design of the rotunda. There are two horizontal girt lines within the full height glass wall to assist in supporting the glass fins against lateral wind pressures. The steel roof trusses have outriggers to carry the hanging load of the glass wall while allowing for a glass skylight return around the perimeter of the steel roof as shown in Figure 2.

Fig. 1 Overall Rotunda geometry.

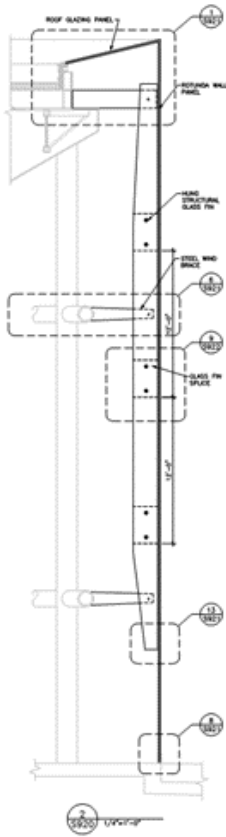
Fig. 2 Fin wall section.

There are several aspects to the design that help make the wall very transparent and allows for the full use of the floor area next to the wall. The glass IGU panels are supported off a steel bar that is connected to the roof structure. The steel bar is in turn siliconed to the glass fin for lateral load transference. This allows the glass fin to be designed for the wind pressure loads only. The other factor in the design is the connection of the glass fins to the horizontal girts using steel plate outriggers. This allows for the span of the glass fins to be shorter and continuous over the supports allowing for a unique splicing connection as well as a reduced fin depth as shown in Figure 3. The final design concept is for the glass fin to stop roughly 3m from the floor so that the bottom IGU panel is only partially supported by the fin and allows for a “fin free” zone at the floor level all around the rotunda perimeter. Figure 4 shows a plan section detail of the glass fin with the steel hanger bar used to carry the IGU panels. The IGU panels are fixed back to the hanger bar with an internal toggle system and the hanger bar transfers the lateral load back to the fin through structural silicone.

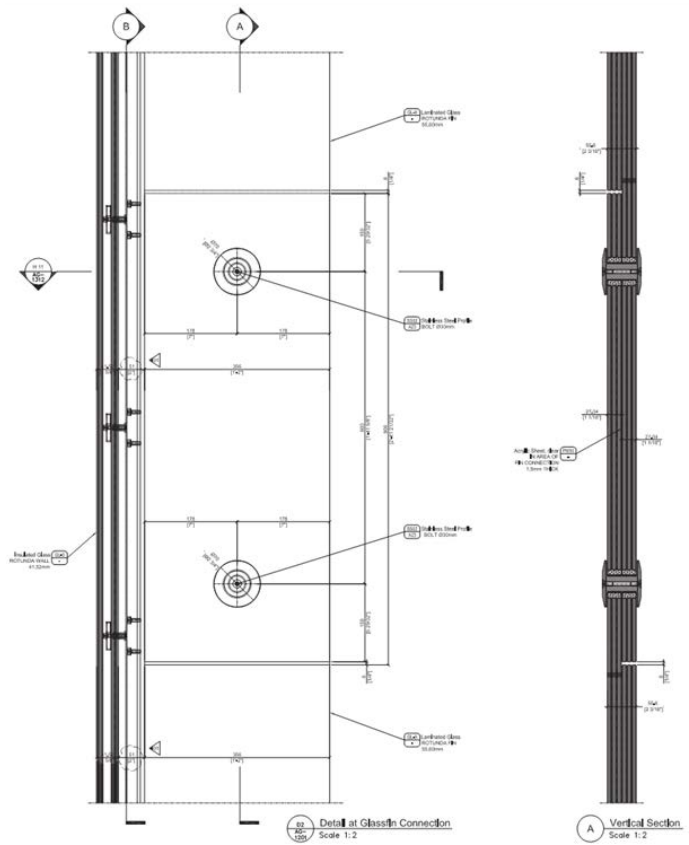
Fig. 3 Glass fin splice detail.

The glass fin is comprised of 6 layers of glass. This is done predominantly for redundancy and post-breakage behavior. The fin is connected back to the steel girts via a steel outrigger plate. This plate is inserted into the glass fin allowing for a semi-concealed connection to the main structure as shown in Figure 2. The glass splice detail uses an overlapping connection of half the glass fin thickness with two simple pin connections within the overlapping zone to create moment continuity and allow for shear and axial load transfer. By having the span of the glass fin shortened by the horizontal girts and outrigger arms, the glass fin pieces can be smaller and shallower resulting in aspect ratios for each piece that are acceptable for the tempering process. It also maintains a smaller connection force requirement at the splice making the simple splice connection possible without using several bolts or heavier glass.

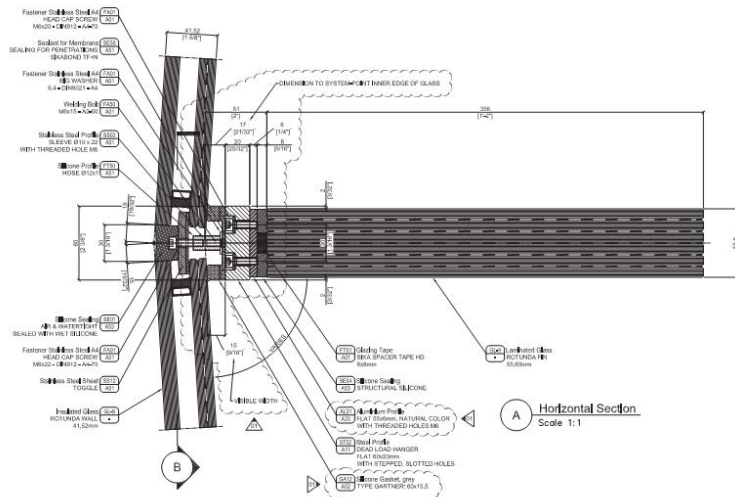
Fig. 4 Plan section of glass fin/wall.

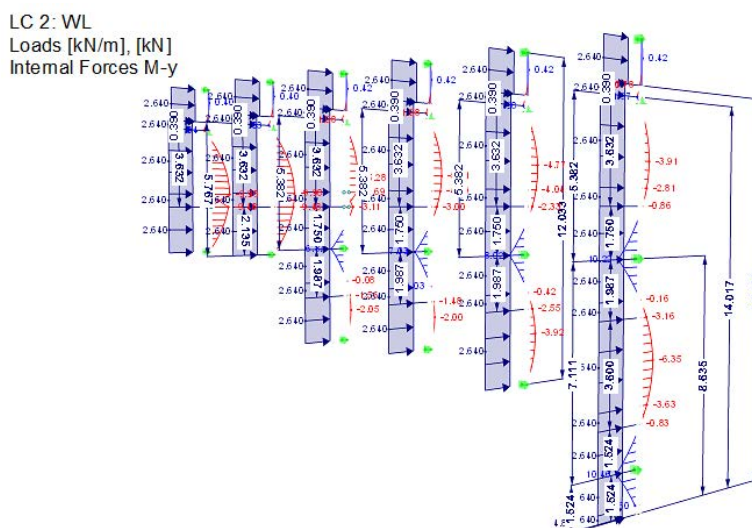
The glass fins were designed using the software program SJ Mepla with global analysis of the overall structure coming from the software program RFEM (See Figure 5). Local models were run to check the connection design and stress levels in the glass fins allowing for any one lite to be broken for post-breakage behavior. The splice locations were offset from the supports in a gerber style system close to the points of zero moment to minimize the stresses at the splices.

Fig. 5 Analytical model of glass fins.

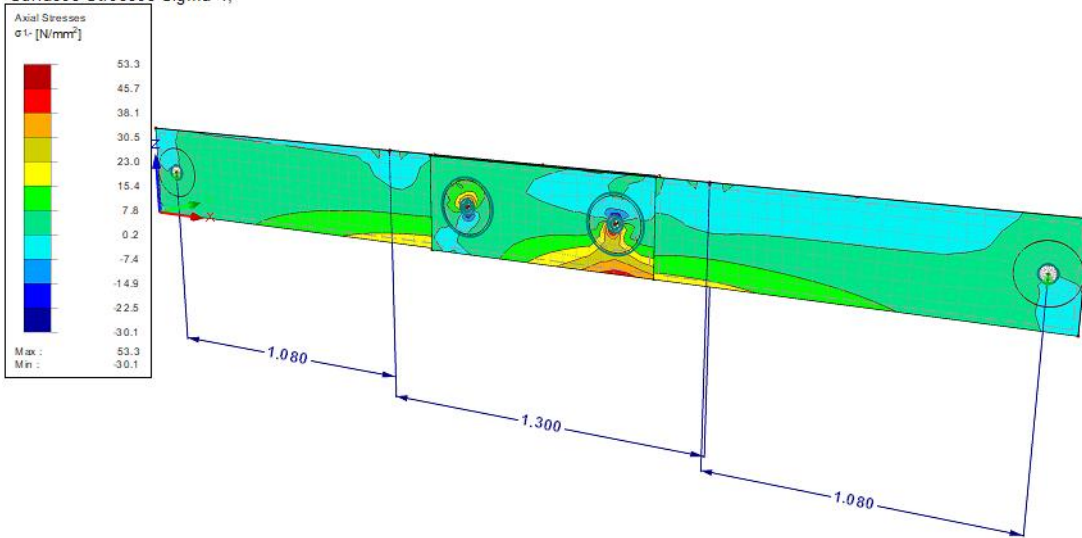
CO 9: 1.5*LC1 + 5*LC2
Surfaces Stresses Sigma-1,-

Results on surfaces "Rigid" not shown.
Surfaces Max Sigma-1,-: 53.3, Min Sigma-1,-: -30.1 [N/mm²]

Fig. 6 Analytical model of tested splice.

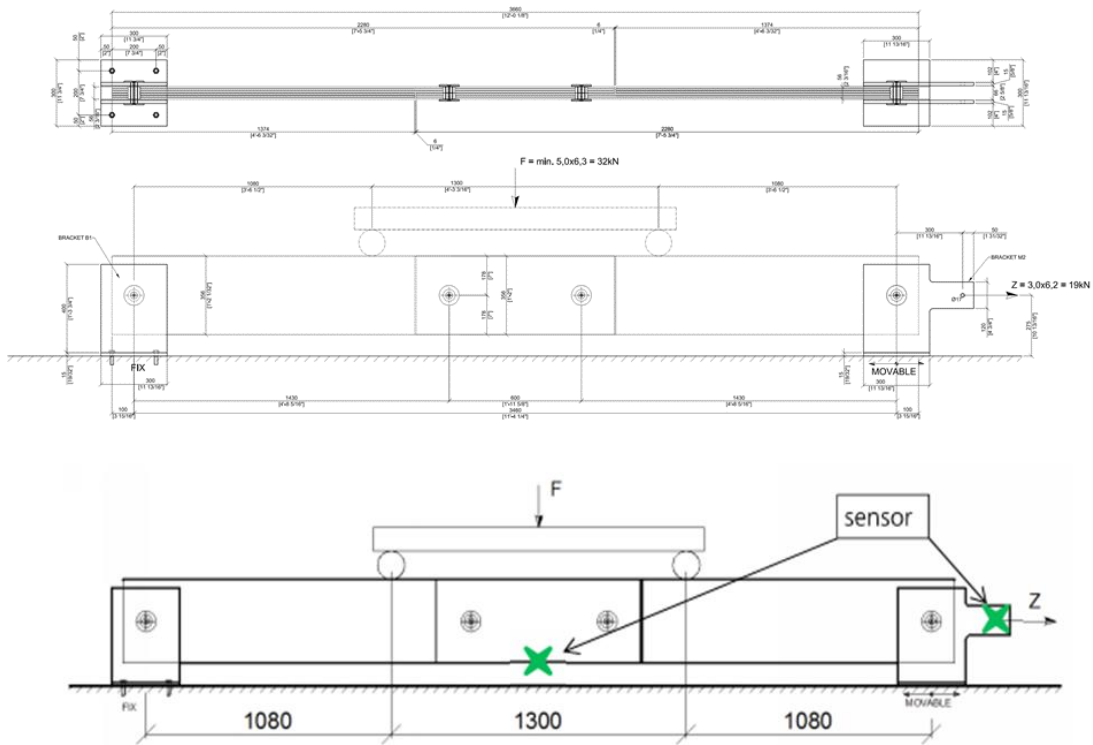
The fin splice connection was tested by the glazing contractor (Josef Gartner GmbH) as required by the contract documents. It was tested at the Laboratory for Steel and Lightweight Metal Construction of Munich University and Applied Sciences in Munich, Germany. Figures 7 and 8 show the test set up and procedure.

Fig. 7 Glass fin splice testing.

The fin was loaded vertically in a 4 point bending application to simulate the wind shear and bending forces at the splice. The fin was also loaded axially to simulate the self weight of the glass which is transferred through the splice and up to the top steel hanger plate. The fins were tested in unbroken and broken conditions. In the broken condition, four specimens were tested where 1 lite of each specimen was intentionally broken prior to load application. The unbroken tests were loaded to two times the service loading, held for 10 minutes, and then loaded to failure. The unbroken tests had good correlation breaking at roughly five times the service loading. While the tests had good correlation, the broken lites were always interior as seen in Figure 9 and the load at breakage was lower than expected based on the modeled stress at the hole.

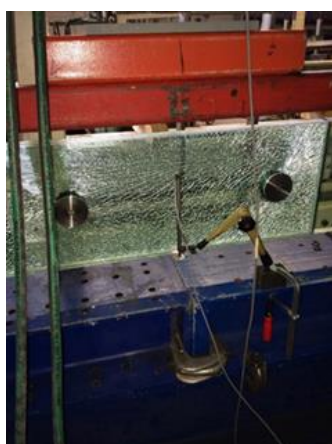
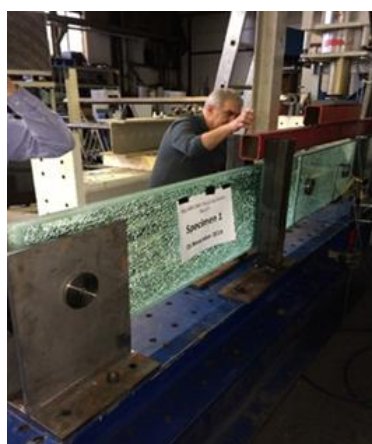
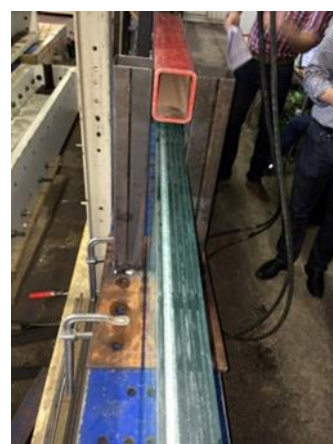
Fig. 9 Glass testing images at breakage.

Both the additional deflection and breakage of the glass were estimated to have been caused by small tolerances in the fitted parts. Over the short distance between the bolts, small gaps can result in larger than anticipated deflections and also allow for some rotation of the shear pins. A rotation of the shear pin can cause localized stresses on a single lite.

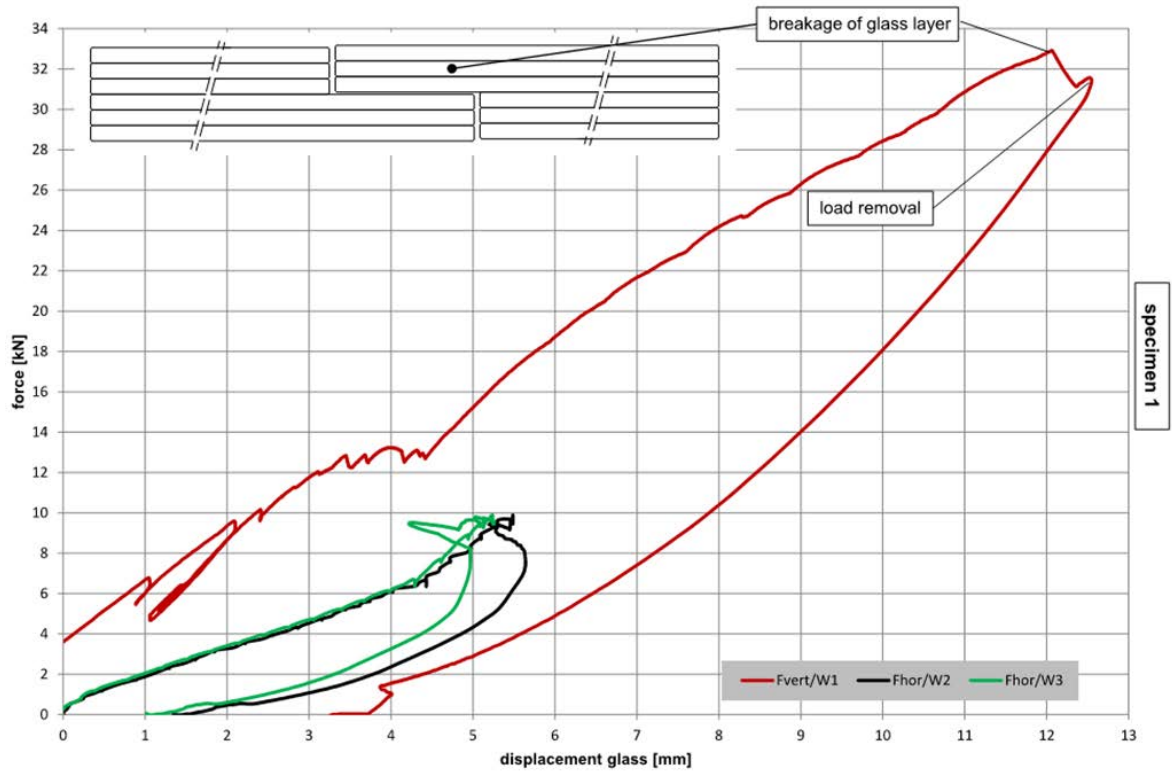
Fig. 10

While the tests failed earlier than predicted, they failed at loads that were greatly in excess of the service loads and also showed very consistent behaviour in both the unbroken and broken tests, as seen in Figures 10, 11, 12, 13 and 14.

The deflections observed in the testing were similar at service loading but were larger than predicted by the analytical model at their peak loading.

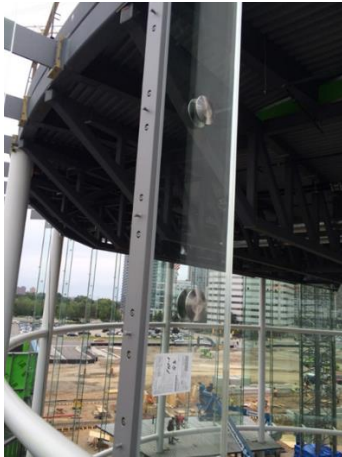
Fig. 15 Construction photo of fin splice.

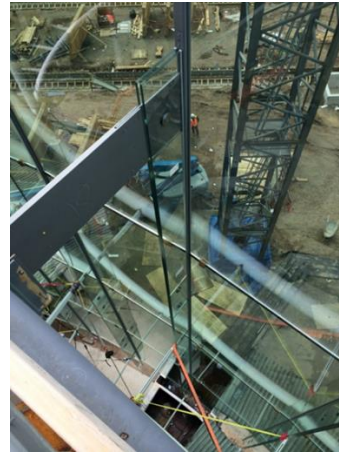
Fig. 16 Construction photo of hanging connection.
