Erin Mills Town Centre – Globe Structure

Andrew Crosby ^a, John Kooymans ^a, Dr. Jens Schneider^b
^aRead Jones Christoffersen Ltd, Canada, ^bTU Darmstadt, Germany

Erin Mills Town Centre is a shopping mall in Mississauga, Canada owned by Cushman & Wakefield in Toronto. The revitalization project was designed by MMC International Architects Ltd. and features a 27.4m diameter glass and steel globe at its Centre Court. The structural glass for this globe structure is created with laminated double curved glass panels patch supported by a steel structure. Some challenges arose during construction due to the frit on the glass panel and the thermal stress created between the inner and outer lites of the laminated assembly. Testing was used to establish a workable solution for replacement glass in order to correct the in-situ issue that was discovered.

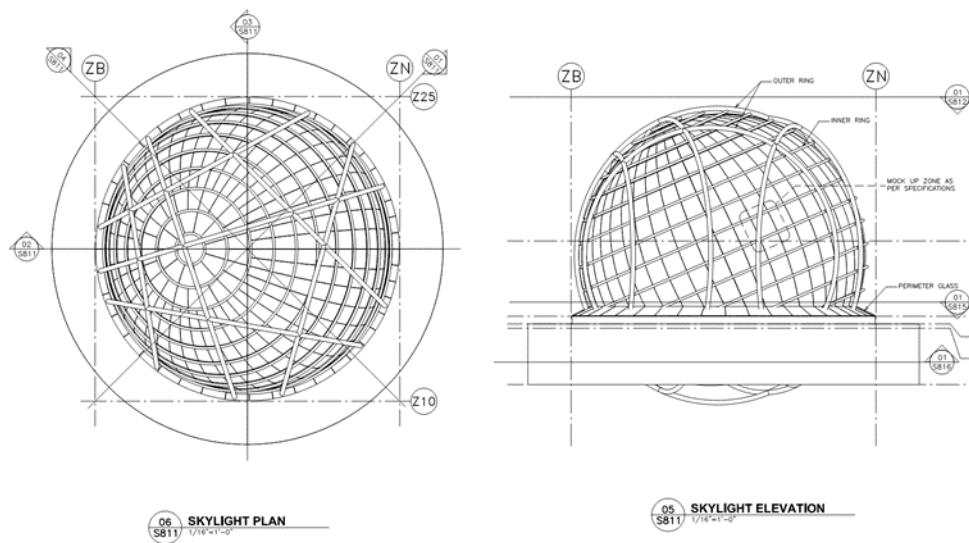
Figure 1 below shows the steel structure for the supporting globe glass panels. We have taken seven random rings that intersect with each other to create a support structure for the evenly spaced rings creating the globe shape and supporting the glass panels. The seven rings support the entire structure globally and bear on brackets off the stiffened roof structure (see Figure 2) that creates the centre court opening. All steel is an exoskeleton structure with the glass panels hung off of it to create a very smooth glass surface on the inside of the building space. This was done to help facilitate air movement along the interior glass surface and keep this movement as evenly spread as possible.

Fig. 1 Overall Globe Steel geometry.

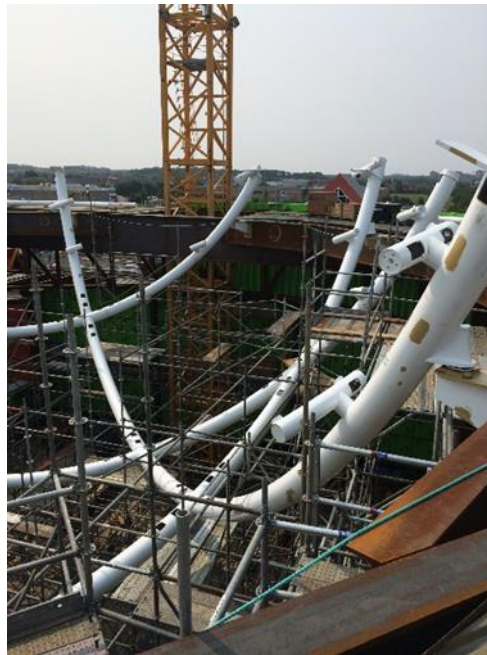
Fig. 2 Main ring supports.

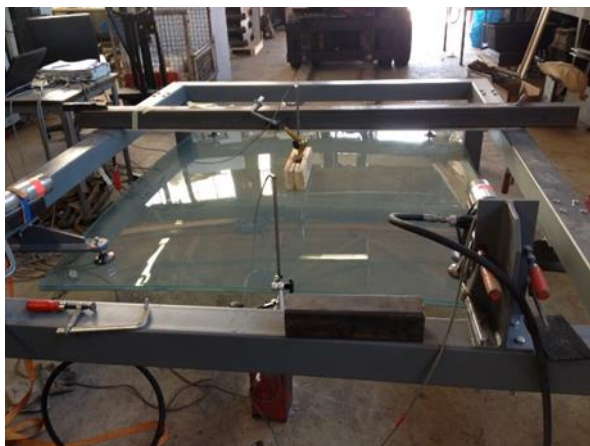
In addition to the test assembly and adhesion testing, load/strength tests were carried out at the Laboratory for Steel and Lightweight Metal Construction of Munich University and Applied Sciences in Munich, Germany. The Figures 3 and 4 below show some of the test procedures done on the larger size panel.

Fig. 3 Glass panel set-up.

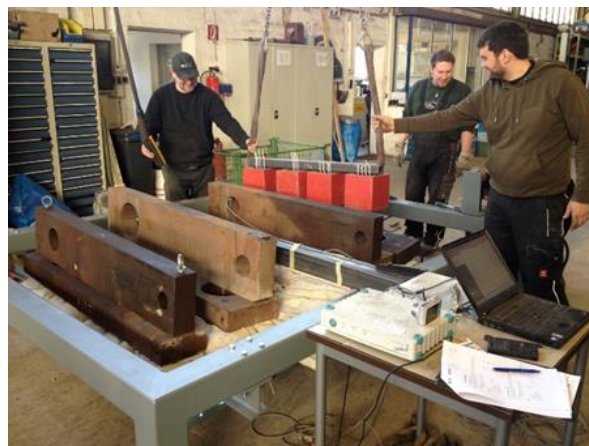
Fig. 4 Test panel under load.

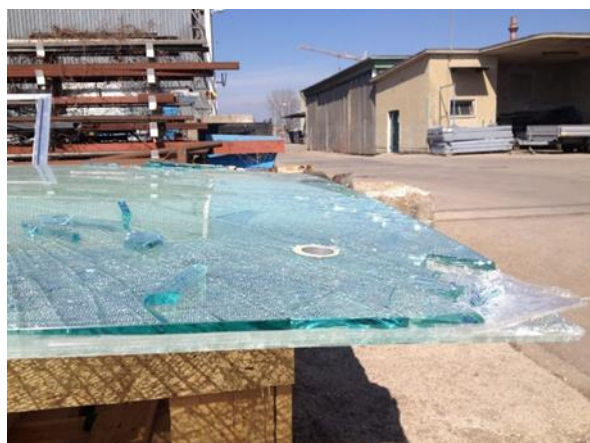
The strength tests and the accelerated adhesion tests all performed well, however, we did have issues with consistency of the assembly and visual imperfections. The Figures 5 and 6 below show these delamination problems (especially after breakage of one lite), and the optical anisotropies/visual distortions inherent in the process.

Fig. 5 Delamination after breakage.

As a result of the issues found in the load tests and the mock-up, it was decided that the assembly would look much better if all three lites were heat slumped annealed glass with the outer lite still having a frit on surface #2 and the inner lite having a hard coat low-e coating on surface #6. It meant revising the fastening system from a point support spider connector to a patch fitted spider connector. Going to the annealed glass, the assembly was revised to three equal lites of 8mm thick.

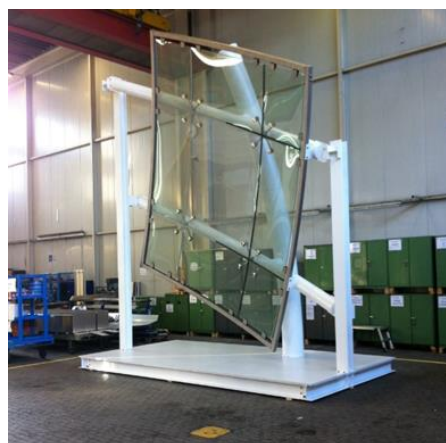
Fig. 6 First mock-up.

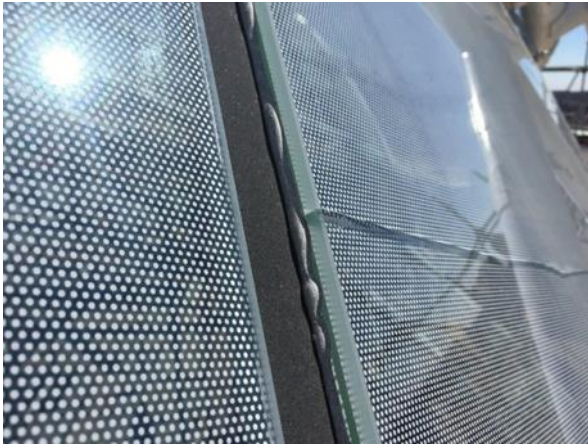
Upon closer examination, it was noted that all the thermal stress cracks originated at a frit dot location. As shown in the Figures below, this was consistent in all panels that cracked. We started to understand where the problem was, but needed a way to find an appropriate solution that we could be confident in. RJC hired Dr. Jens Schneider at this time to review the issue at hand and devise a test that would allow us to establish the cause and to then recommend a solution to the problem.

Fig. 7 Thermal crack in panel.

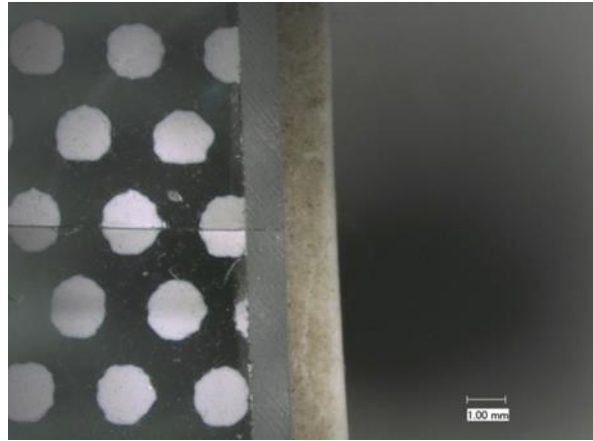
Fig. 8 Close-up of thermal crack originating at frit dot.

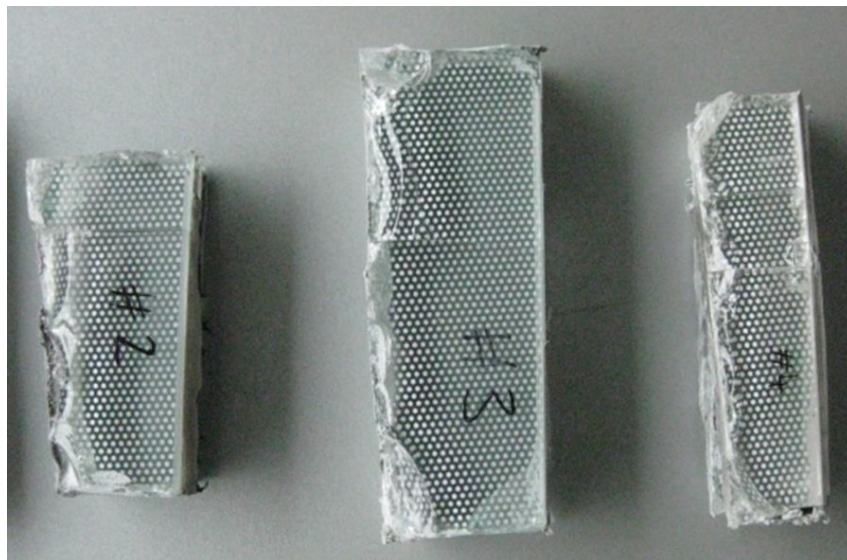
Additional information was gathered by taking samples (see Figure 9) of the in-situ glass by cutting out a section at the location where the thermal crack initiated. These were catalogued and taken back to the labs at TU Darmstadt.

Fig. 9 Samples of cut from failed glass panels.

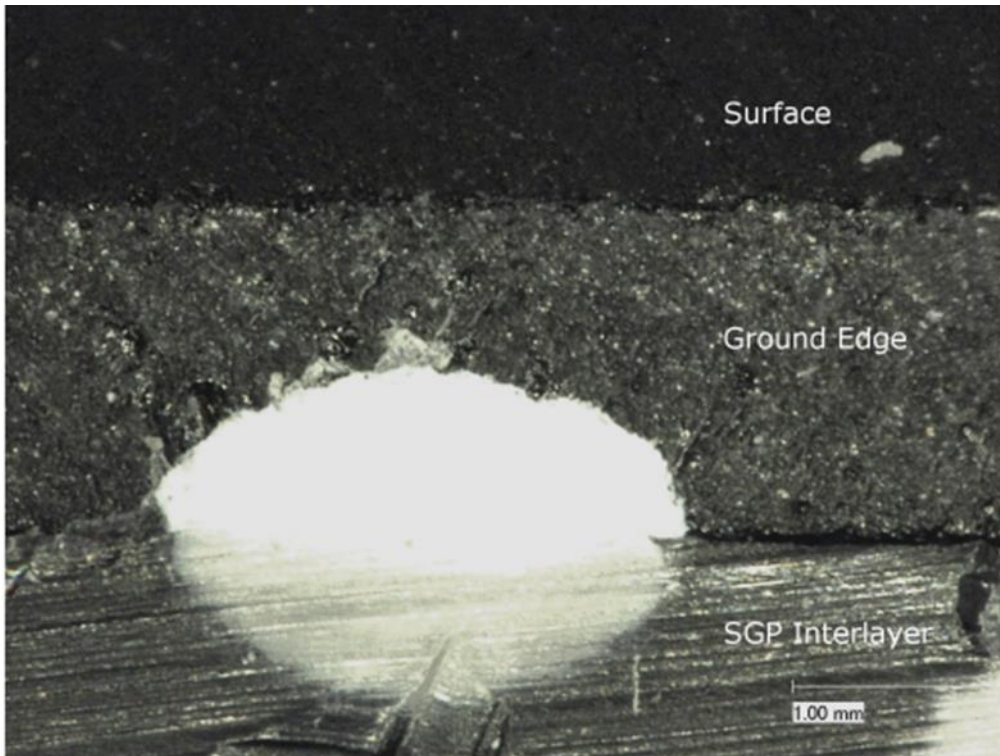
The microscopic image below shows the frit taken right to the edges of the glass including the chamfered edge. It was becoming obvious that this was an issue and causing premature failures of the assembly. In addition, the specimens taken from site were opened up at the crack line to examine the fracture patterns and evaluate potential causes. These examinations also confirmed that the issues arose at the frit location directly at the edges of the glass panels.

Fig. 10 Frit at the edge of the chamfer.

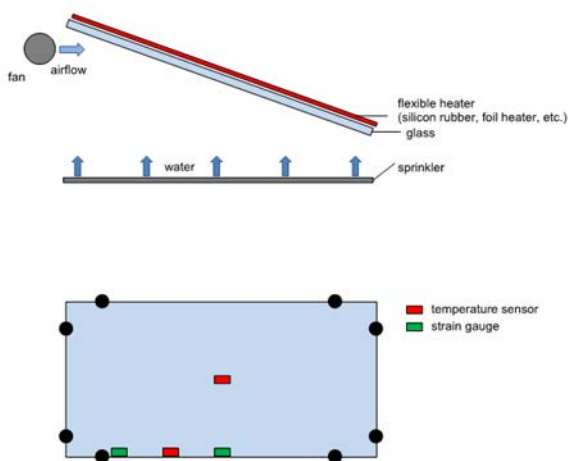
To further satisfy that the new glass assembly utilizing an edge deletion of frit of 10 cm from the edge of the panel could resist the thermal stresses anticipated, additional testing was done on full size specimens to see what thermal gradient would produce a stress failure in the panel (See Figures 11 and 12). This test was used to confirm that the thermal gradient anticipated on site would fall within a safe zone for the actual capacity of the glass assembly.

Fig. 11 Test set-up.

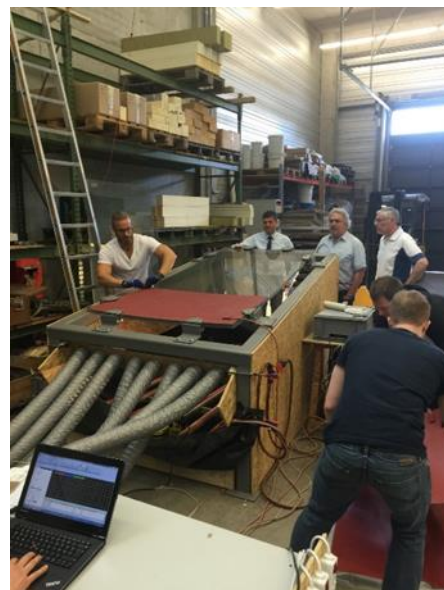
Fig. 12 Test in process

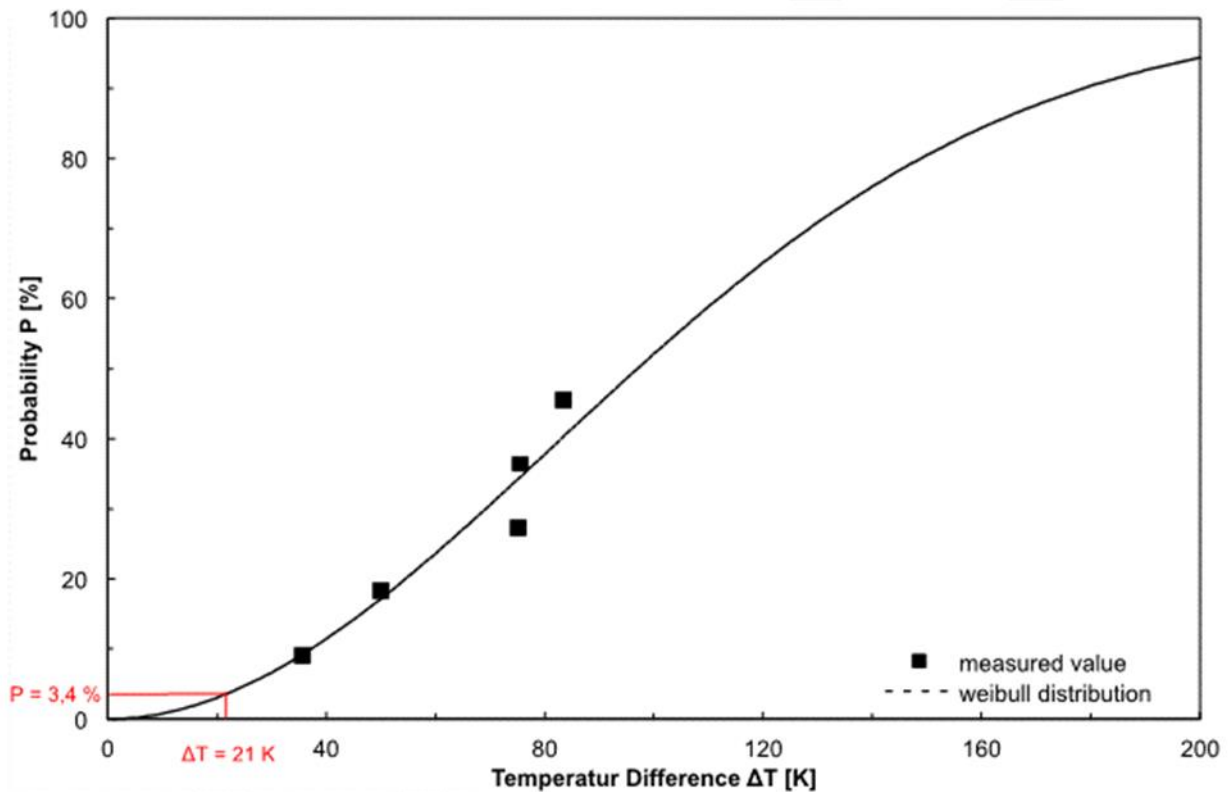
The test was carried out using three different assemblies. Series 1 was as per the in-situ panels (frit to the edge of the glass). Series 2 had an edge deletion of 10 cm, while series 3 had no frit at all. The tests resulted in a probability of failure curve as shown below in Figure 13 for the series 1 specimens. Series 2 and 3 could not be graphed in a similar manner since the glass specimens only broke due to in plane thermal stress due to the test setup and did not break due to the thermal gradient between surface #1 and surface #6.

Fig. 13 Adaption of the Weibull distribution to the test data.
