Non-Contact 3D Characterization System of Scratch-Induced Surface Damage on Monolithic Glass Panel

Zhufeng Pan ^{a,b}, Jian Yang ^{a,b,c*}, Xing-er Wang ^{a,b}, Yige Wang ^{a,b}, Gang Li^d, Xianfang Jiang^d

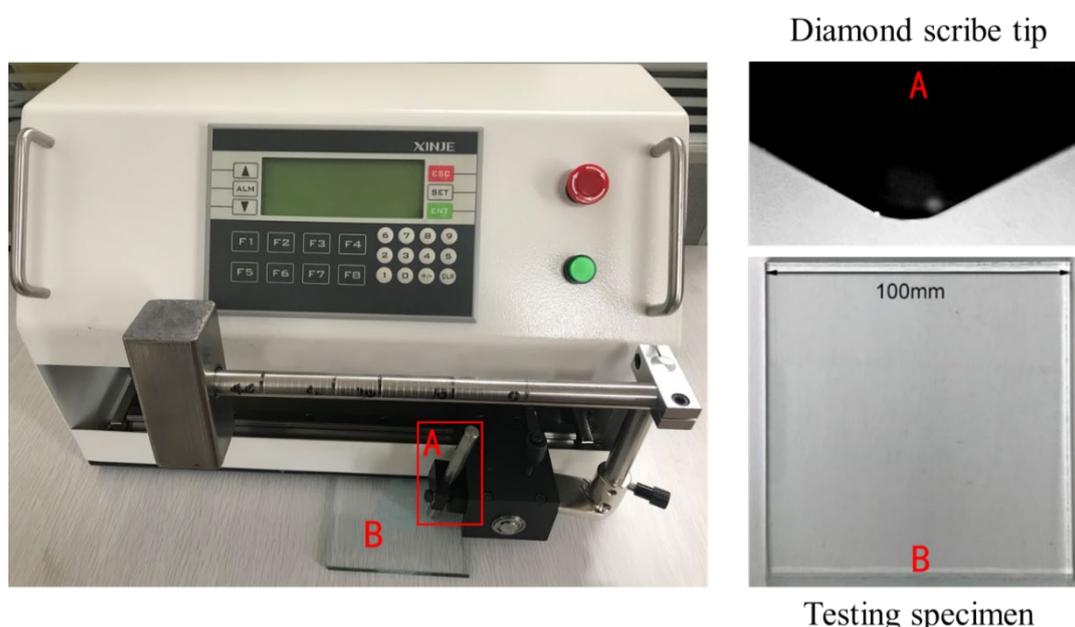
Fig. 1: Scratch testing machine and glass specimen

In this study, soda lime silica (SLS) glass specimens were 6 mm thick with a size of 100 × 100mm. Due to the convenient fabricate process, square panels were selected. All the SLS glass specimens were annealed glass provided by the same supplier. Air side and tin side of each specimen were distinguished by the UV light inspection. Surface damage was introduced by a scratch testing machine, as Fig.1 illustrates. It can generate deep-to-close artificial scratch-induced damage by adding different scratching load with a constant moving speed of 5 mm/s. Indenter is spherical shape with a diamond tip which has an angle of 120 and a radius of 0.1 mm. The applied load was determined to be 5, 10, 20 and 30N, respectively. All scratches were 10 mm long and were placed on the tin side of the specimen which was normally exposed to the external environment and was more likely to have critical surface damage.

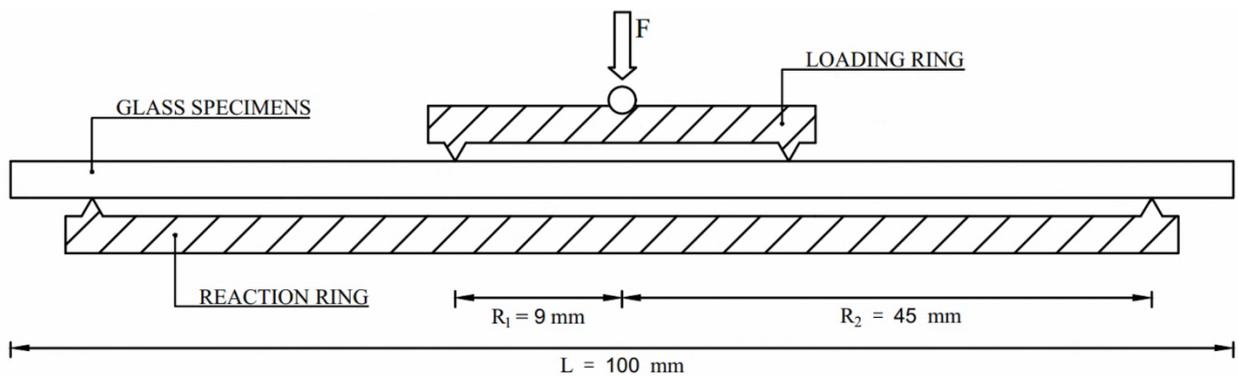
Fig. 2: Coaxial double ring test configuration

Coaxial double ring (CDR) test was applied to determine the flexural strength of both intact and scratched glass specimens based on the EN1288-5, as shown in Fig. 2. Comparing with the traditional four-point bending test, CDR test can avoid edge failure by applying the load using a loading ring and a reaction ring, with the diameter of 18 and 90 mm in this test, respectively. The highest bending stress locates on the centre of the glass plate (Pisano et al. 2021). The test setup is able to determine the flexural strength of the architectural glass elements under multi-axial stress as it is close to the state under service stage (Castori and Speranzini 2019; Pisano and Carfagni 2016). Tests for all type of specimens under scratching load were conducted on the universal testing machine with a 10 kN load cell, as shown in Fig. 3. A 0.06mm thick self-adhesive film was used to hold the fragments together for further evaluation of fracture initiation and fracture pattern after failure. The displacement rate of the test was 0.006 mm/s, corresponding to a fixed stress rate of 2 MPa/s. Ten specimens for each series were tested. Load and displacement data were recorded during the CDR tests.

The flexural strength of the glass plate can then be calculated according to EN1288-1 based on the Kirchhoff-Love plate theory as the following equation shows:

$$\sigma_f = \frac{3(1+\mu)}{2\pi} \left[\ln \frac{R_2}{R_1} + \frac{(1-\mu)}{(1+\mu)} \frac{R_2^2 - R_1^2}{2R_3^2} \right] \frac{F}{h^2} \quad (1)$$

where, σ_f is the failure stress, h is the thickness of glass specimen, F is the load at failure, $\mu=0.23$ is the Poisson's ratio. R_1 and R_2 are the radius of the loading and reaction ring, respectively. R_3 represents the radius of the circular specimen. For square specimen, R_3 can be calculated from Equation 2, where L is the edge length of the specimen:

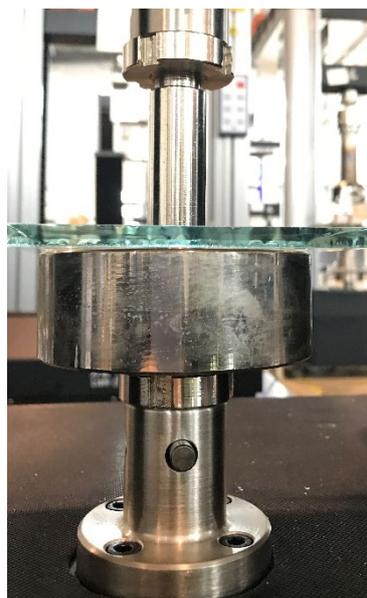
Fig. 3: Test setup for coaxial double ring test

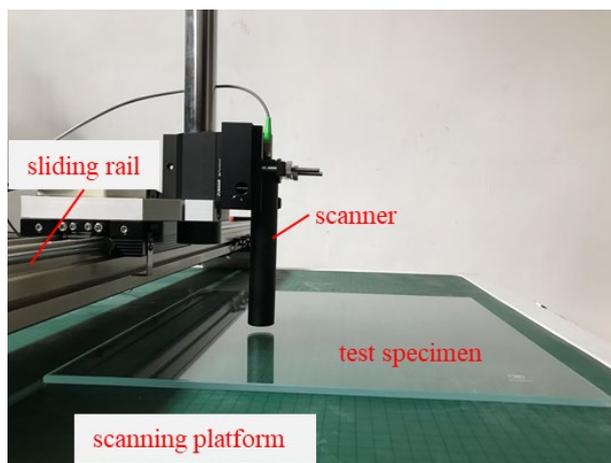
Fig. 4: Side view of surface damage scanning system

To achieve the goal of automatic operation and 3D characterization of the surface damage for the potential size of monolithic glass panels, a non-contact scanning system was developed. It consists of three parts, as shown in Fig. 4. A platform with the size of 1000×1000 mm was placed on the centre, so as to meet the demand of scratch damage detection. A two-way sliding rail was installed on the top of the platform to ensure that the scanning devices can move across the whole glass panel from side to side. Both monocular microscope and chromatic confocal scanner were fixed on the sliding rail to move in the plane automatically based on the control signal. Monocular microscope has been used to obtain the spatial information of scratch on the surface through an initial detection, see (Pan et al. 2020) into details. Once the damage area was determined, the microscope was then replaced by a chromatic confocal scanner for a detailed scanning (Yongqing Wang et al. 2021). The physical principle of the chromatic confocal scanner is mainly from the wavelength dependence of a longitudinal chromatic aberration and the analysis of the spectral components from the reflection of light (Miks et al. 2010; Yu et al. 2018). The technical specializations of the device are listed in Table 1. The depth results can be obtained from the average value of the reflection components inside the light spot. By using the lightweight scanner, this system is able to capture the depth information of damage to meet the requirement for non-contact 3D characterization on-site replacing the confocal microscope.

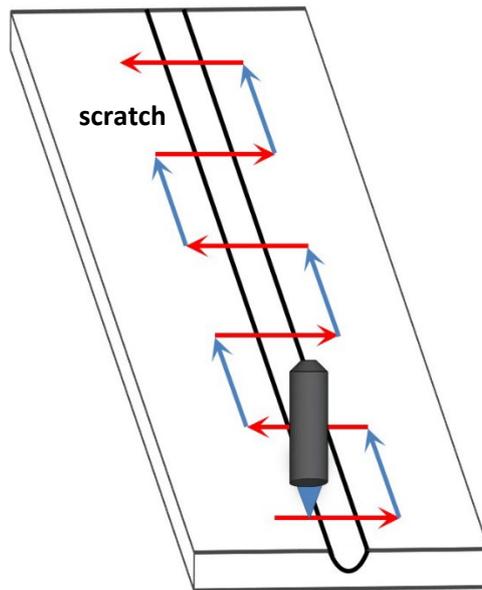
Fig. 5: Scanning path for chromatic confocal scanner

A serpentine-type scanning path was set on the controller to scan through various cross sections of the damage area, as shown in Fig. 5. In order to obtain enough measured data to guarantee the reliability of the results, a least number of ten cross sections were scanned for each scratch. Each scanning cross sections were at equal distance.

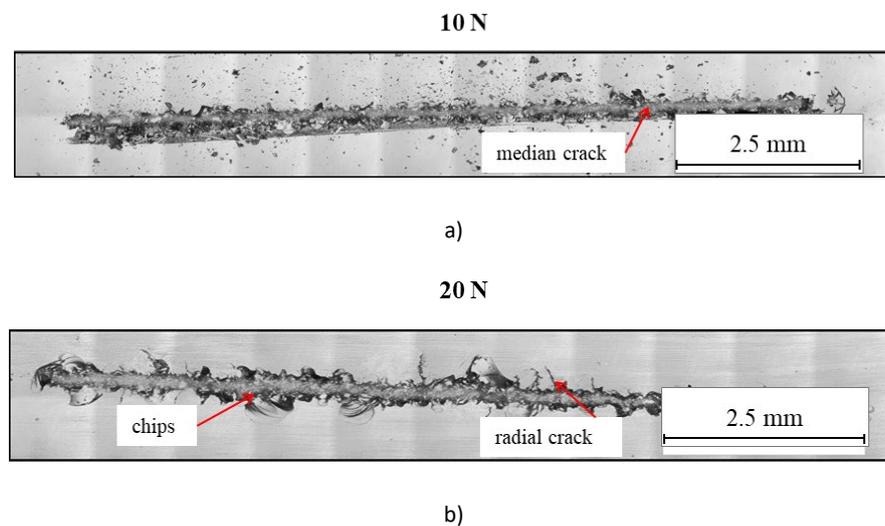
Fig. 6: Plan view of damage characteristic on glass surface with a) 10 N; and b) 20 N;

Microscopic evaluation was firstly conducted on the confocal microscope to obtain the reference 3D profile of the surface scratch, the plan view of the surface scratch was shown in Fig. 6. It can be observed that when the scratching load is relatively low, the median cracks along the thickness of the glass is the major type of crack. With the increase of the scratching load, lateral cracks along the depth and the radial cracks on the surface are generated, whilst the interaction of lateral cracks coalesces into chips.

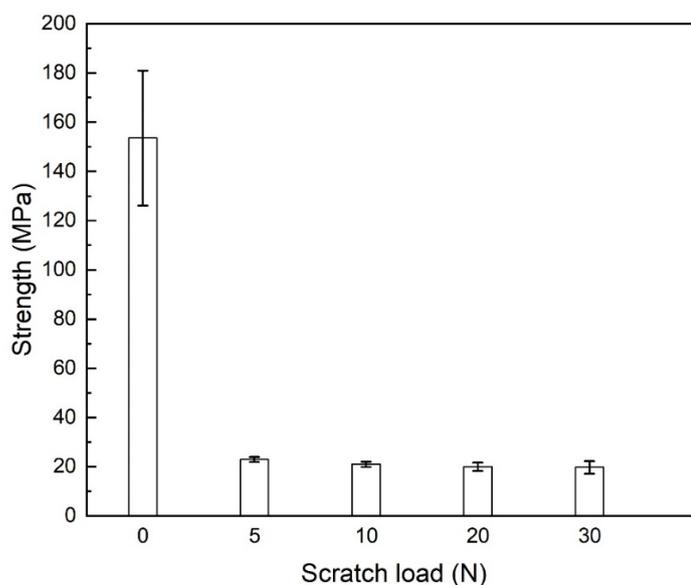
Fig. 7: Flexural strength of SLS glass specimens with different scratch load

Test results were listed in Table 2. The flexural strength of test specimens for CDR test were calculated and shown in Fig. 7. The results show that when the surface scratch was introduced, the flexural strength of glass specimens see a relatively large decrease by almost 75% the strength of the intact glass specimens even with very low scratching load. By contrast, with the increase of the load, the decreasing trend is not obvious. The results reveal that the depth of the damage has a certain upper limit. Fracture pattern for both types of annealed glass specimens is shown in Fig. 8. The initial failure of the intact specimens is inside the loading ring, which is caused by the microscopic flaw on the glass specimen. However, the fracture of the scratched specimens occurs in the area along the scratch and directly propagates to the side at a certain angle. The fracture may indicate the requirement of surface damage characterization of aged architecture glass panel, since they are likely to contain scratch-induced damage. It acts as the main cause towards the brittle failure of the glass panel.

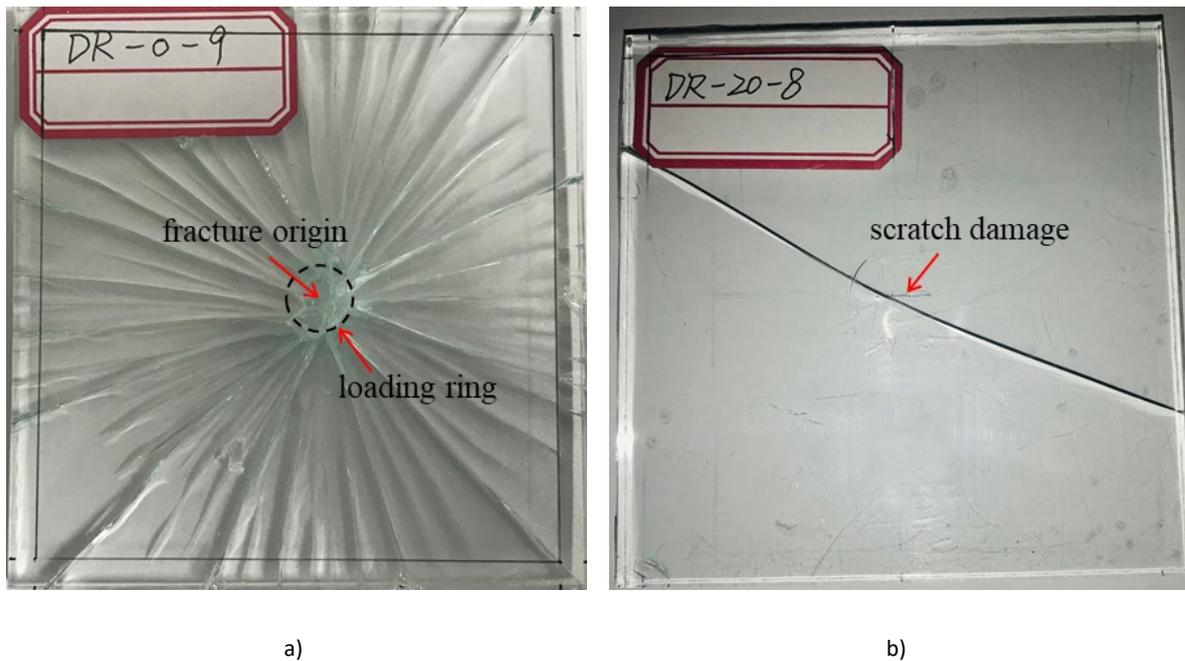
Fig. 8: Fracture pattern of a) intact and b) scratched glass specimens

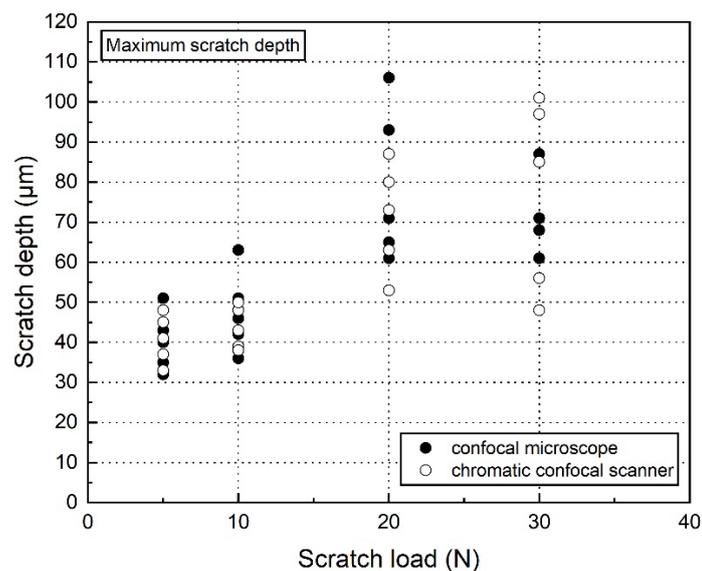
Fig. 9: Comparison of scratch depth results from confocal microscope and chromatic confocal scanner

To assess the performance of the proposed scanning system, depth information collected from the chromatic confocal scanner were compared with the reference data obtained from the confocal microscope. The maximum scratch depth profile obtained from different cross sections of the test specimens for both devices are shown in Fig. 9. The depth profile shows a gradual increase with the rising scratch load. However, there is an upper limit, which agrees with the observations from (Haldimann et al. 2008). The chromatic confocal scanner can achieve stable performance under low scratching load. As for higher scratching load scenario, the depth profile varies due to the propagation of the median crack on different areas, whereas the deviation between both devices is relatively low so that the reliability can be guaranteed.
