Rapid Safety Assessment and Experimental Derivation of Damage Indexes for In-Service Glass Slabs

Chiara Bedon, Salvatore Noé

Abstract

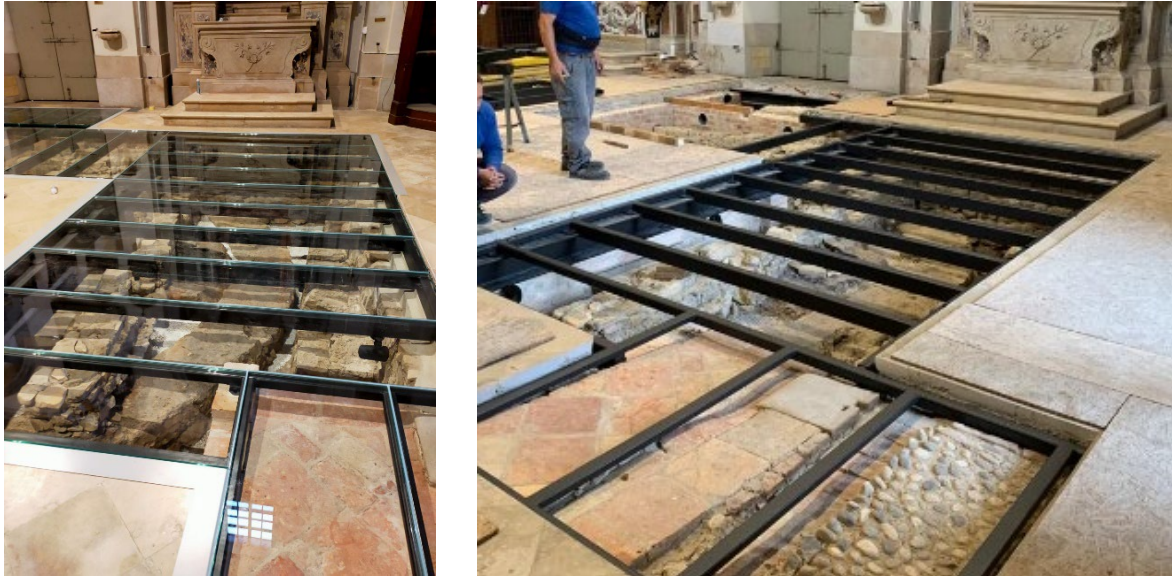
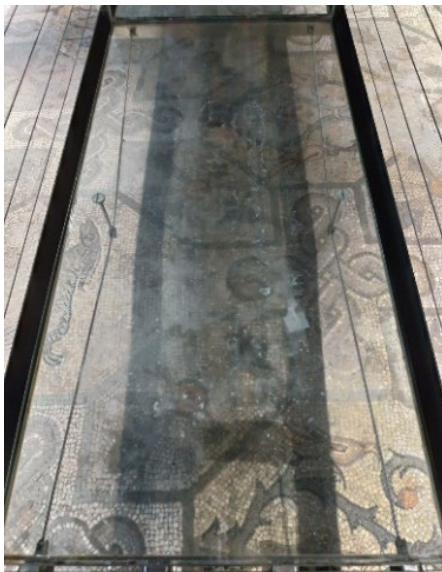
Fig. 3: Overview of examined LG pedestrian systems: (a) SM#1-LGU layout (pictures taken during retrofit interventions, Courtesy of Seretti Vetroarchitettura), (b) top view of SM#2-LGU modular unit (reproduced from (Bedon & Noè 2021) under the terms and conditions of CC-BY license) and (c) glass failure detail for SM#3-LGF panel.

The first one, herein called SM#1-LGU, is located in San Giorgio di Nogaro (UD). At the time of the experimental analysis (December 2020), the typical modular unit was characterized by 8 / 10 / 8 mm thick, fully tempered (FT) glass layers to compose the resisting LG section, with 0.76 mm thick PVB bonding layers. The original pedestrian system, ≈ 15 years apart from the on-site installation, has been retrofitted during Spring 2021 and replaced structural components with identical properties (Figure 3

(a). The total size is $L= 2.80$ m in length by $B= 0.51$ m in width, and hollow box steel frame members (60 mm \times 100 mm in section, 5 mm in thickness) are used to realize a linear support along the maximum edges. The connection takes advantage of interposed 5 mm thick and 20 mm wide rubber tapes. Such a geometrical configuration resulted by specific site features at the time of the original design planning (Figure 3 (a)), and resulted in relatively stiff LG panels with a short bending span B .

interaction between LG and the top AN layer is ensured by contact only. The tested modular units are linearly supported along the short edges. To limit large bending deformations under walking occupants, two pairs of pre-stressed tendons composed of AISI 316 steel are used (10 mm the nominal diameter). Their mechanical interaction with the bottom surface of LG is offered by two unilateral mechanical mid-span point supports only. The difference of two selected modules was represented by the presence of intact glass layers (SM#2-LGU) for the LG + AN sample, or by the presence of one fractured glass layer for the LG section (SM#3-LGF). To note that the top LG layer was fractured during maintenance operations, and a carpet was temporarily used to cover cracks, before replacing the LG + AN module (Figure 3 (c)).

All the samples were subjected to preliminary visual inspection to detect possible anomalies, visible damage and other possible issues. For the present investigation, no visible damage was observed for SM#1-LGU and SM#2-LGU samples, with regard to glass panels or restraints. PVB discolouring was perceived in the bonding layers, and this still represent a signal of deterioration (El-Sisi et al. 2020). Visible and rather uniform fracture in the top glass layer was recorded for SM#3-LGF module, as schematized in Figure 3 (c).

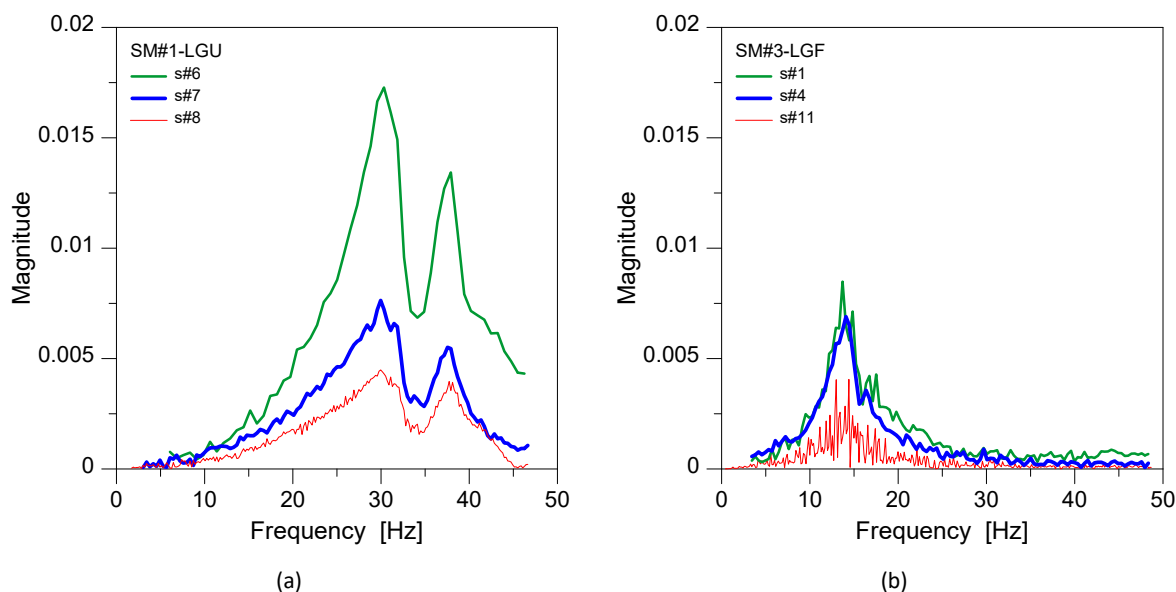
Fig. 5: Frequency domain response of the examined systems: example of selected experimental signals for the (a) SM#1-LGU and (b) SM#3-LGF modules.

Figure 5 shows selected examples of FFT signals from vertical accelerations. It can be easily perceived a markedly different vibration response of examined modules, with relatively high variation of fundamental vibration frequency. Compared to existing design standards to prevent severe vibration issues in pedestrian systems, it is possible to see that FFT peaks denoting the presence of vibration modes are significantly higher than the recommended minimum value of 5 Hz (Bedon & Fasan 2019). Besides, it is worth to note that the mechanical and geometrical properties of typical LG slabs are relatively different from other construction typologies, and thus result in higher sensitivity to walking induced effects.

The experimental vibration frequency of the examined systems was measured in 30 Hz (± 0.39) for SM#1-LGU system. For SM#2-LGU and SM#3-LGF slabs with similar geometrical and mechanical properties, but different damage magnitude, the experimental investigation resulted in 15.05 Hz (± 0.2) and 13.8 Hz (± 0.21), thus up to -8.3% vibration frequency decrease, due to glass fracture (Bedon & Noè 2021). Often, no interventions and verifications are required for traditional slabs and floors with fundamental frequency higher than 5-8 Hz (ISO 10137:2007). On the other side, it was shown also in (Bedon & Fasan 2019) that existing reference indicators and comfort assessment procedures cannot

FFT signals as in Figure 5 are of utmost importance for simplified damping estimates (Clough & Penzien 1993). A number of studies have demonstrated that damping has greater sensitivity for characterizing damage than natural frequencies and mode shapes in various applications, but damping-based damage identification is still a research direction ‘in progress’ and is not yet well resolved (Cao et al. 2017). Among others, the half-power bandwidth method is the most representative and widely used approach, due to simplicity in implementation. Accordingly, while damping in LG systems can be affected by several parameters, the analysis of experimental signals in the frequency domain gives:

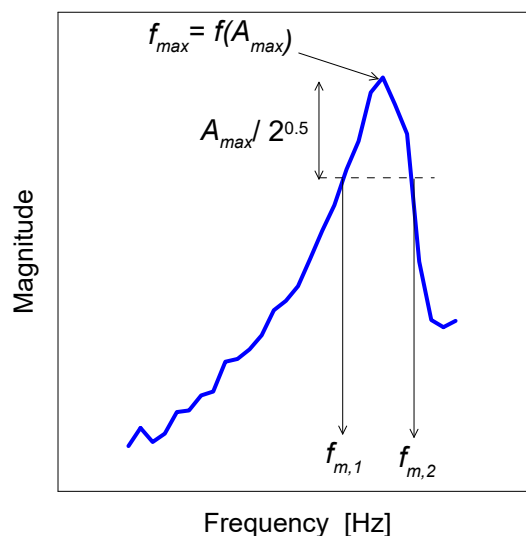
Fig. 6: Rapid damping computation based on classical FFT-based classical half-power bandwidth method.

where the values in Equation (8) are calculated as in the schematic drawing of Figure 6. f_{max} is the resonant frequency and $f_{m,1}$, $f_{m,2}$ the frequencies at the left-hand and right-hand sides of f_{max} respectively, with the amplitude of $f_{m,1}$ and $f_{m,2}$ being calculated as $1/(2^{0.5})$ times that of f_{max} . For the presently examined in-service systems, the average damping was quantified in 6.78% for SM#1-LGU, 7.25% for SM#2-LGU and 8.95% for SM#3-LGF module. The so-calculated damping values reveal a rather uniform value for SM#1-LGU and SM#2-LGU systems, and a relatively higher damping term for the SM#3-LGF affected by partial glass fracture.

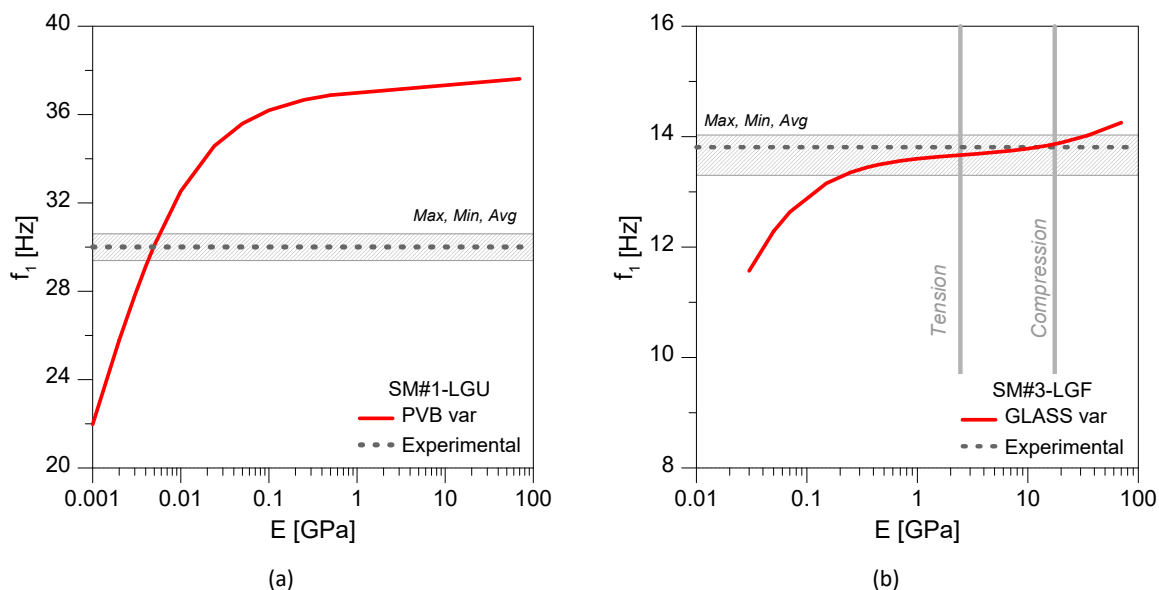
Fig. 10: Material characterization based on FE model updating:
 (a) interlayer stiffness for SM#1-LGU system and (b) fractured glass layer characterization for SM#3-LGF module.

Typical comparative results are proposed in Figure 10.

More in detail, Figure 10 (a) shows the effect of PVB stiffness on the fundamental vibration frequency of SM#1-LGU module. Compared to the average experimental vibration frequency (with evidence of experimental range from a total of 9 signals), it can be seen that the best match is found for E modulus for PVB foils in the order of ≈ 4 -5 MPa. Worth to note that the so calculated equivalent E modulus is in the same order of magnitude of the study reported in (Bedon 2019a, Bedon & Noè 2021), where part of the Aquileia walkway panels have been experimentally investigated with a similar approach ($E = 4$ MPa the proposed equivalent modulus). The experimental study carried out by El-Sisi et al. (2020) on small-scale aged PVB samples under static and dynamic loads confirmed that aged specimens (8-year laboratory ageing protocol) are characterized by bi-linear constitutive response under high strain rates, but a strong decrease in stiffness and overall dynamic parameters, including energy absorption.

In Figure 10 (b), curve fitting is proposed for the SM#3-LGF module in which the degradation of PVB foils acts in combination with glass fracture for the top LG layer (Figure 2). The parametric FE analysis shows in this case that the best match of experimentally derived vibration frequency for the system is in the order of 15 GPa for the fractured glass layer, and this finding is in close correlation with the compressive fractured glass modulus calibrated in (Kozłowski 2019).
