Glass Bridges and Glass Walls

Frank Wellershoff, Michael Sendelbach, Felix Schmitt
Gartner Steel and Glass, Germany, www.gartnersteel.com

Keywords: Glass Bridge, Glass Wall, Testing, Production, Transport, Erection

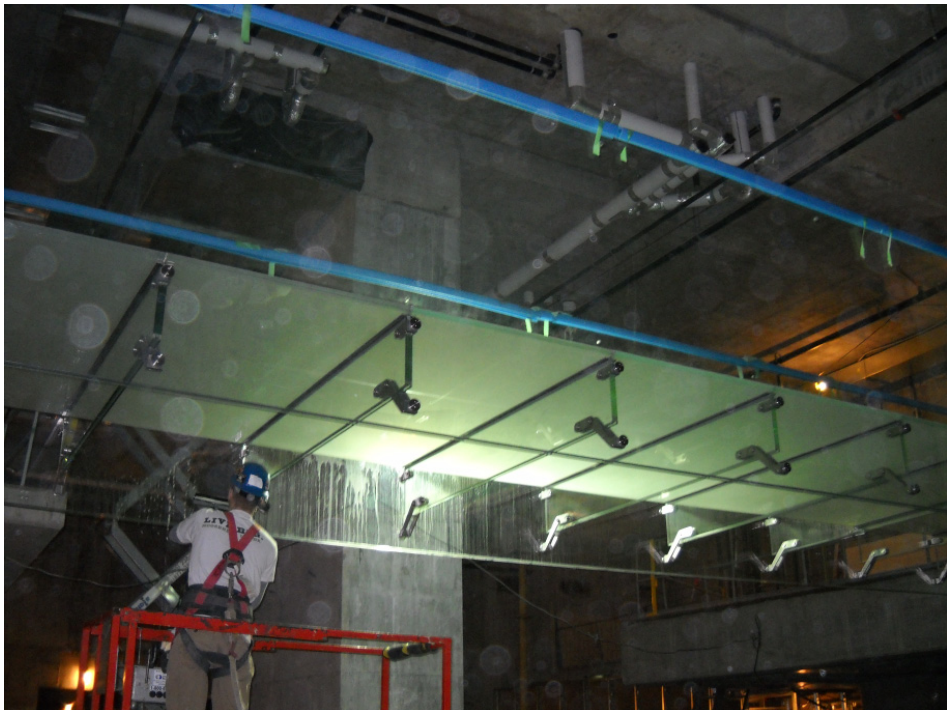
The installation sequence is similar to the installation sequence for the “Eaton Center” Bridge. The Bridge was properly cleaned before the hand-over.

Figure 11: Installation in the Ritz Carlton Hotel

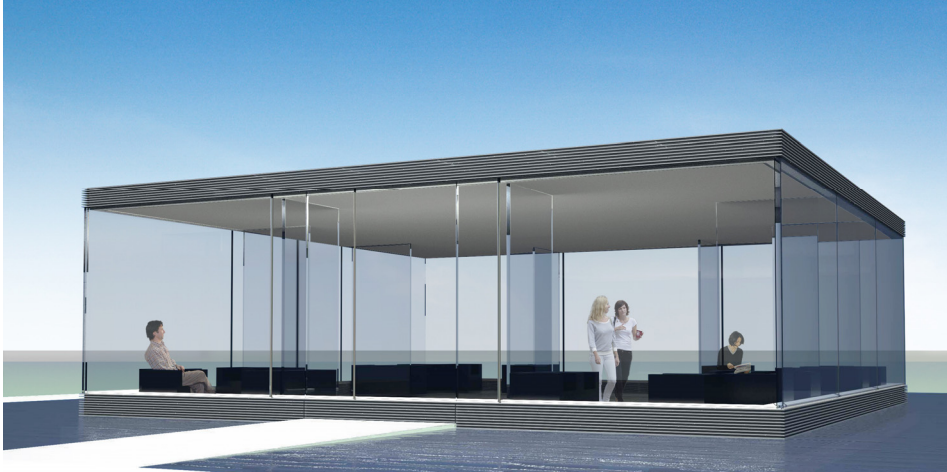
The new Kravis Center at the Claremont MC Kenna College contains besides other buildings a “living room” in the middle of a courtyard. The 11 m x 11 m large steel grid roof is supported by 8 glass walls. Under dead weight and live load the normal force acting on each glass wall is 30 kN. But the real challenges are the high earthquake load assumptions according to the California Building Code. It defines for the area of the MC Kenna College an equivalent horizontal force of 150 % of the self weight for allowable stress design methods.

In the controlling load combinations for allowable stress design the horizontal force at the top of each glass wall is 80 kN combined with a normal force of 10 kN (or 18 kN).

Figure 14: Kravis Center, Living Room (Rafael Vinoly Architects)
