Investigation of Laminated Glass Failures Due to Thermal Contraction in Thick Interlayers

Abstract

Laminated glass, SentryGlas, thermal contraction, Mode II substrate failure, cold climate

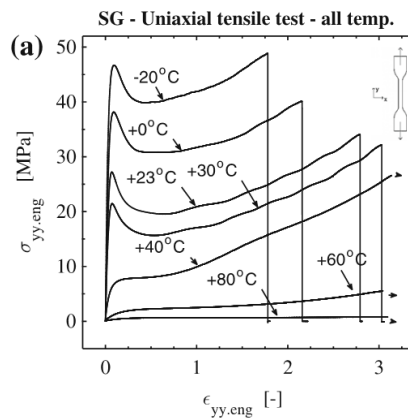
Fig. 1: SG stress-strain curves across a range of temperatures (Santarsiero).

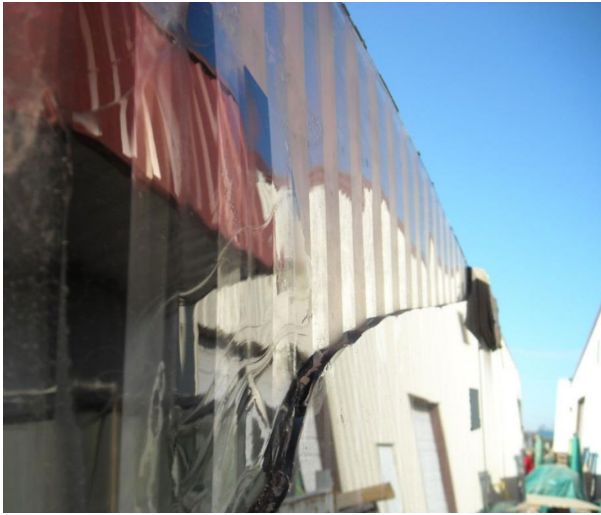
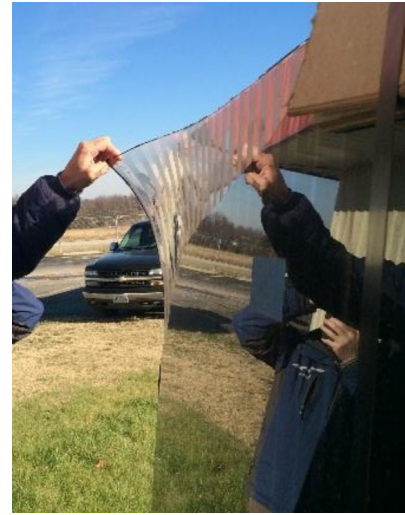
Fig. 3: Failed glass from site. Left: Thin layer of glass stuck to interlayer as evidenced by wavy reflection; Right: Fully detached flexible interlayer at one corner.

Over 80% of the failed panels were at spandrel locations and all failures occurred in one or both of the outer two plies. Failures coincided with cold snaps at the project location, where temperatures were below -20°C, often with high winds (>60km/h gusts; Weather data taken from National Weather Service; No accounting of wind speed was taken in surface temperature determinations).

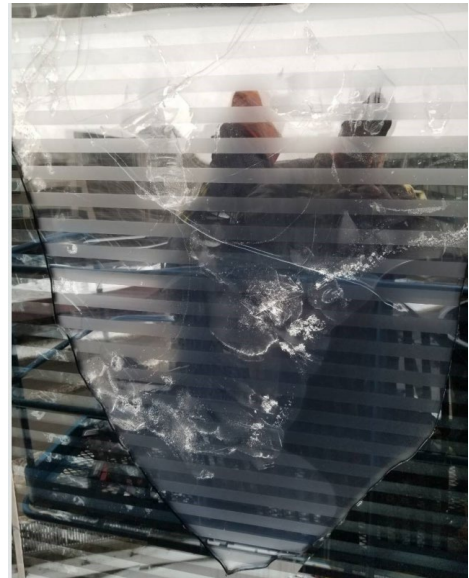
Fig. 4: Left: Salvaged site panel with fully detached interlayer and Ply 1 fragment suffering adhesive failure; Right: Failed site panel where a portion of the outer ply has detached from the interlayer, leaving a thin adhered layer of glass across a portion of the detached zone.

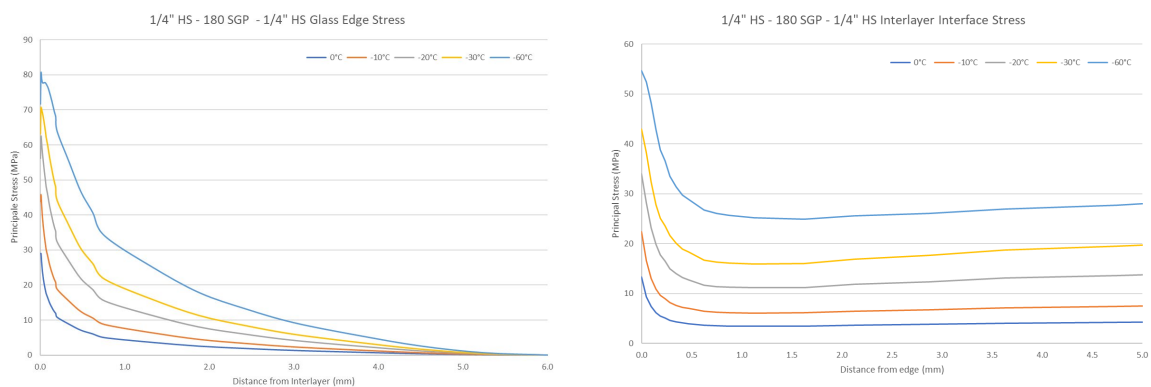
Fig. 6: Calculated stress (glass stress on left, interlayer stress on right) showing localized concentration of stress at edge.

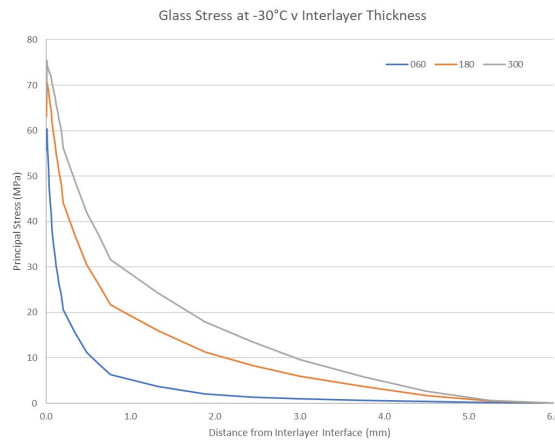
Fig. 7: Correlation of glass stress at -30degC with interlayer thickness, showing increased area under high stress with thicker interlayers.

The FEA results show clear correlation of and increase in both interlayer and glass stresses with increased interlayer thickness. Utilizing the ASTM E1300 RCSS method of determining probability of failure based on applied stress and area of applied stress the effect of increased interlayer thickness on probability of failure is particularly pronounced when comparing 4.57mm interlayer with 1.52 interlayer.

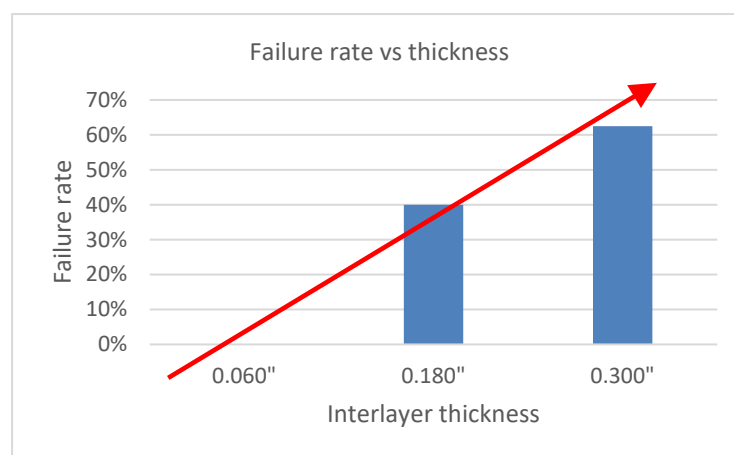
Fig. 8: Correlation between interlayer thickness and failure at cold temperatures.

Freezer testing resulted in failures that were approximately linear with interlayer thickness. All failures occurred between 27 and 75 days of cold temperature exposure and testing indicated no relationship between specimen type and time to failure, however, testing indicated very strong correlation between interlayer thickness and probability of failure. All failures resulted in Mode II (in plane) substrate fractures, thin glass skin on interlayer and some adhesive delamination. Failures typically resulted in damage to both sides of an interlayer indicating the weakness on one side of the interlayer results in higher stresses on the opposing side, resulting in failure on both sides.

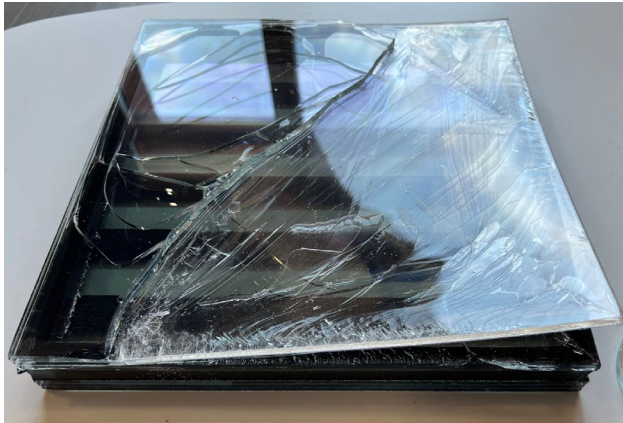
Fig. 9: Freezer tests compared with site glass. Left: freezer test thin layer of glass adhered to on surface (Mode II failure) and adhesive delamination bottom on #3 surface. Right, site sample
