# The Performance of Vacuum Insulating Glazing Units Subjected to a Soft Body Impact

Isabell Schulz <sup>a</sup>, Cenk Kocer <sup>b</sup>, Franz Paschke <sup>a</sup> and Jens Schneider <sup>a</sup>

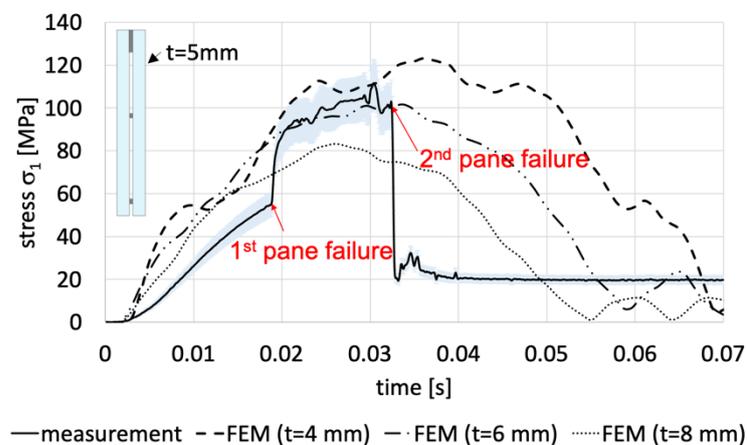
It is worthwhile to consider the impact test of the VIG (producer A) at the 100 mm drop height. Both the glass panes of this VIG unit failed catastrophically when impacted at 100 mm. Two fundamental fracture processes were observed on the glass panes (see figure 4). First, in both glass panes radial cracks originating in the impact contact region (centre-of-glass) formed. The impact energy was high

enough so that pieces of broken glass were ejected from the centre-of-glass area despite the thin plastic foil covering the glass surface. Over the glass pane facing the impactor, additional concentric circular cracks (ring cracks), axially centered to the centre-of-glass, were formed. These fracture patterns are consistent with the centre impact and progressive bending of the sample. At the impact point, bending creates compressive stress on the glass under the impactor (Surfaces 1 and 3), and tensile stresses over the glass surface on the opposite surfaces (Surfaces 2 and 4). As the bending continues, the stresses in the glass at the edge of the frame increase such that there are tensile stresses produced on Surfaces 1 and 3, closer to the edge of the sample. It is from these edge tensile stresses that the ring cracks, as shown in figure 4, originate. This was reported by Chiu (2015) for VIGs under a ball drop impact test and matches stress plots of monolithic panes simulated in SJ Mepla. Figure 5 is a plot of the  $\sigma_1$  stress on Surface 4. From the stress result one can see that glass failure progressed in two steps. About 17ms after initial impact the first pane broke leading to a sudden increase in the stress and 15ms later the second pane broke, being the one on which the strain gauge was applied.

Fig. 5: Measurement of the stress  $\sigma_1$  in the centre of Surface 4 of the VIG (producer A), simulation data for a monolithic of 4, 6 and 8 mm thickness for a 100 mm drop height

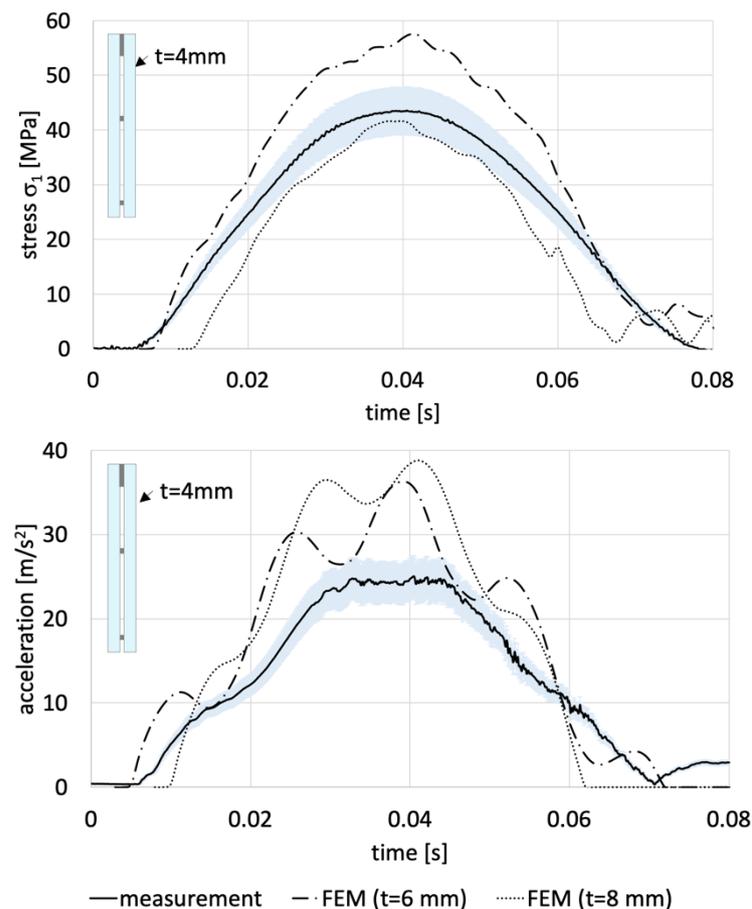
Figure 6 are plots of the measured 1<sup>st</sup> principal stress ( $s_1$ ) and acceleration for a VIG impacted at a drop height of 20 mm, where the VIG survived the impact event. The FE results for impact on an 8 and 6 mm monolithic glass panes are also given. The VIG is constructed from 4 mm glass, and thus, would be an equivalent total thickness of about 8 mm. However, it is interesting that, in Figure 6, overall, the VIG response does not match that of a monolithic glass pane. Even though there is some correlation between the magnitude of  $s_1$ , the period of the data does not agree. The similar is observable for the acceleration data, yet here not even the magnitude is in agreement. In addition, the acceleration data seems to indicate that the vibrational modes of the VIG show quite a different behavior to the one observed for the monolithic glass panes.

Fig. 6: Measurement of the stress  $\sigma_1$  in the centre of Surface 4 of the VIG (producer B), simulation data for a monolithic of 6 and 8 mm thickness and acceleration of the pendulum body for a 20mm drop height

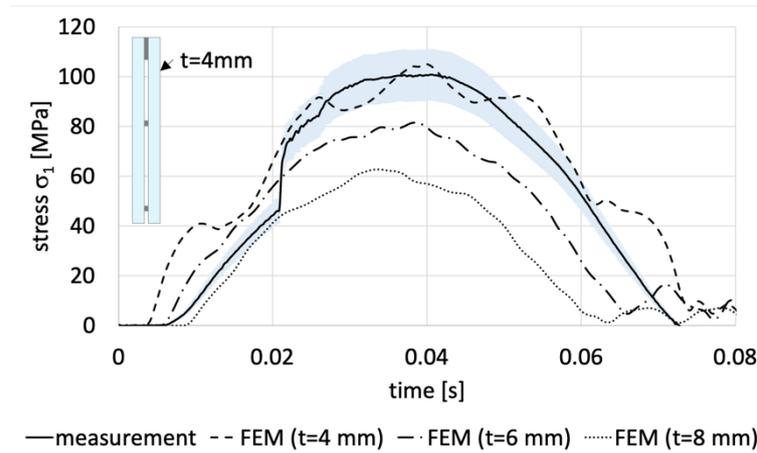
For the second impact, the drop height was increased to 50 mm, and at this height the glass pane on the impactor side failed. The failure origin was at the position of a pillar near the centre of the unit. The failure process is addressed in the section concerning the laminated VIG, since the same failure was observed for both specimens. From the  $s_1$  stress data in figure 7, the second pane did not fail during the impact event, where the data clearly indicates that the stiffness decreases; i.e., the tensile stress increase caused by failure of one of the panes is observable.

Fig. 7: Measurement of the stress  $\sigma_1$  in the centre of Surface 4 of the VIG (producer B), simulation data for a monolithic of 4, 6 and 8 mm thickness for a 50 mm drop height

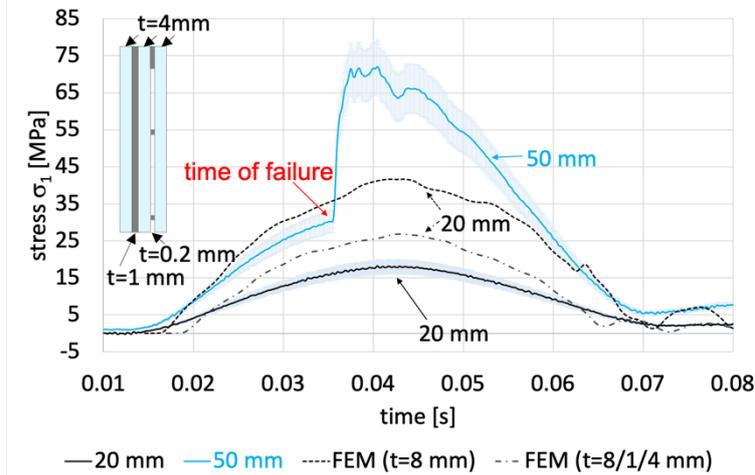
Figure 8 is a plot of the  $s_1$  stress of the laminated VIG. When comparing the stress data, for 20mm drop height in figure 8 to the data in figure 6, it is clear that the maximum measured stress is lower for the laminated VIG because of the increased stiffness of the additional glass pane. However, at the 50 mm drop height, the stress measured on the laminated VIG, when the single glass pane failed, is lower than that measured in the VIG only. This is an indication that the failure of the glass may not be due to the tensile stress from the overall bending of the sample. To gain further insight, the failure pattern in the glass was examined in detail. By correlating the branching events at the cracks it was found that the origin of failure was at a pillar contact point. Images of the fracture pattern are shown in Figure 9, with a magnified image of the pillar at the origin of failure. The fracture pattern at the pillar is indicative of an indentation process, where a contact “cone crack” has formed because of the high tensile stresses on the glass surface. What is unique, however, is that the cone crack in this case has formed into a larger asymmetric geometry which has then propagated into a radial crack. This is possible since at the failure point the local contact load on the pillar forms the cone crack, which extends into the glass as the impact event progresses. Once the cone crack extends far enough into the glass to be influenced by the stress field due to bending of the glass panes, it propagates in two directions away from the pillar following the radial stress trajectory (see figure 9b). Since the crack at this stage is ‘accelerating’ it is highly likely ‘branching’ (also known as bifurcation of the crack front) will occur (Hull 1996). This is clearly seen as the two branching fracture lines that originate at the pillar. When the other failed VIG samples were examined the same failure origin at a pillar was identified.

Fig. 8: Measurement data of the stress  $\sigma_1$  in the centre of Surface 4 of the laminated VIG (producer B) for a 20 mm and 50 mm drop height and comparative FEM results for an 8 mm monolithic and a laminate consisting of 8 mm monolithic, 1 mm cast resin and 4 mm monolithic
