Restoring Hi-Tech Architecture

Peter Lenk ^a, Peter van de Rotten ^b, Ed Forwood ^c

In this paper we will discuss a challenging, iconic, heritage, refurbishment project – Channel 4’s headquarters building located in London, England. The building was originally designed by Richard Rogers and Partners in collaboration with Arup, RFR and was executed in 1994 by Eiffel under a sub-contract package with Permasteelisa. We will methodically outline the procedures that were followed to assess and restore this ageing, iconic cable net façade where, in an almost unprecedented way, the face glass is used structurally to support the dead load of the panels below to create a chain of suspended glass panes. After approximately 25 years of service Arup was called back to provide advice to the client following a glass breakage incident. This triggered a detailed condition survey which concluded that a project refurbishment was overdue. Arup then provided further studies to inform strategic options as to how to best refurbish the façade. This advice led to the appointment of Octatube to provide Pre-Construction Services Agreement (PCSA) support to assist the façade appraisal and to carry out desi

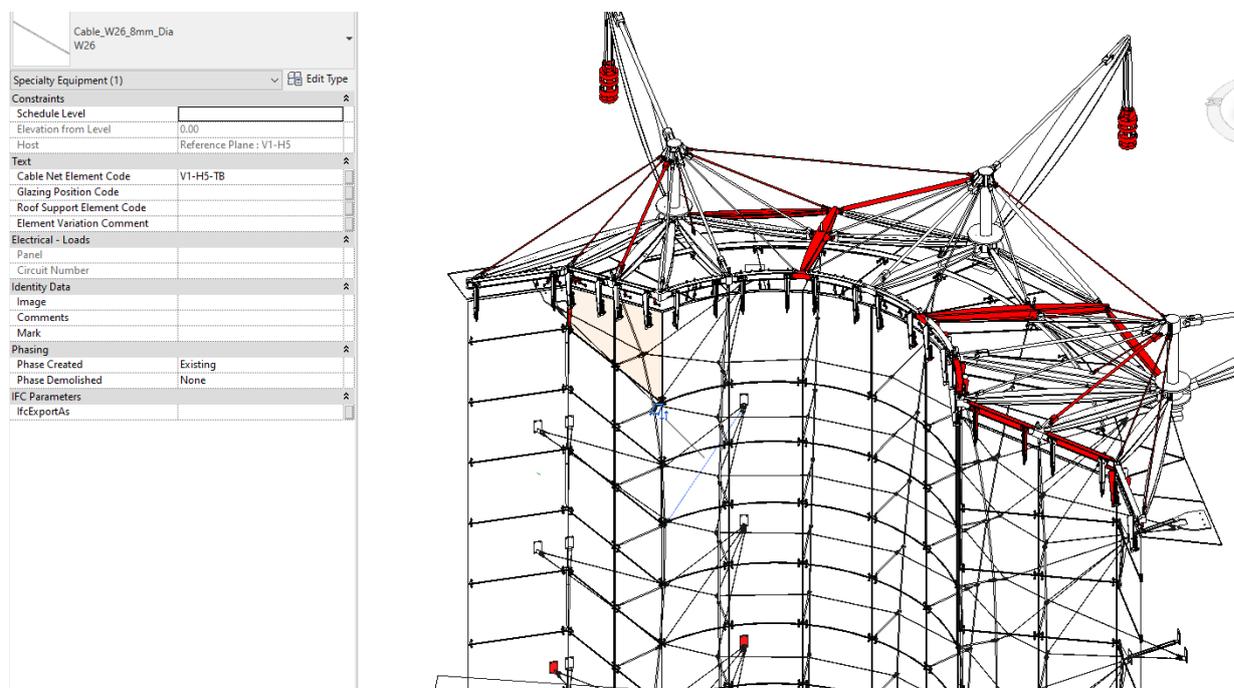
Fig. 6: Extract from BIM Model.

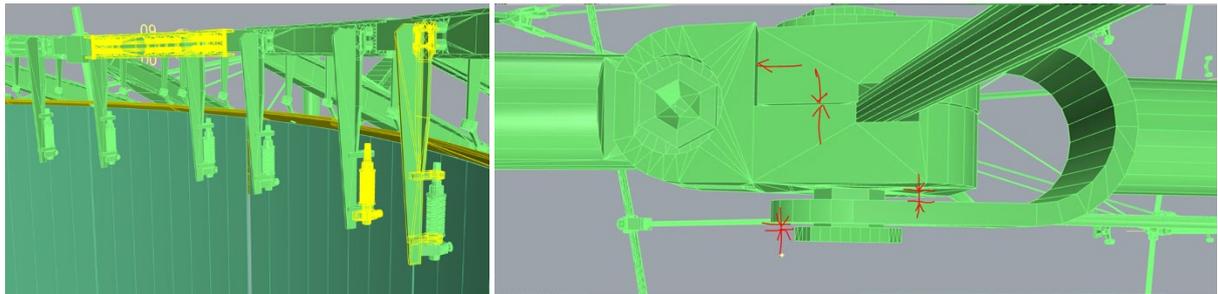
Fig. 7: Example of components groups and clamp connection resolution.

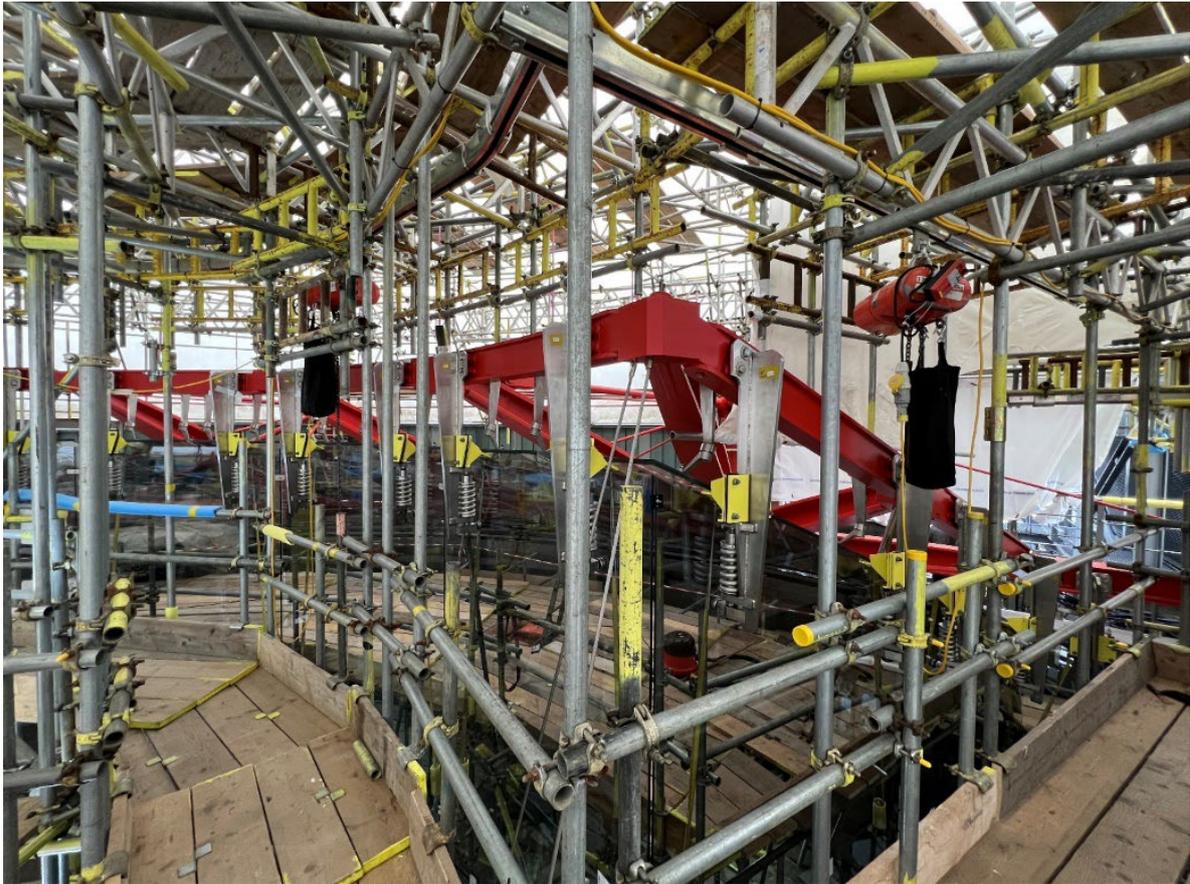
Fig. 14: Scaffolding, 3rd load path.

Prior to the façade disassembly safety over-clamps were also installed in some locations to provide a secondary connection detail where the surveyed fit of the nodes appeared at risk of loosening to such an extent that there was potentially risk of attachment of key connections.

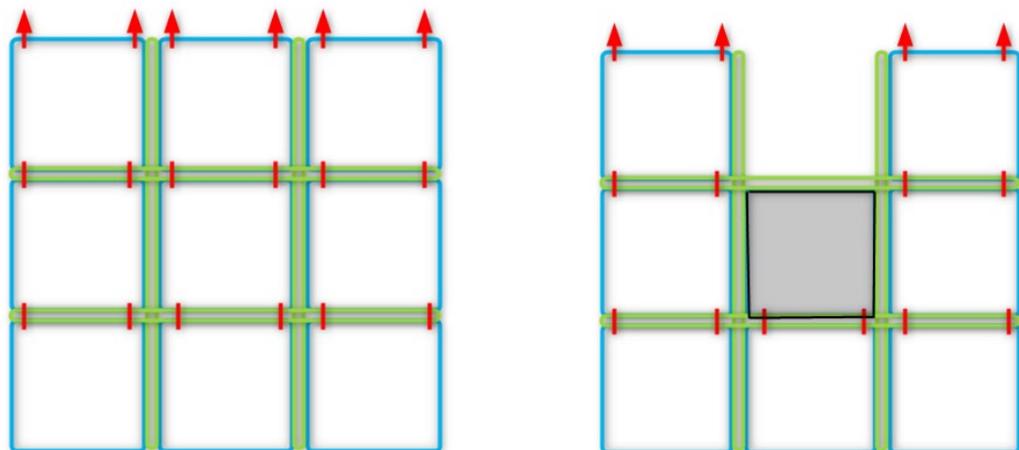
Fig. 15: Mechanical schematization of load path with broken panels. Blue: glass panel, red: steel duos, green: silicone seam. At the top, the glass is suspended from the roof, indicated by red arrows. On the right picture the vertical chain is broken and requires a load re-distribution.

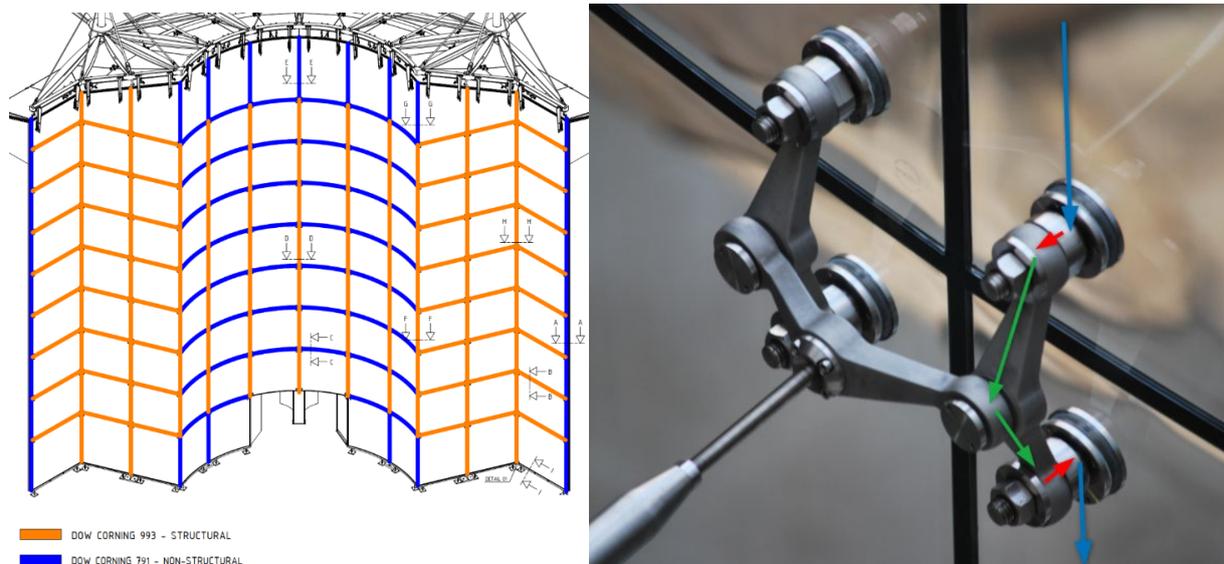
Fig. 16: Left: orange structural sealant, secondary load path.
Right: Chain of primary load path, glass (blue), rotula (red) and duo (green).

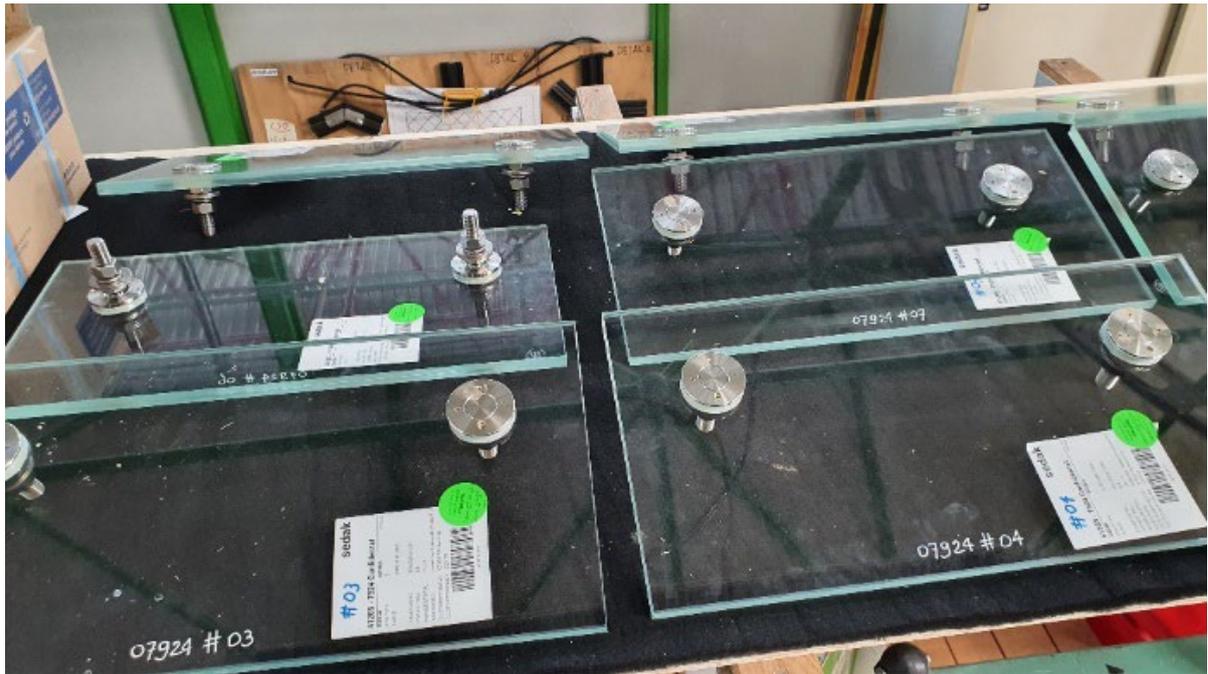
The custom designed point fixing, with the rotula captured with mortar in the glass, was tested. The rotula is subject to high in (glass) plane loads due to the suspension of the façade panels as a chain. According to the results of the tests it can be stated that the special designed rotula with mortar injection is strong enough for this project. The 6 mm glass sheet (inner sheet) broke first followed almost immediately by the 8mm sheet.

The glass initial breakage can be attributed to the point of the highest stress in the calculations as seen in the screenshot of the FEM model showing the location of the highest stress. There were no changes in the appearance of the Hilti resin and no damage observed.

Fig. 17: Samples for testing.

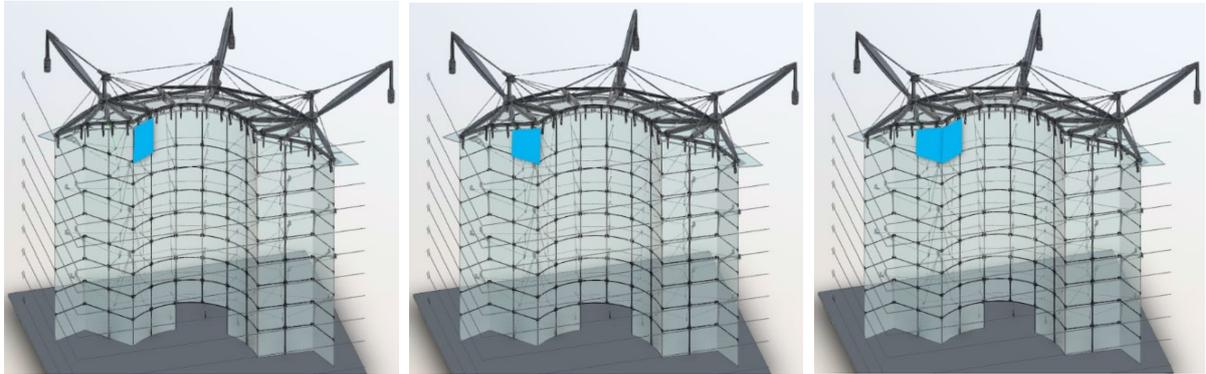
With structural calculations a sensitivity analysis has been done in case of breakage of one or two panels. The load distribution is used to determine the loads for this test. The second load path includes the mobilization of DC 993 silicone, to redistribute the dead loads establishing a post breakage load path. This test assessed a glass package with 2 plies: 8.6 mm (fully tempered, SGP).

Fig. 21: Examples of glass breakage scenarios considered through modelling.
