# Redundancy Tests on Glass Fins

**Keywords:** Structural glass, Glass fins, Physical tests, Redundancy, Post-breakage behavior

## 1. The Spartherm HQ case study

## 2. The National Gallery of Ireland case study

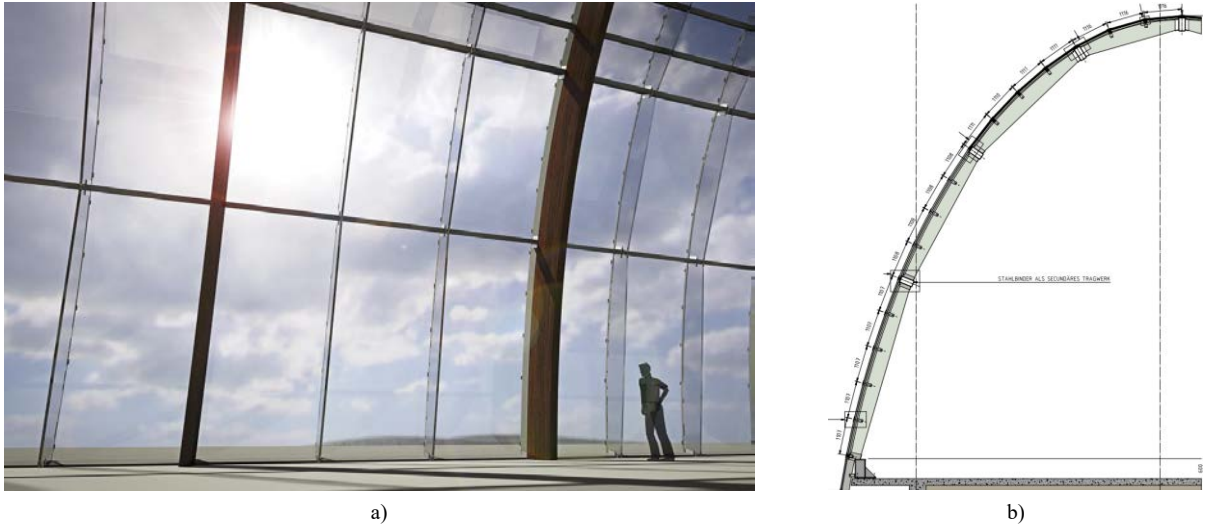
Fig. 2a) and b) Architectural render of the wooden beams at the building top floors and elevation drawing of the glass fins [Podufal-Wiehofsky, Octatube].

At the top floor of the building, the primary load bearing structure for the façade and the external loads is obtained by a set of wooden arches. Horizontal steel hollow sections join the wooden beams to one another and also provide the

supports for the glass fins. The fins are composed of laminated heat strengthened glass with a thickness of 10mm. Between the glass sheets four PVB sheets are used. All edges are arised and ground for safety and esthetical requirements. In order to guarantee structural redundancy to the whole glass fin package, a steel rectangular hollow section RHS 80 x 30 x 3 is connected to holes in the glass via two, three or four steel joints depending on the glass fin length (Figure 3). Finally, cold bent unit with a bending radius up to 20 meters are installed on top of the rectangular hollow sections. The glass fins are supported at the edges by custom-made steel shoes welded on the side of the primary steel (Figure 4). Please note that due to budget cut, the glass fins design option has eventually been discarded and vertical steel hollow profiles have been adopted.

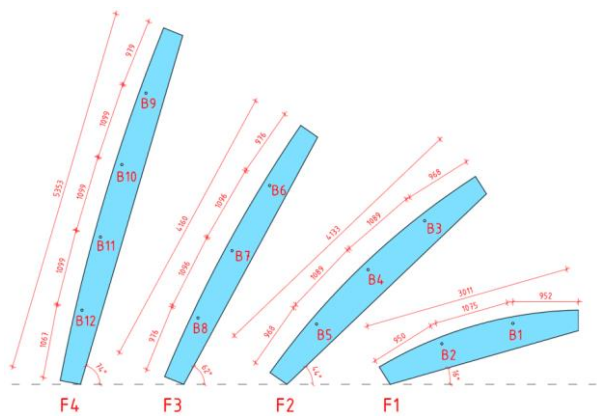
Fig. 3 Sizes and positions of glass holes in the fins. F1 and F2 are segmented on the load outer edge. Types F2 to F4 have a curved outer edge [Octatube].

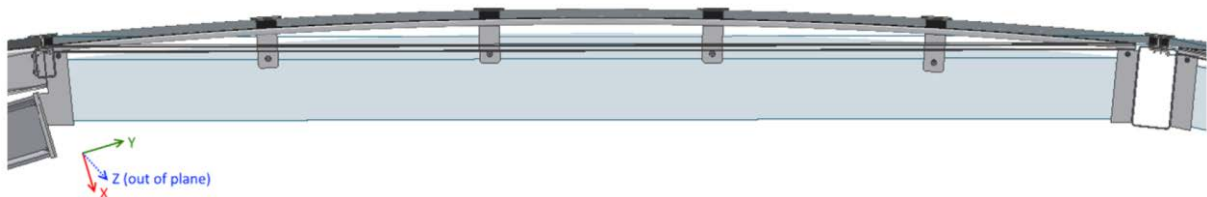
Fig. 4 Glass fin F4, side view [Octatube].

Among four possible fin shapes in the project, two samples of the normative glass fin F4 (length = 5353 mm, height at center = 430 mm, height at ends = 300 mm) are tested both in unbroken and fractured state. Sample 1 is tested for loads acting along the positive X direction (see Figure 4). The following loads are considered: cold bending forces, permanent loads (cold bent glass unit, glass self-weight, the steel RHS weight is neglected) and wind pressure. The fin is placed horizontally, therefore all loads are carefully scaled down to match site conditions.

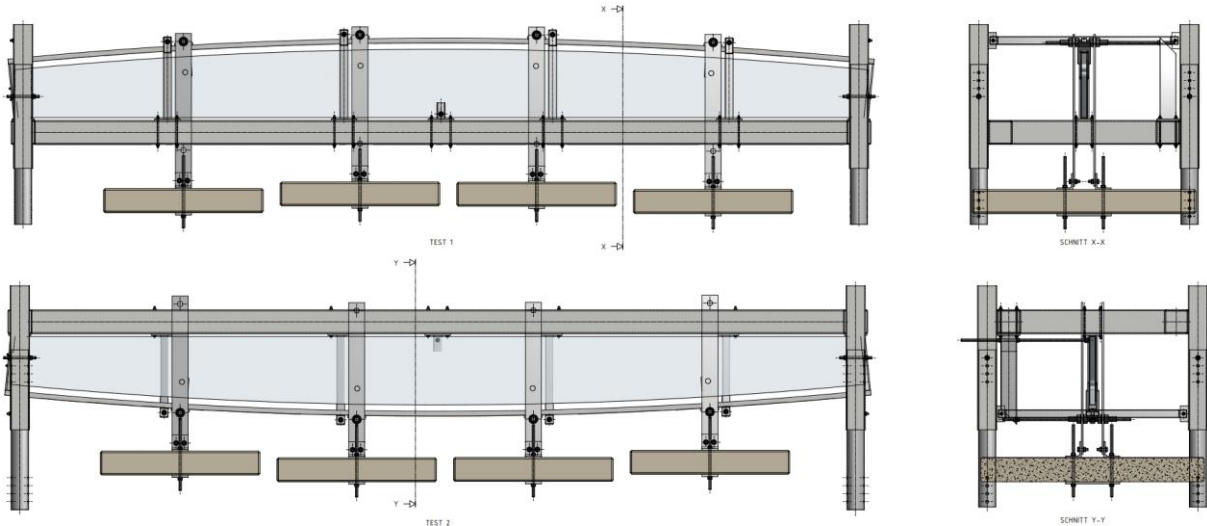
Fig. 5 Test setup drawings (TOP: Sample 1. BOTTOM: Sample 2). The concrete blocks shown are for illustration purpose only [Octatube].

For both cases, the distributed loads are applied to the four holes in the glass fins by means of concrete blocks of about 500 kg each connected via a steel system. When necessary, extra concrete tiles weighing about 9 kg each are added. A single steel frame is engineered to be able to carry out tests for both samples (Figure 5). All tests are carried out at room temperature of about 20°C.

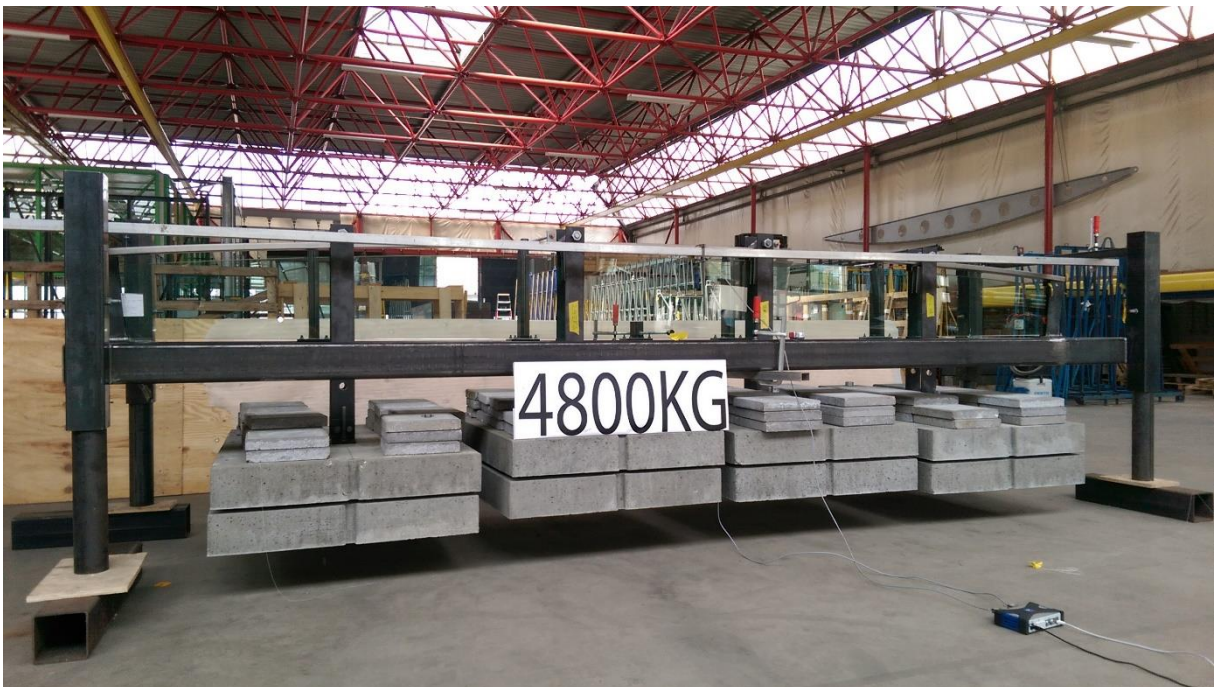
Fig. 8 Sample 1 – 2.5x ULS301= 4800 kg [Octatube].

A total load of 4800 kg is gradually applied on Sample 1 to simulate load case 2.5xULS301. An overall stable fin is observed under the loads. Furthermore, the unfractured glass surface proves that the proposed structural design of the fin (including detailing of the connections) is safe also from a strength point of view.

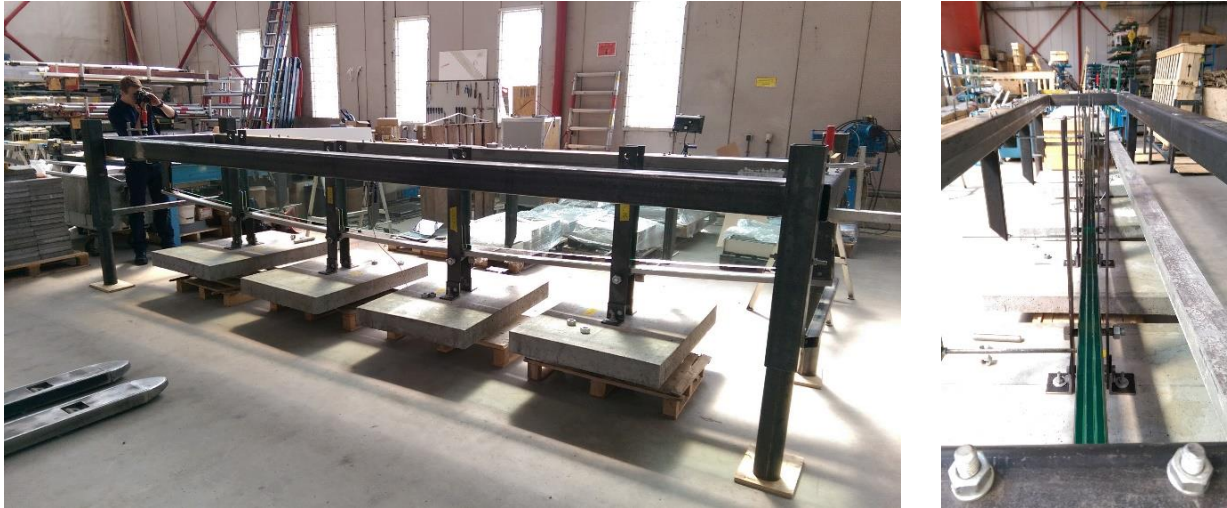
Fig. 9 Right, Sample 2 – 2.5xULS302. Left, lateral deflection under the loads is monitored via a displacement gauge [Octatube].

Sample 2 should be tested under a total load of 1100 kg. However, the total number of tiles applied to simulate ULS302 is four and this results in a total load of  $4 \times 500\text{kg} = 2000\text{kg}$ . Also in this case and even with a higher test load, the fin safely withstood the buckling load without any signs of instability or visible damage on the glass.

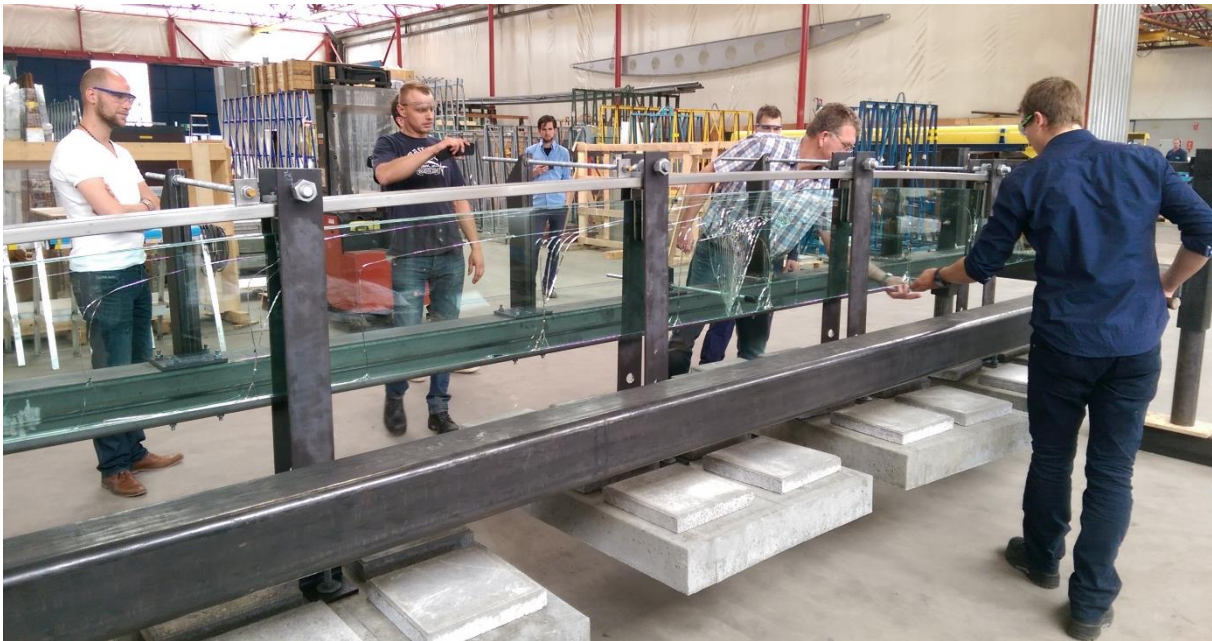
Fig. 10 Sample 1 is cracked in seven spots along its length and all three panes [Octatube].

For Sample 1, the post breakage behavior under a total load of about 2200 kg is assessed. All three panes in the glass beam are manually broken in seven points after that the full load is applied. Under the effects of the static load, the cracks in the glass are observed to grow further from their origin causing a diffused crack pattern and concentrating the most in a particularly weak spot in the beam close to one of the holes (Figure 11). The redundancy of the system is guaranteed by activating the secondary load path through the utilization of the steel RHS 80 x 30 x 3 connected to the top of the glass fin. In this way a ductile behavior of the system is achieved and a safe post breakage mechanism is possible as the beam gradually fails.

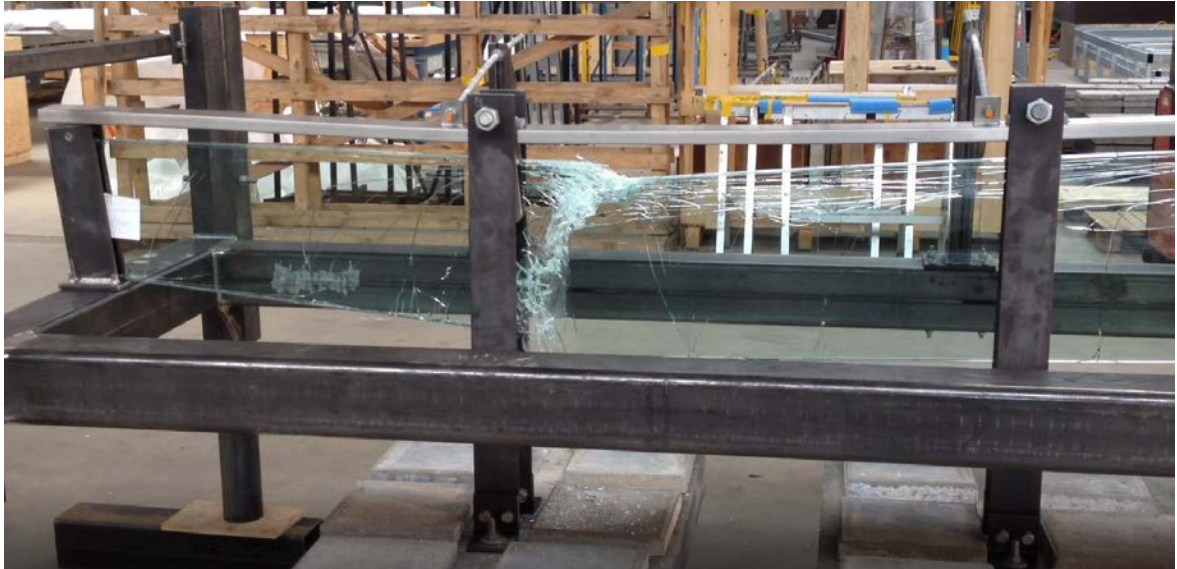
Fig. 11 Cracks in the glass fin during post breakage load test [Octatube].

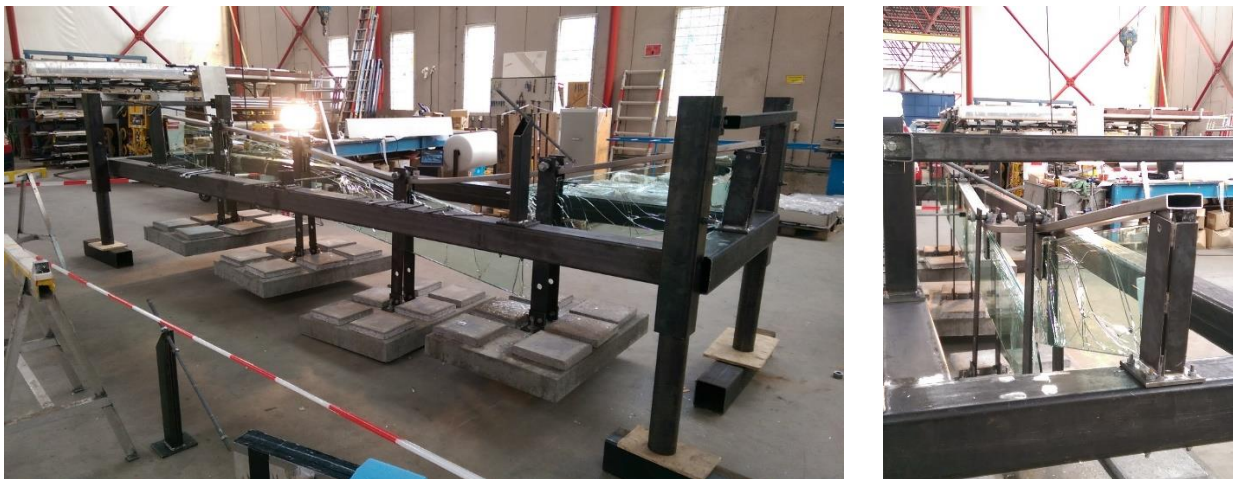
Fig. 12 Sample 1 – Post breakage failure [Octatube].

Finally, sample 1 underwent a loading test where all glass plies in the fin were manually broken in seven spots. Under the effect of a reduced load (2200kg), the glass fin gradually failed in a ductile fashion. This was achieved by introducing overall redundancy to the system via bolting a steel RHS 80 x 30 x 3 on top of the glass fin. Furthermore, the result showcased the importance of designing a structural system that also has a secondary load path to be activated in case of failure of the primary load bearing system. Also in this case, the test result is satisfactory.

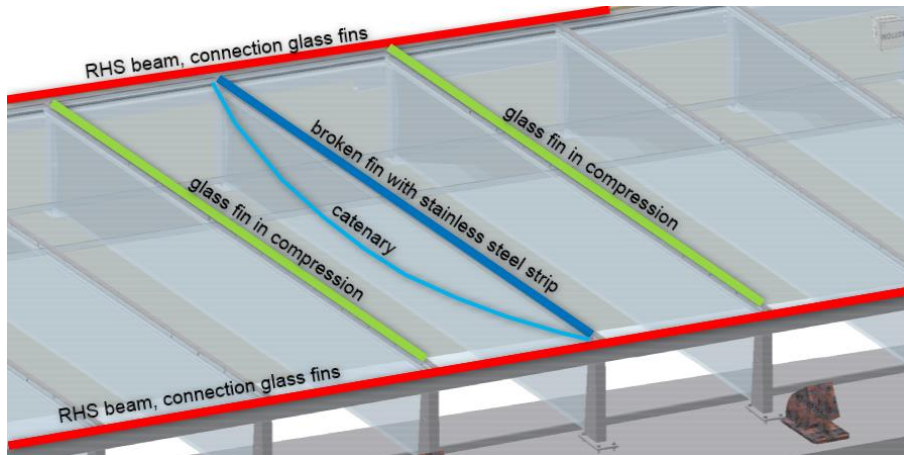
Fig. 15 Active system in case of broken glass fin.

During the engineering phase of the glass fin roof it was explicitly taken into account that glass may become damaged, by an unidentified hazard, during the life-time of the roof. Glass fins structures are always designed with structural redundancy, by creating multiple lines of safety for glass fin design. At the TU Delft different concepts of providing redundancy through the addition of steel profiles has been extensively researched at the TU Delft (Louter, 2011). And extensive testing of glass beams with a range of different compositions under different levels of pre-applied damage has been performed (Bos, 2006). For this project a secondary load path has been designed, in cooperation with T/E/S/S, in case one of the glass fins experiences a three-sheet fracture. In case of complete fracture the glass becomes a suspended structure since a catenary line is formed between the glazing support profiles. The catenary forces are transferred in-plane to the fins adjacent next to the broken fin.

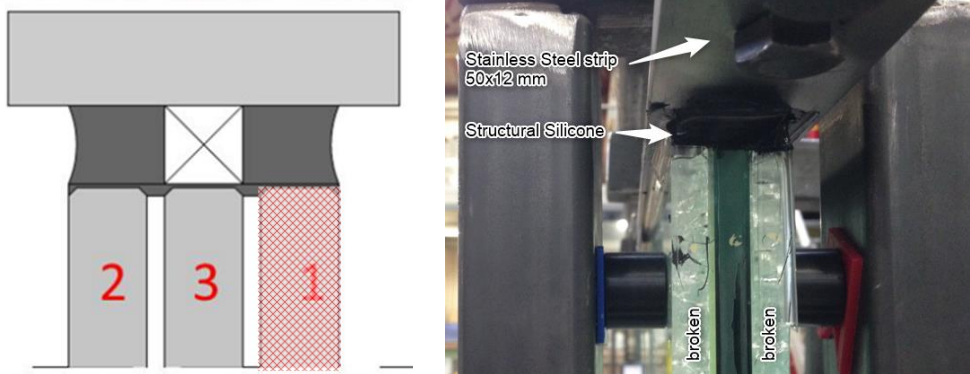
Fig. 16 Cross section of the glass fin, on or two sheet broken, stainless steel connected to glass with structural silicone.

1. Residual capacity in the strength of the material – no glass sheets broken: Under normal circumstances, the glass fin transfers all vertical loads to the supports. The fin shoe on the left side provides horizontal support, since the bottom is fixed. At the top of the fin shoes, the glazing support profile is hinged.
2. Lamination of the glass fin – one glass sheet broken: See Fig 16. The glass fin is actually a laminated pane with three separate glass sheets. If one sheet is damaged, there are always two additional glass sheets which are capable of carrying the applied forces on the fin.
3. Lamination of the glass fin – two glass sheets broken: See Fig 16 and 17 In case two separate sheets are damaged, the fin is still required to remain structurally safe. The fragility has shown that the fin is able to carry at least the self-weight of the glass and the superstructure.

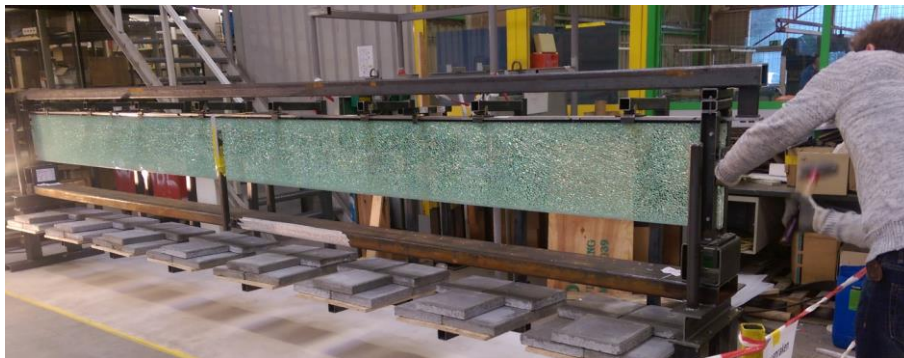
Fig. 17 Fin with two broken glass sheets, post failure behavior.

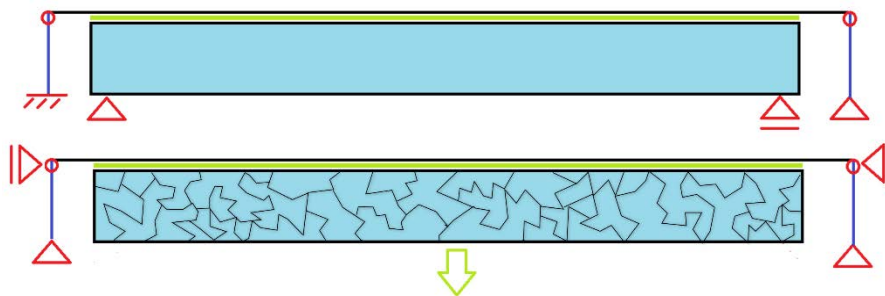
Fig. 18 Top: fin in unbroken situation. Bottom: fin in broken situation, supported by the glazing support profile.

The test fin has a length of 6000 mm, a height of 400 mm and sheet thickness of 10 mm. The glass fin consists of three sheets, fully tempered glass, which are laminated with 6x0.38mm of PVB as interlayer. The strip has been sealed on the glass fin using a structural sealant, Dow Corning 895. To equally space the steel strip on the fin, foam tape has been used with a height of  $t = 10\text{mm}$ , the sealant has a width of 10mm per side and a thickness of 10 mm. The dimensions of the stainless steel profile are 50x12mm, AISI 316L is the quality adopted. The total length of the profile is 6250mm, where the profile protrudes 125mm at both ends of the glass fin. Short slotted holes, parallel to the fin, are made in the profile to allow for a small initial deformation. This enables the formation of the catenary.

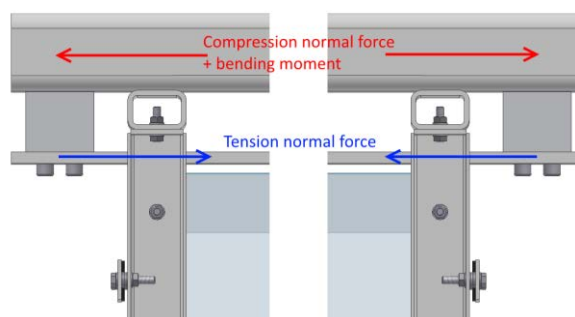
Fig. 19 Broken fin, closed system of tension normal force and compression normal force, SHS 80\*80\*8 mm, S235 (source M. van Telgen MSc).

When the glass breaks the glazing support profile deforms due to the load, then the vertical load is transferred to the bolted supports at the ends. This results in a tension normal force in the stainless steel strip, a horizontal reaction force (directed outwards) and a vertical reaction force (directed upwards) at the supports. The horizontal force is carried by the subsequently described system in the following section. The vertical force is carried by the support structure through the fin shoes as a normal force.

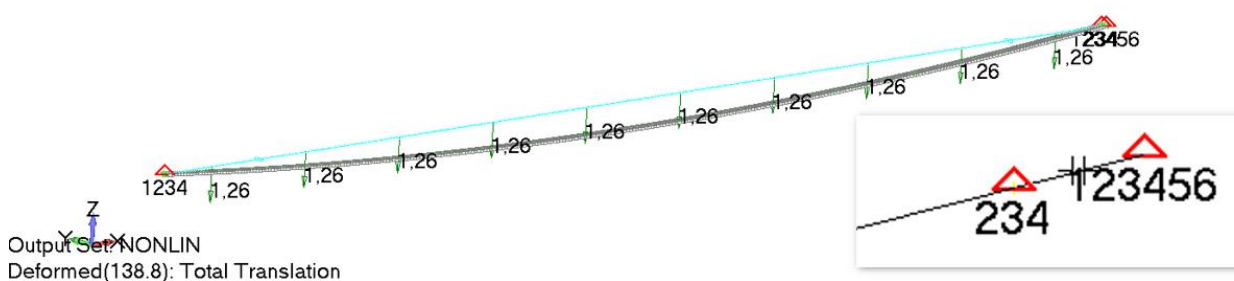
Fig. 20 Simply supported beam under a uniformly distributed load of 1.26 kN/m. GAP element highlighted on the right hand side.

For the test a simplified numerical calculation has been carried out. The FE model consists of a single ‘beam’ element, with geometrical and mechanical properties of a 50x12 mm stainless steel strip, two sided supported. On one side a gap element of 6mm has been introduced, to simulate the the slotted hole present in the test setting. The total linear load applied to the beam element is 1.26 kN/m (including glass fin weight). A non linear large deflection calculation was performed.

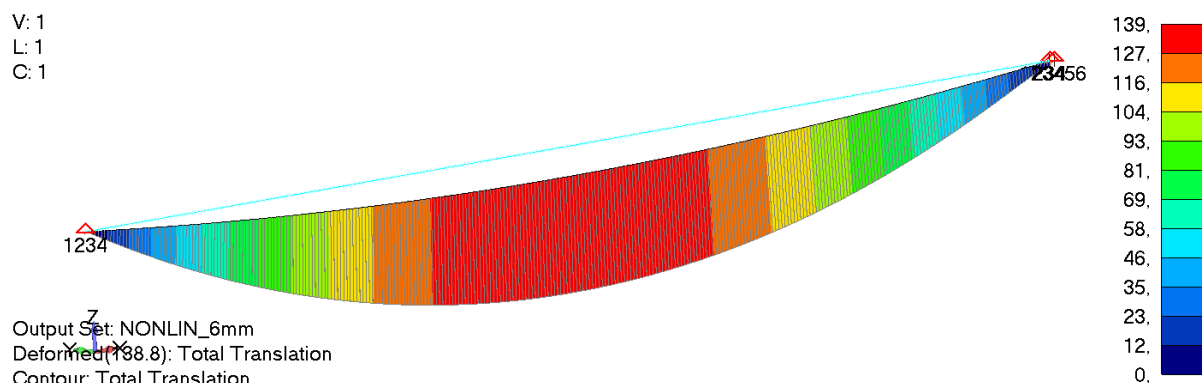
Fig. 21 Deflection of the strip under applied loads. GAP of 6 mm.

A deflection of 139 mm results from the performed analysis and it describes the system response in case the glass fin has no load bearing capacity after all glass plies are broken. The full weight of the glass fin is supported by the catenary. The system response to the GAP element introduction is quite sensitive For comparison, a FE model of the stainless steel strip without the GAP element, deflects vertically by 93 mm.

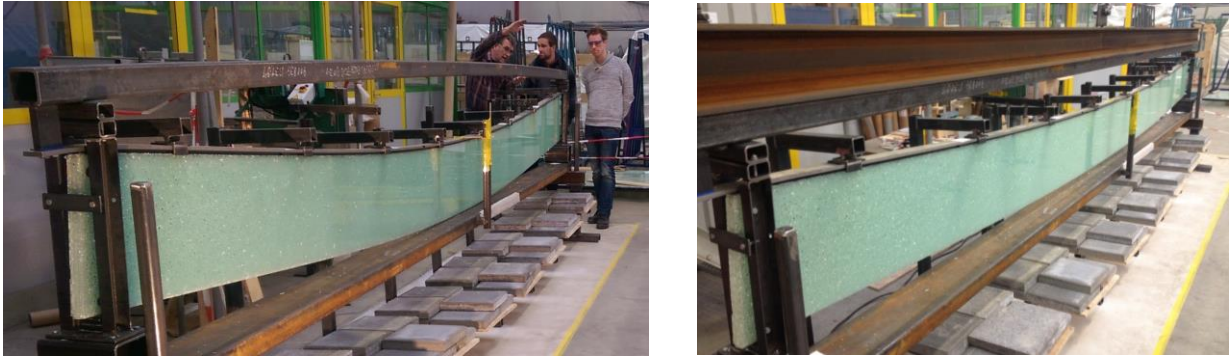
Fig. 22 Deformation of the system after breaking the third glass sheet.

The deformation of the fin after breakage of the third ply, was instant. After the first deflection a small additional deflection was observed. The total deformation was 182mm, where 140mm was predicted with an FEM model, which is not discussed in detail in this paper. The RHS80x80x8 section deflects upwards due to the bending moment. This leads to additional deflection of the glass fin because the supports moved inward. After applying a much stiffer HEA profile on top of the SHS, the deflection of the glass fin was only 135 mm. The beam was left standing for a week. During this time period, no additional deflections were measured.

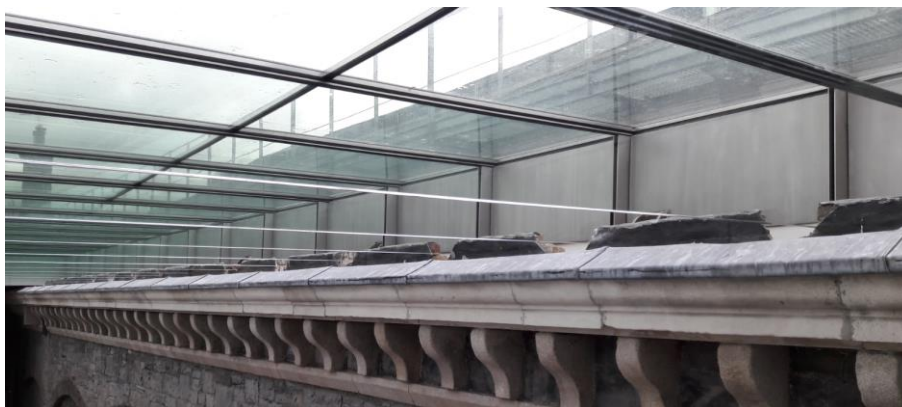
Fig. 24 Glass on installed on site.
