Experimental Analysis of Fire Resistance of Laminated Glass Beams

Abstract

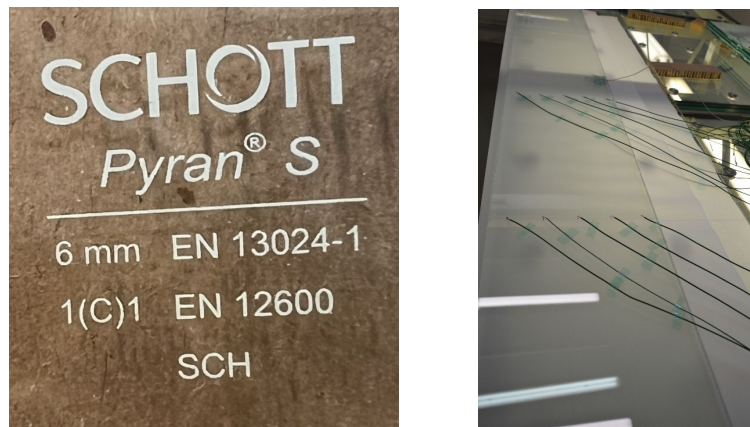
Fig. 3: Sample B: on the left, the PYRAN® S borosilicate glass label; on the right, the attachment of thermocouples and a measuring cable for recording deflection during the fire test.

Sample B (Fig. 3) was based on the composition of laminated glass with a total thickness of 30.76 mm. Two panes of 6 mm thick PYRAN® S (SCHOTT, 2023) borosilicate glass were added to the outer sides, see Fig. 2. The interlayer was again made of EVA (ArmiGlass, 2020) foil with a total thickness of 0.76 mm.

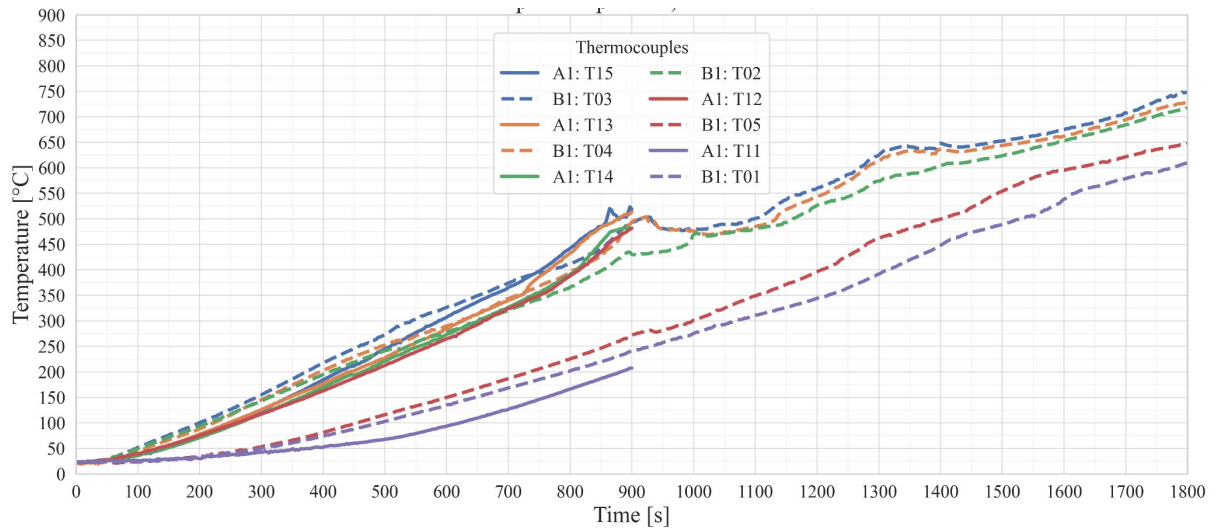
Fig. 7: Comparison of temperatures at the same thermocouple positions from sections A1 and B1.

The fire test of test specimen A (Fig. 7) was started by activating the heating at time $t = 0$. In the initial phase, no significant visual changes were observed on the surface of the glass beam. Approximately 60 seconds after the start of heating, slight fogging of the glass occurred.

The fire test of test specimen B (Fig. 7 and 8) was started by turning on the heating at time $t = 0$. In the initial phase, there were no significant visual changes on the surface of the glass beam. After approximately 455 s, clouding of the fire-resistant glass was observed.

The experiment confirmed that the combination of a significant temperature gradient and constant mechanical loading represents a critical stress state for laminated glass beams. At the same time, the importance of using borosilicate protection in terms of modifying the fracture process was demonstrated (Fig. 7). The temperature and deformation data obtained form the basis for future experimental research and subsequent numerical modelling of heat transfer and thermo-mechanical behaviour of laminated glass under fire load.

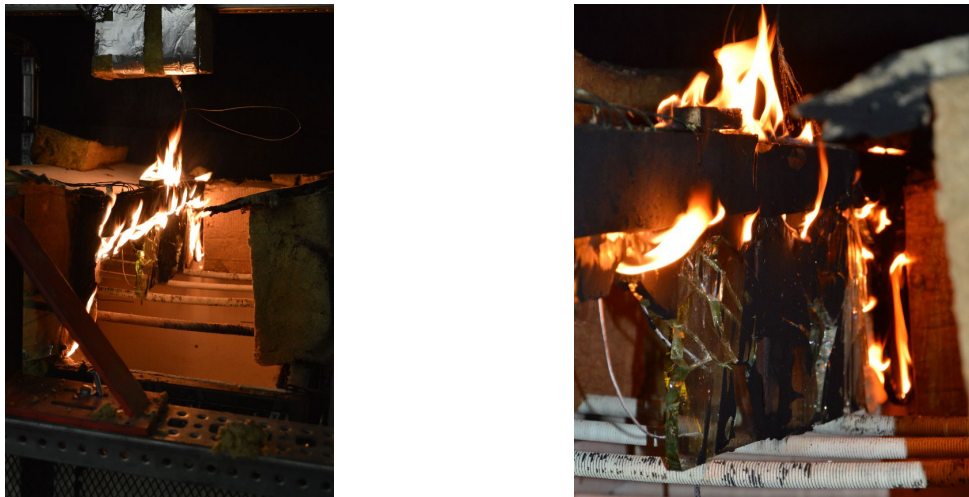
Fig. 9: Sample A – Deformation of the sample after the fire test.

The unprotected beam gradually developed cracks in all glass plies (Fig. 9) and collapsed completely after 900 seconds. Significant temperature gradients of up to 300 °C were recorded in the cross-section, leading to intense thermal stress and collapse. The increase in temperature was accompanied by a progressive increase in deflection, and after the individual plies cracked, the layers were no longer able to transfer the load.

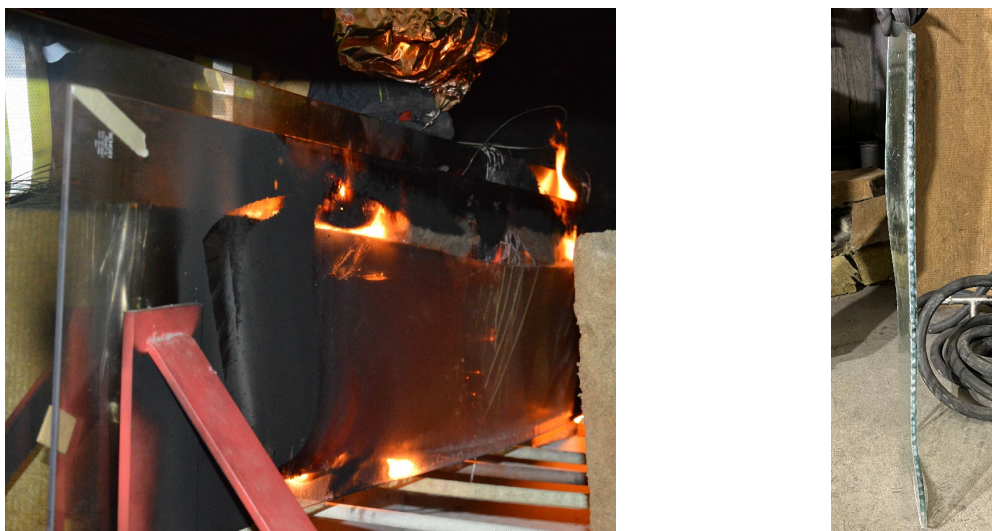
Fig. 10: Sample B – left: deformation of the sample after uncovering, right: deformation of the middle ply of float glass.

Failure mode was different for the beam with a borosilicate protective layer (Fig. 10). The presence of external layers modified the temperature field in the cross-section and influenced the time development of defects. The test lasted 1800 s without the element collapsing during exposure. Here, too, a correlation was observed between the temperature increase, the degradation of the EVA (ArmiGlass, 2020) interlayer, and the change in the nature of the deformation, but the time course was different from that of the reference sample.
